Fairway Rehabilitation and Maintenance Master Plan for the Danube and its navigable tributaries:

NATIONAL ACTION PLANS

UPDATE MAY 2016

Developed within the **EU co-financed project FAIRway**

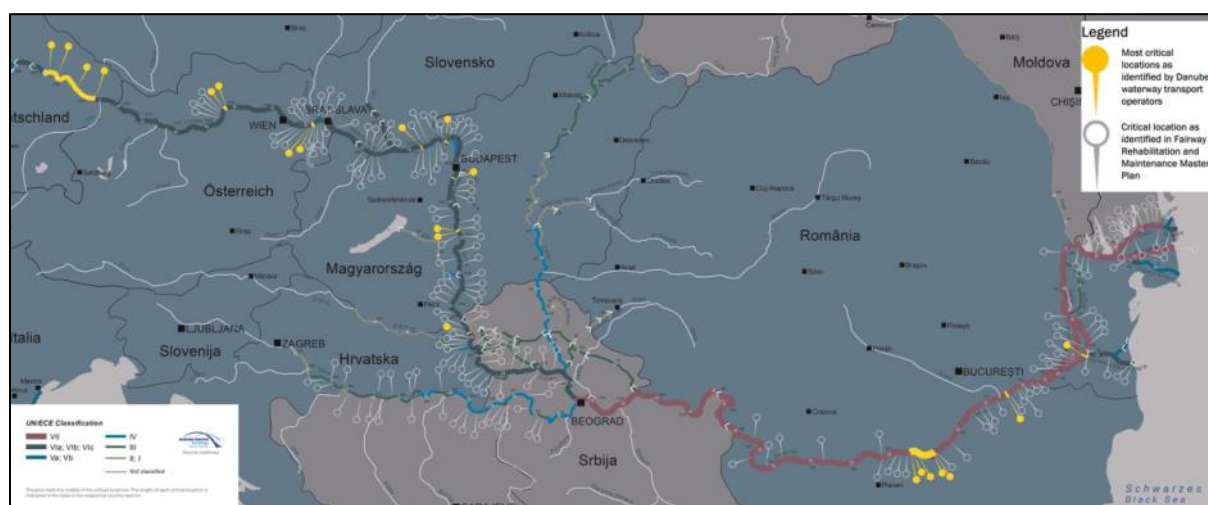
Introduction

It focuses on the most critical sections as identified by a sample of 24 important shipping organisations and waterway administrations in December 2014. From the user perspective, the locations and stretches marked yellow in the map and listed in the table below cause the biggest navigational problems and should consequently be treated with the highest priority. For reporting purposes, some of the locations have been grouped in the country chapters.

location and length (km)			right bank / left bank	name of sector or location
river-km (from - to)		length		
2,321.70	2,312.00	9,50	DE / DE	Straubing (lock)–Straubing-Sand (port)
2,312.00	2,282.50	29,70	DE / DE	Straubing-Sand (port)–Deggendorf
2,282.50	2,249,90	32,50	DE / DE	Deggendorf – Vilshofen (backwater Kachlet)
2,014.00	2,013.50	0,50	AT / AT	Weißkirchen
2,010.20	2,008.90	1,30	AT / AT	Dürnstein
1,888.40	1,887.60	0,80	AT / AT	Treuschütt
1,884.70	1,883.50	1,20	AT / AT	Hainburg
1,735.50	1,733.70	1,80	HU / SK	Nyergesújfalu
1,698.00	1,697.00	1,00	HU / HU	Dömös
1,638.40	1,637.40	1,00	HU / HU	Budafok
1,559.80	1,559.70	0,10	HU / HU	Dunaföldvár
1,558.50	1,557.50	1,00	HU / HU	Solt
1,408.20	1,400.00	8,20	HR / RS	Apatin
309,00	308,00	1,00	RO / RO	Cochirleni
568,20	567,80	0,40	BG / RO	Milka Island
567,00	566,70	0,30	BG / RO	Belene Island
562,00	561,50	0,50	BG / RO	Coundur Island
541,60	541,00	0,60	BG / RO	Vardim Island

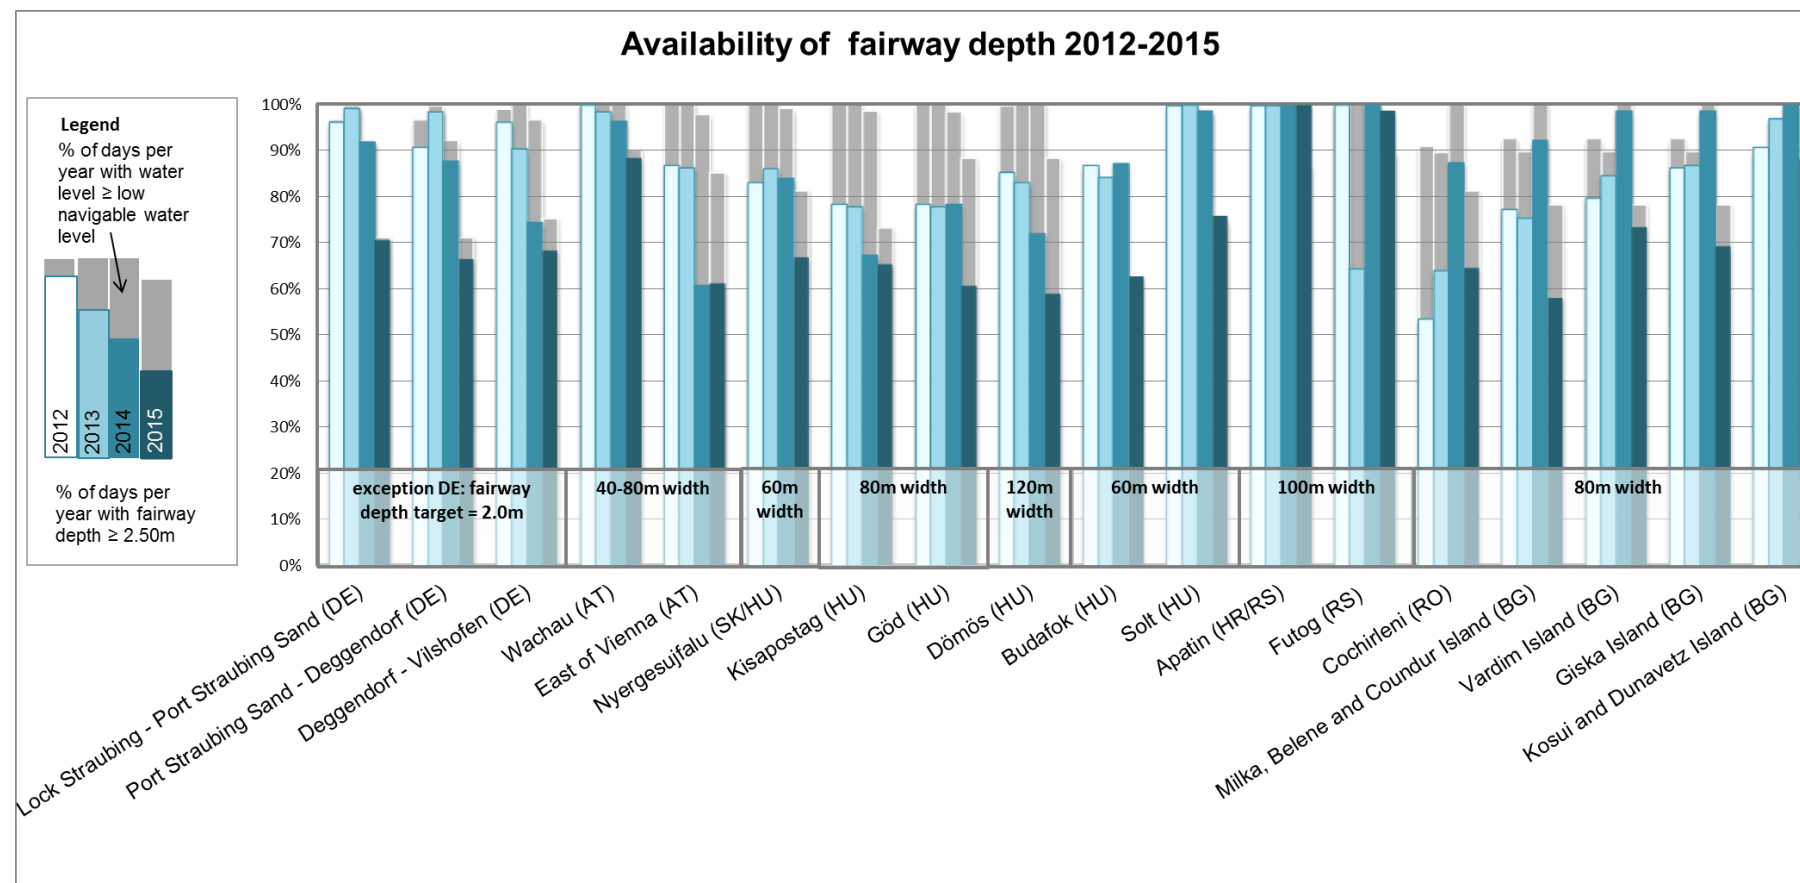
Key facts illustrated in the “Fairway availability 2012–2015” figure on the previous page:

Fairway availability varies quite intensely (predominantly dependent on hydrological conditions and implemented maintenance measures).

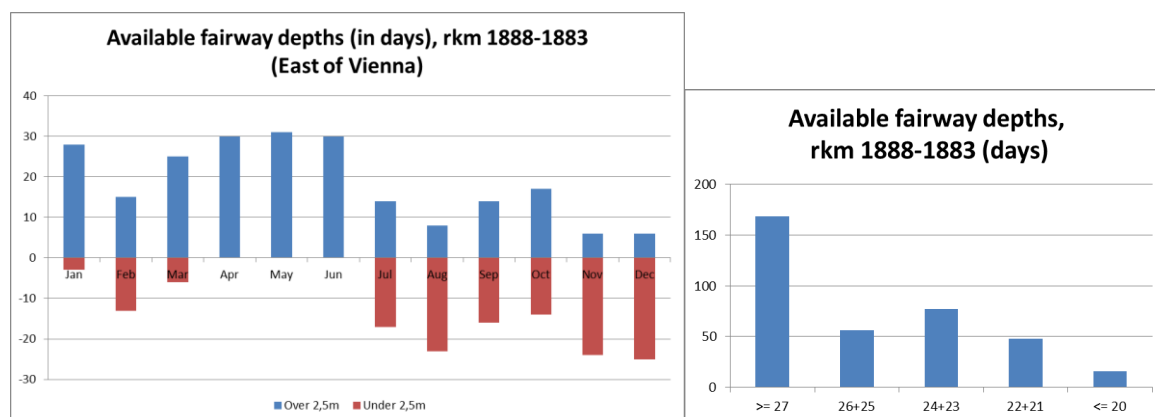
The year 2015 was characterised by difficult waterway conditions in the free flowing section of the Austrian Danube between Vienna and Bratislava: in the spring season (between January and March) 22 days (or 24%) with a fairway depth less than 2.50 metres were registered. In the second half of 2015 (July–December) even 119 days (or 65%) with a fairway depth lower than 2.50 metres were recorded, due to the low discharge levels (see next section). Altogether, the targeted depth of 2.5m was provided on 224 days in 2015. On 77 days, a fairway depth of 2.3 – 2.4 m was provided.

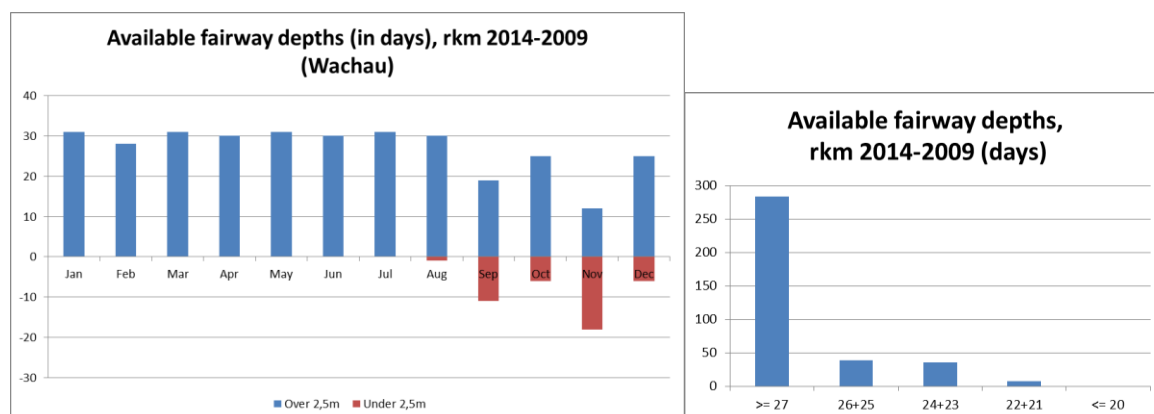
The second free-flowing section – in the Wachau valley – was faced with comparably good conditions: in the months January until July 2015 a fairway depth of over 2,50 metres could be provided on all days (100%). Available fairway depth dropped below 2,50 metres on 42 days in the months July-December 2015 (23%). The targeted depth of 2.5m was provided on 323 days. On 35 days, a fairway depth of 2.3 – 2.4 m was provided.

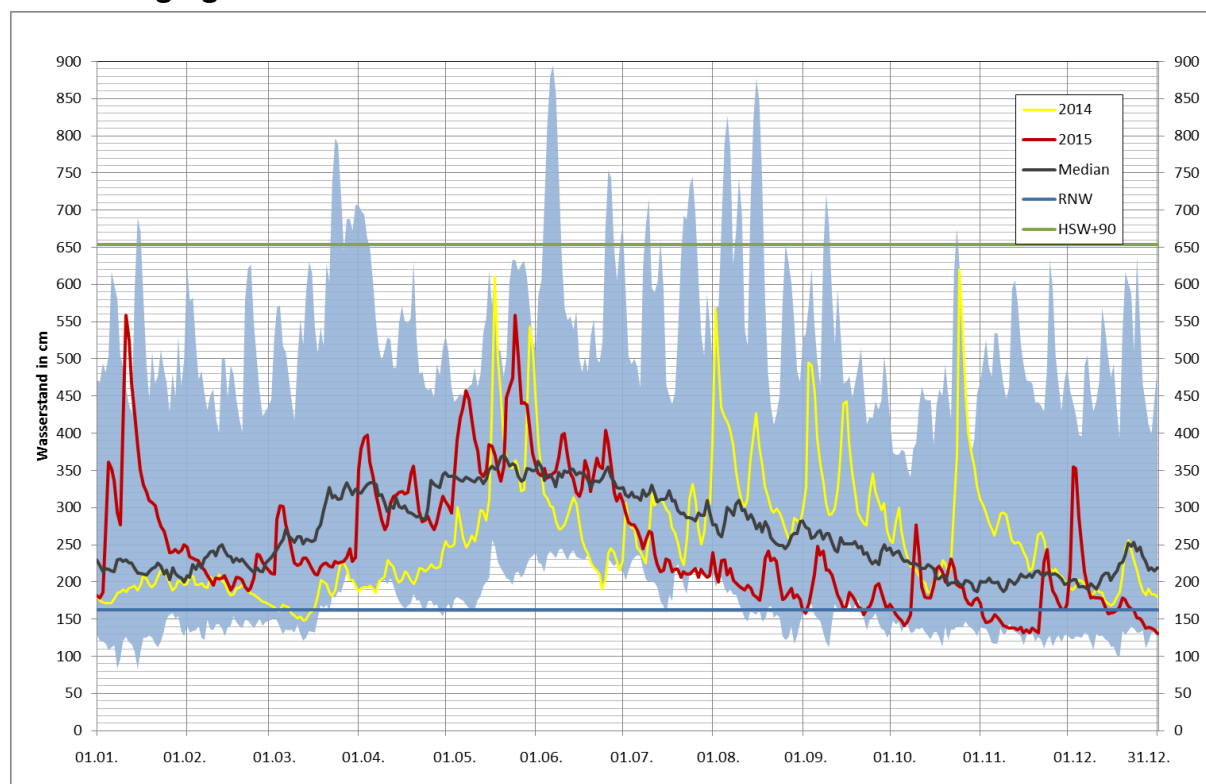
Water level gauge East of Vienna 1981-2015

In the year 2015 relatively bad conditions as regards the water levels were encountered in the free-flowing and critical locations east of Vienna. Water level gauges fell below the median value in a large part of the year. The statistically exceptional low water period of summer 2015 was followed by a continued low water season in autumn 2015. The severest water level conditions were observed in the months of November and December 2015, with water levels that approach the low values of one of the worst years in recent history, the year 2003.

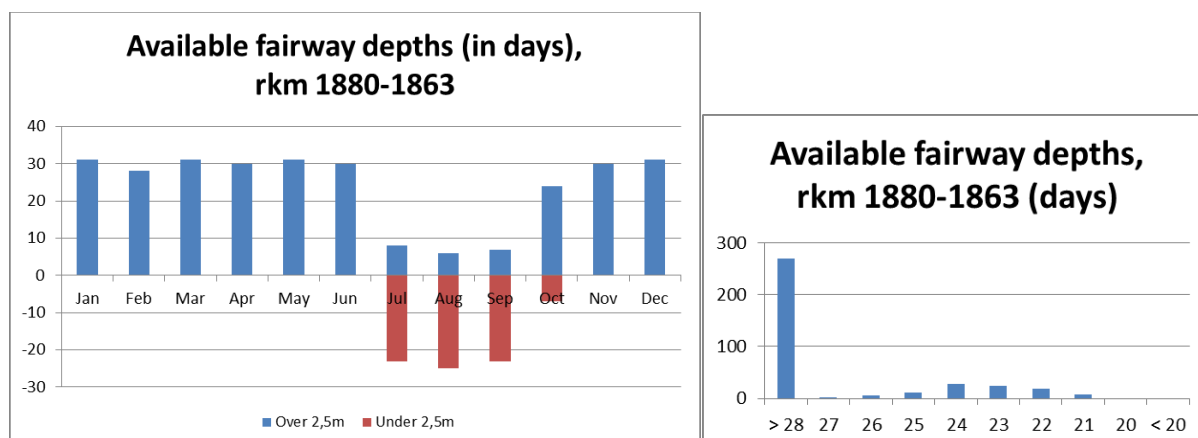
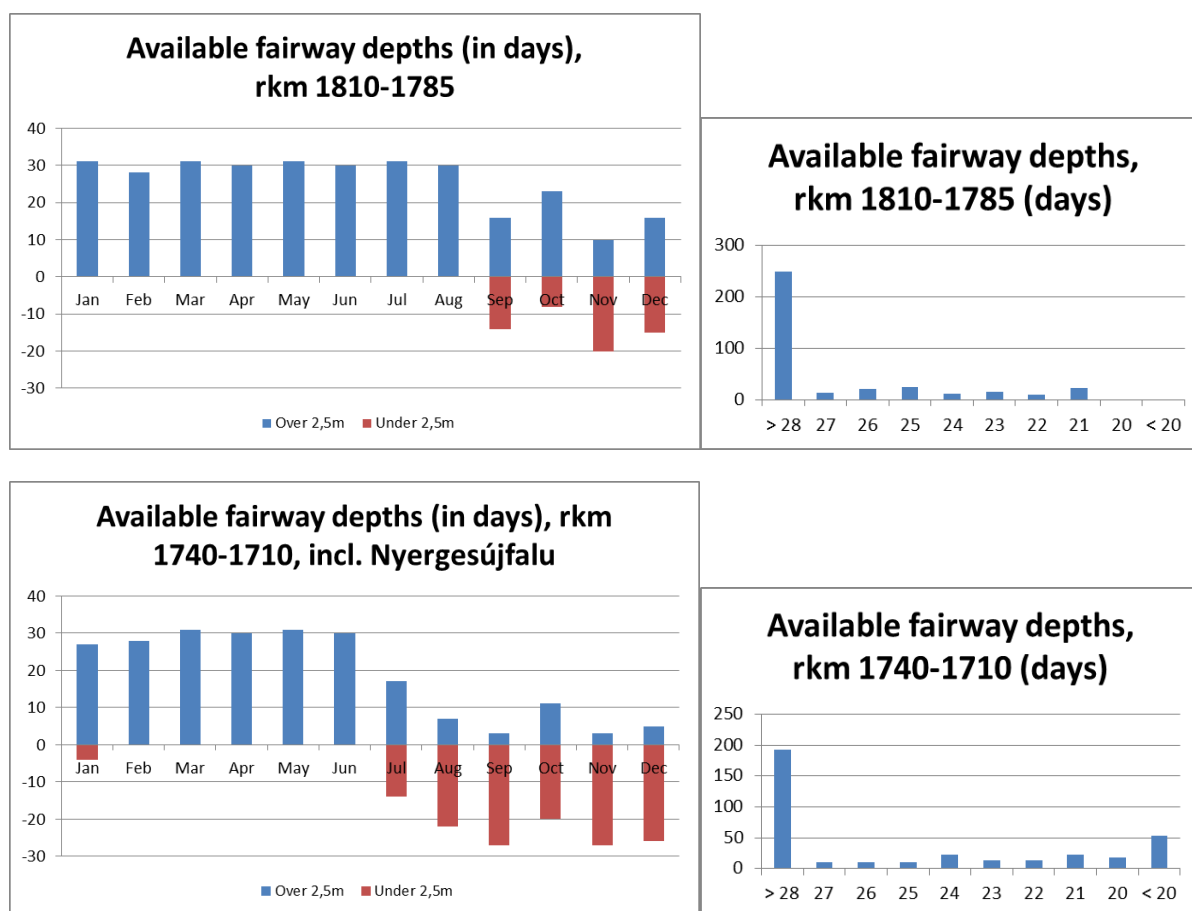
In the graphs below you can also see the availability of the depths in all three sections in days, which were above or below 2,5 m.

In Part III. (the most critical section rkm 1735,5 – 1733,7 – Cenkov (in HU language – Nyergesújfalu)) 53 days were below 2,0 m (4 days with 1,6 m of depth only).

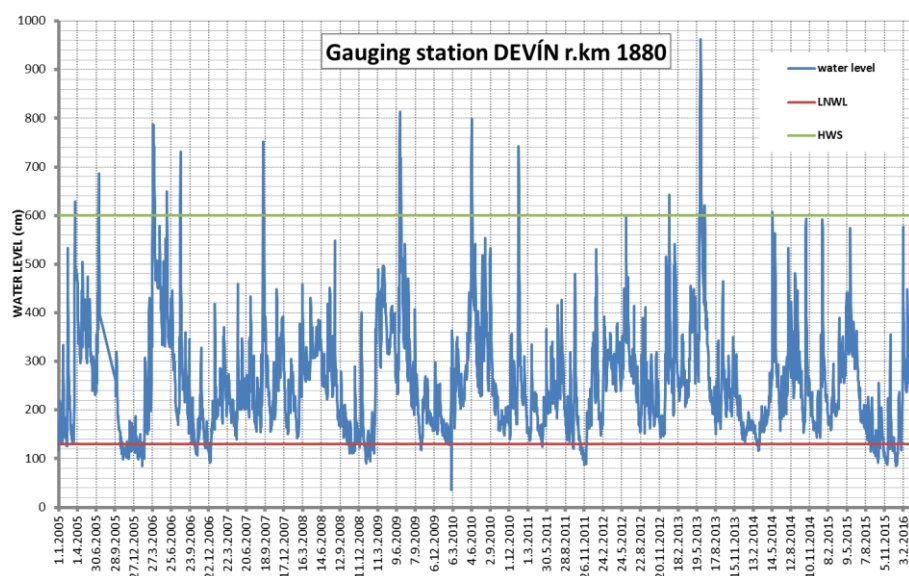
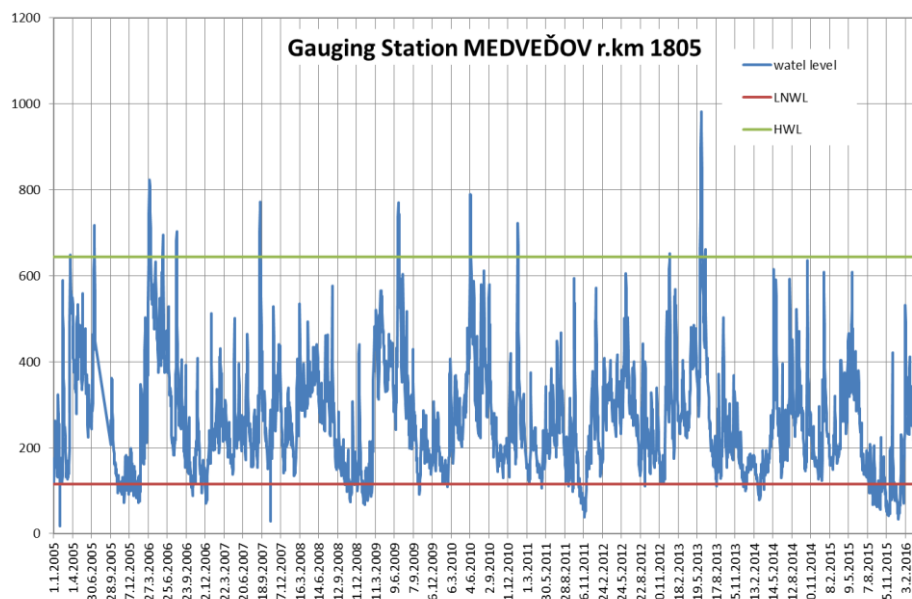
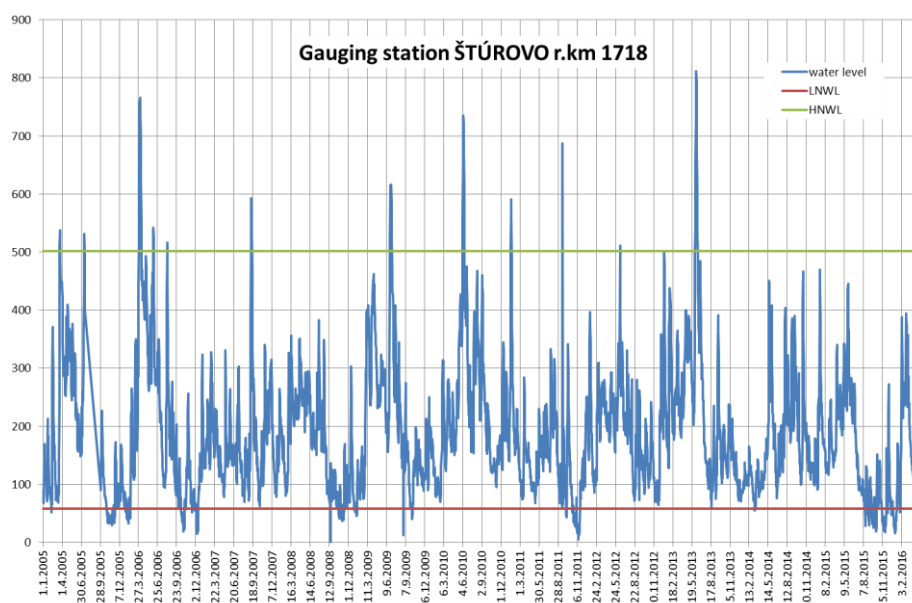
The following graphs represent the course of water level in particular gauging stations. Values of LNWL and HNWL were provided by Danube Commission.

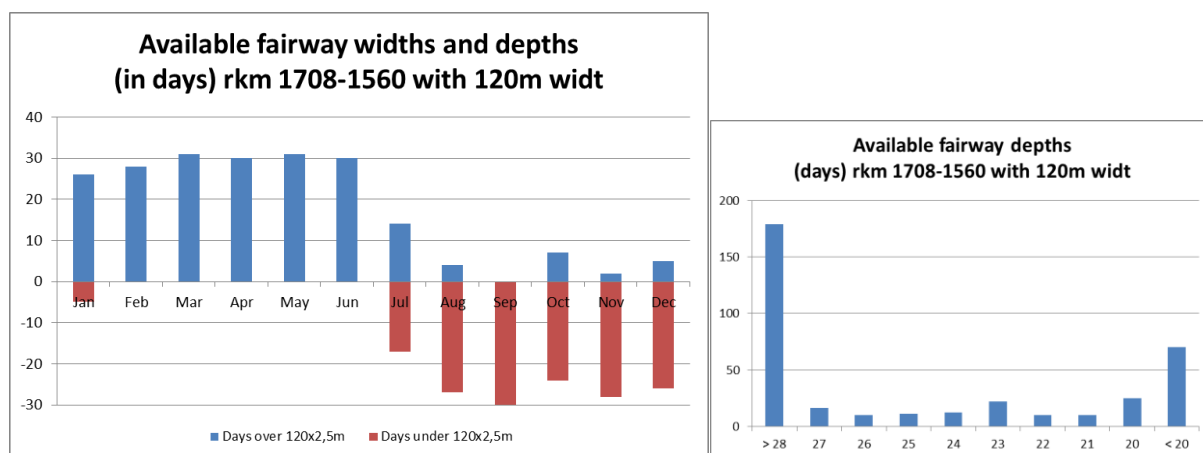
The critical location Budafok, mentioned by the Danube users in 2014 to be one of the main critical sections, has never been the worst section in terms of depth, but is considered critical because of limited width, which is 60 meters. As it is probable that further critical locations arise (in addition to the ones mentioned in the table), these will be reported in the text.

In 2015 a min. fairway depth of 2.5 m was available in Middle-Danube section for 205 days/365 days (~56%). However between January and June the water depths of at least 23 dm was available for the navigation, but after that period the water level had a drastic effect on the Hungarian Danube: In autumn's and winter's months the navigable depth of the fairway was only less than 18 dm on 45 days, and less than 17 dm on 36 days.

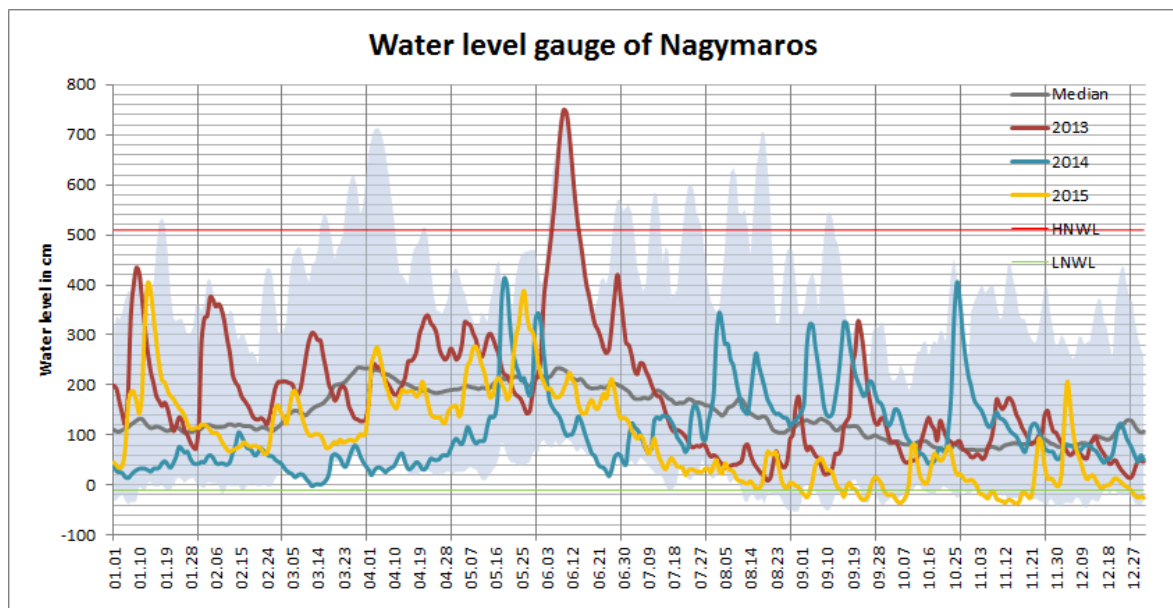
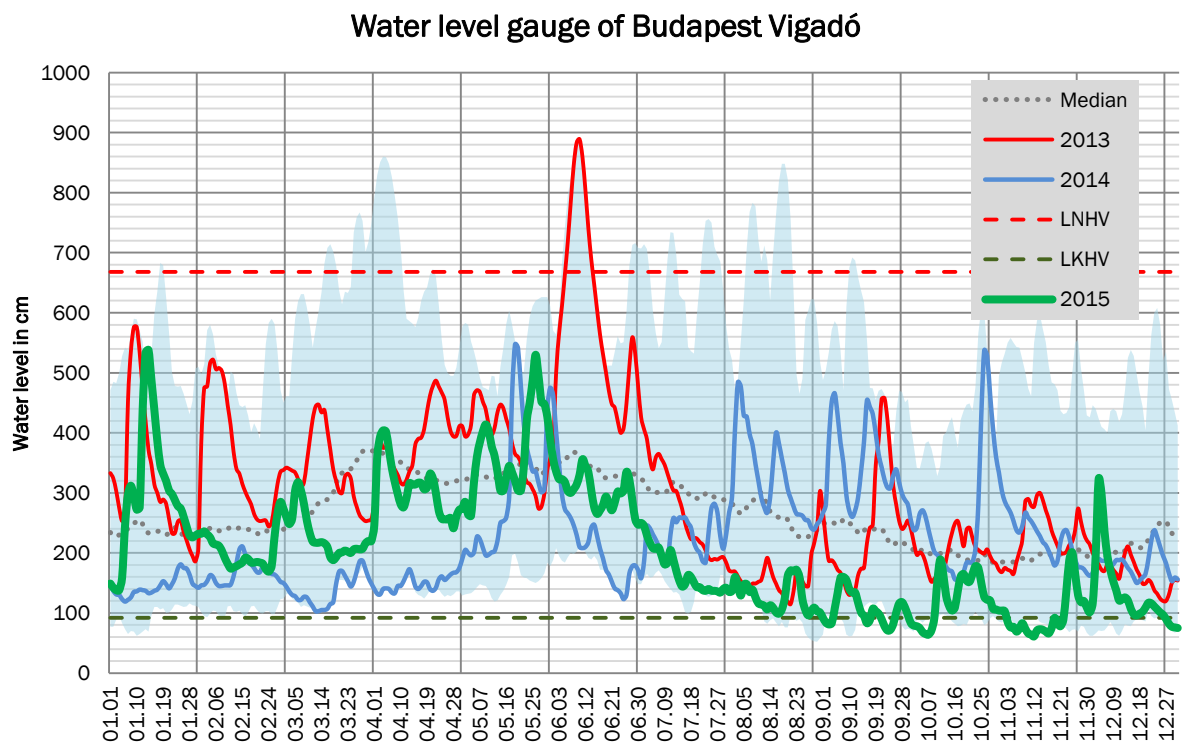
The Nagymaros gauge refers to Dömös and the while Budapest gauge to Budafok. As there is usually no significant difference between them, only the Budapest gauge will be shown in the future.

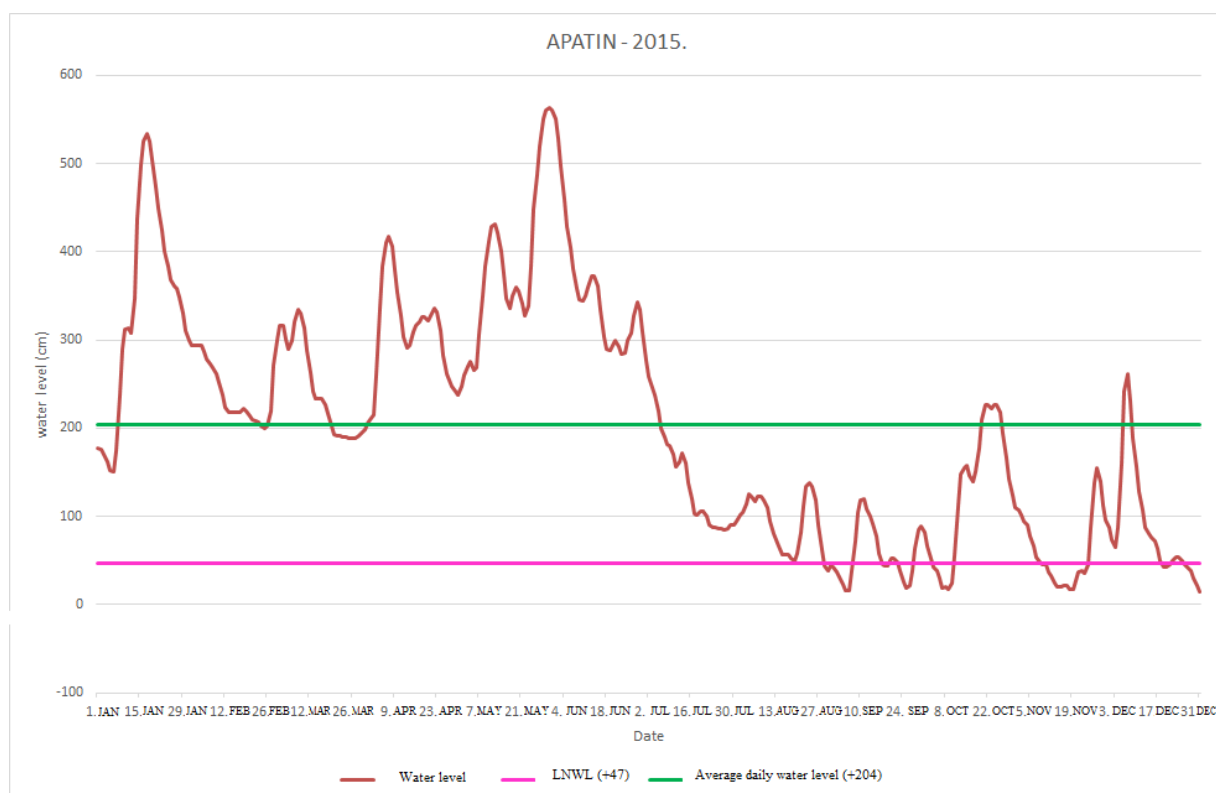
In 2015 at the gauging station Apatin the water level under low navigable water level was present in August and in short period in September, November and December.

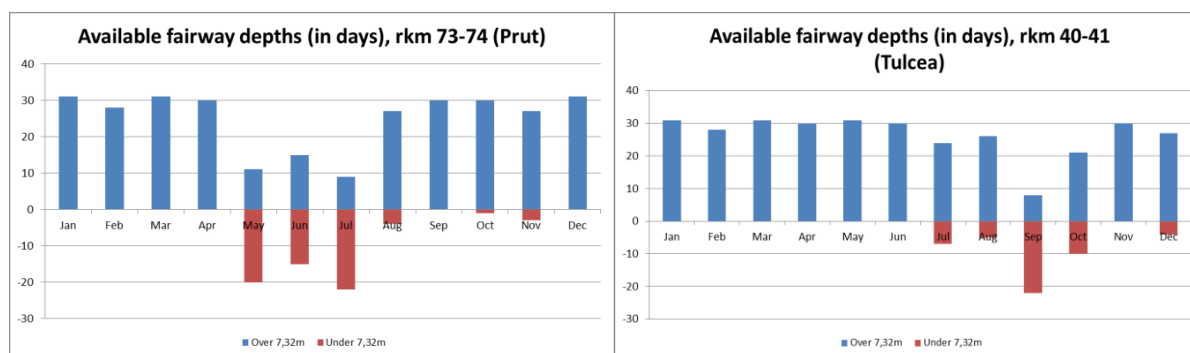
For the maritime sector of Danube, were encountered problems related to navigation depth, in the main critical areas, on the section downstream Galati: Prut and Tulcea. To note, in this sector, the minimum navigation depth is 7.32m (24 feet) and has a maritime navigation regime. Special problems were only in the Prut, in the period May-July, when they recorded a total of 62 days. In general, here in most areas, they were ensured the navigation depths because of dredging works which were carried out in most areas. Referring to navigation conditions on the River on this sector they were meet on entire period, depths over 2.5m

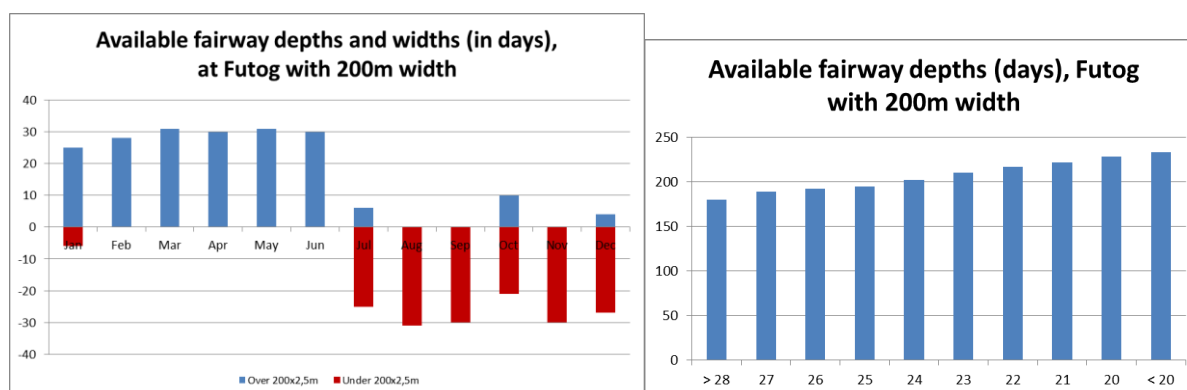
The situation on the critical sector Futog was a bit worse in 2015 compared to 2014, having in mind available fairway depth and width. Fairway width is still reduced to the minimum Level of Service, which is 100 m. On the 100 m fairway width, fairway depth of 2.5 m was achieved for 360 days (98.6%). On the 120 m fairway width, fairway depth of 2.5 m was achieved for 273 days in 2015 (74.8%).
