# **Fairway Rehabilitation and Maintenance Master Plan for the Danube and its navigable tributaries:**

## **NATIONAL ACTION PLANS**

**UPDATE MAY 2017**

Developed within the **EU co-financed project FAIRway Danube**

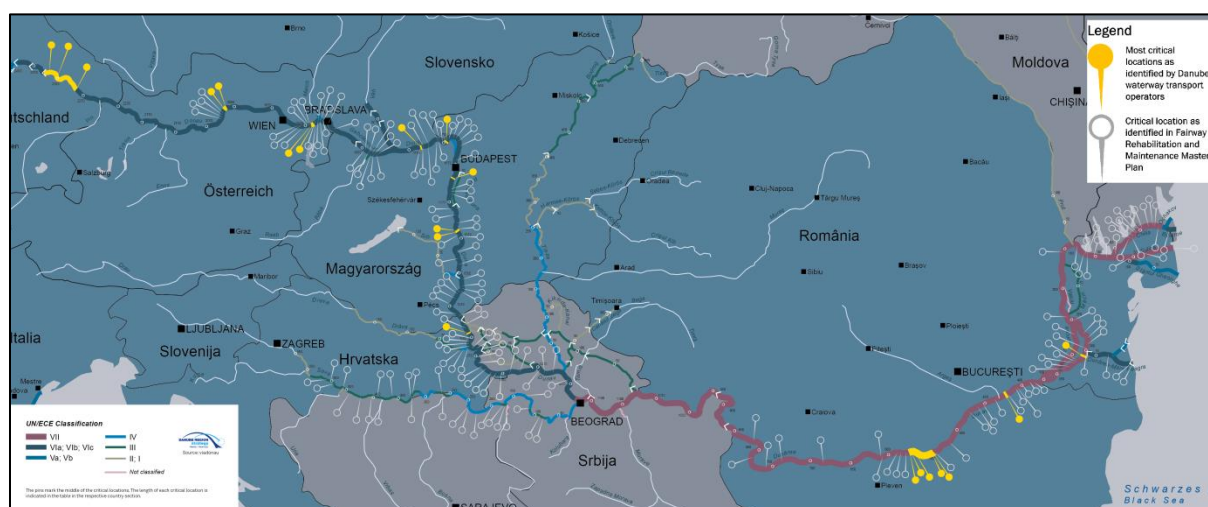
location and length (km)			right bank / left bank	name of section or location
river-km (from - to)		length		
2,321.70	2,312.00	9,50	DE / DE	Straubing (lock)–Straubing-Sand (port)
2,312.00	2,282.50	29,70	DE / DE	Straubing-Sand (port)–Deggendorf
2,282.50	2,249,90	32,50	DE / DE	Deggendorf – Vilshofen (backwater Kachlet)
2,014.00	2,013.50	0,50	AT / AT	Weißkirchen
2,010.20	2,008.90	1,30	AT / AT	Dürnstein
1,888.40	1,887.60	0,80	AT / AT	Treuschütt
1,884.70	1,883.50	1,20	AT / AT	Hainburg
1,735.50	1,733.70	1,80	HU / SK	Nyergesújfalu
1,698.00	1,697.00	1,00	HU / HU	Dömös
1,638.40	1,637.40	1,00	HU / HU	Budafok
1,559.80	1,559.70	0,10	HU / HU	Dunaföldvár
1,558.50	1,557.50	1,00	HU / HU	Solt
1,408.20	1,400.00	8,20	HR / RS	Apatin
568,20	567,80	0,40	BG / RO	Milka Island
567,00	566,70	0,30	BG / RO	Belene Island
562,00	561,50	0,50	BG / RO	Coundur Island
541,60	541,00	0,60	BG / RO	Vardim Island
538,50	537,00	1,50	BG / RO	Giska Island

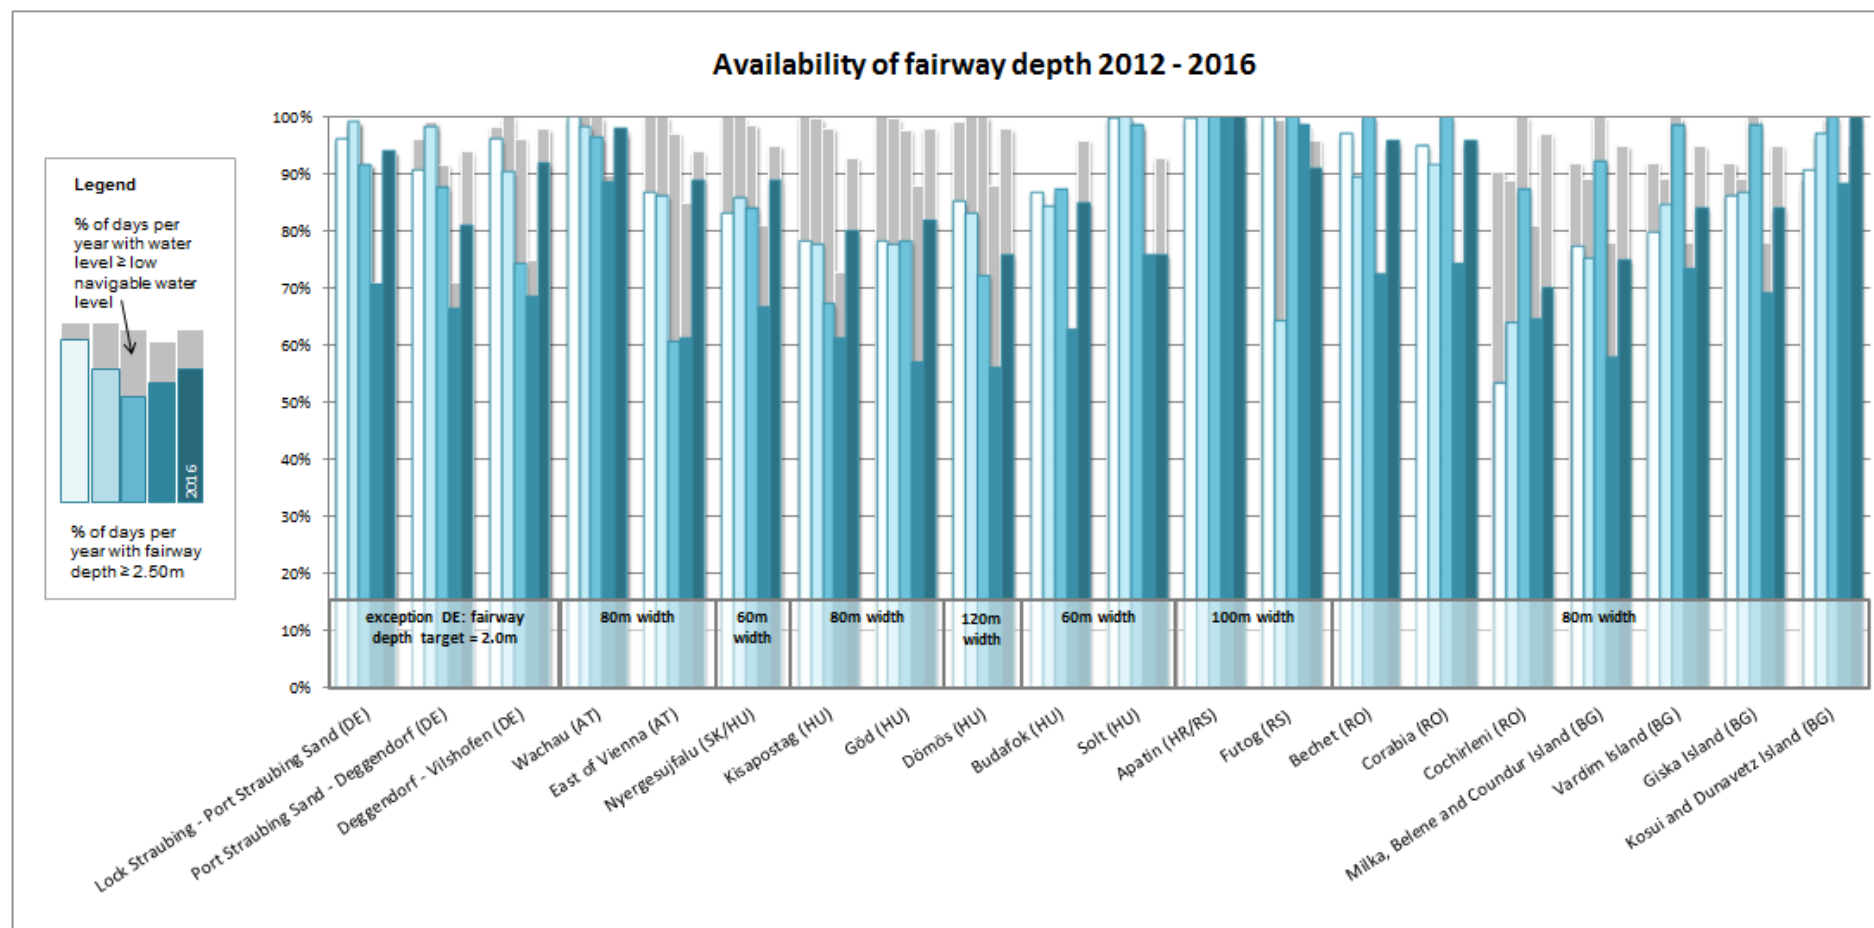
**Key facts illustrated in the “Fairway availability 2012–2016” figure** on the previous page:

**Fairway availability varies quite intensely** (predominantly dependent on hydrological conditions and implemented maintenance measures).

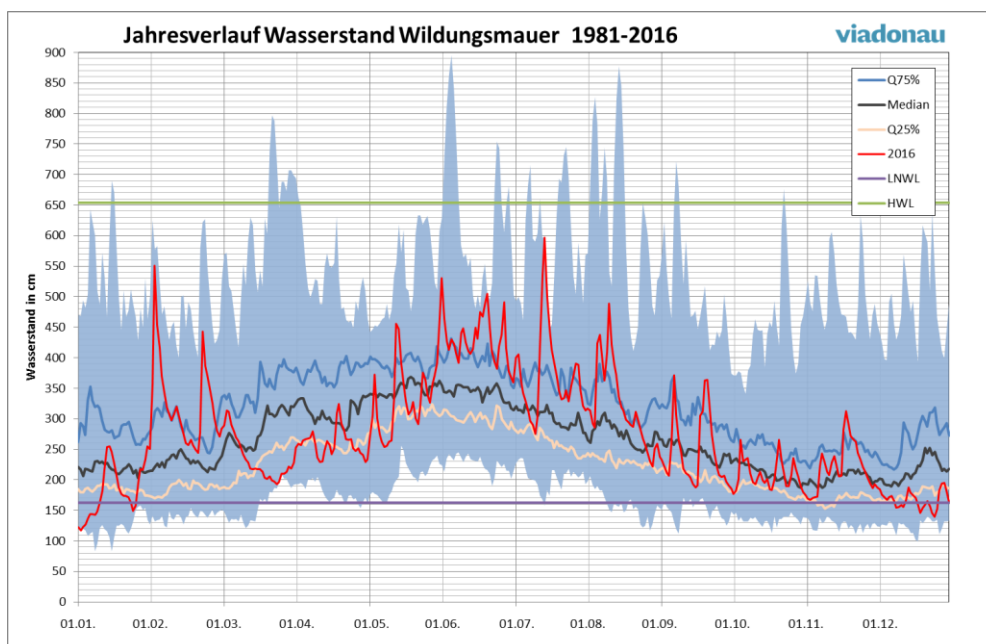
### Water level gauge East of Vienna 1981- 2016

In the year 2016, good conditions as regards the water levels were encountered in the free-flowing and critical section east of Vienna. Water level gauges measured values above the median value in a considerable part of the year, especially during the summer months.

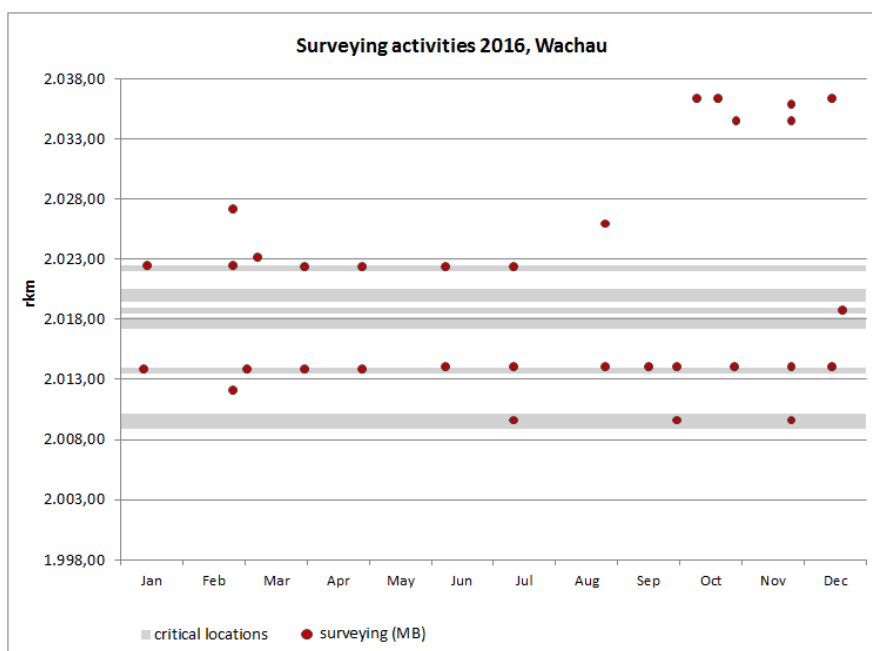
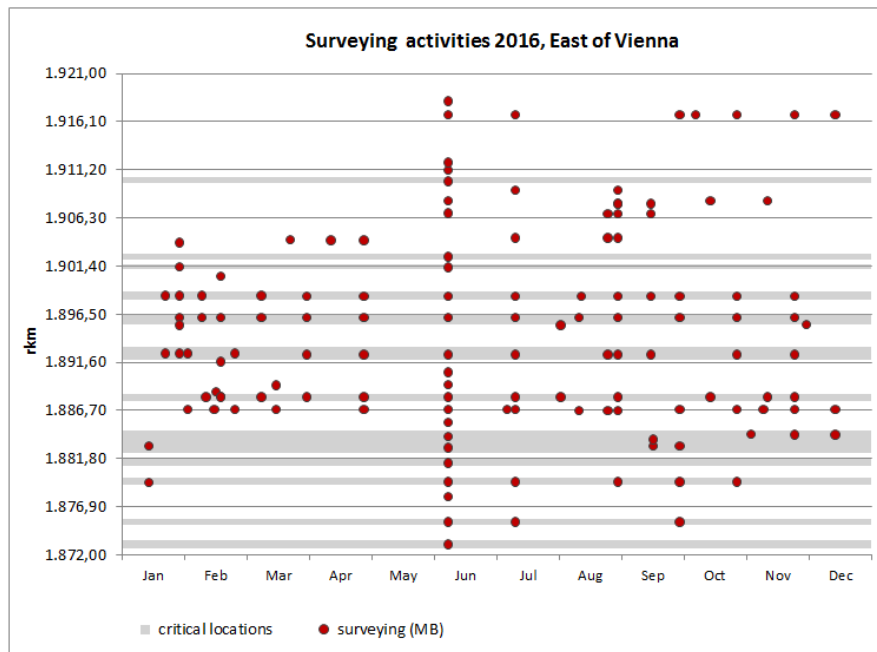
In the section Wachau only the most critical location Weißenkirchen (rkm 2013.50 – 2014) was surveyed monthly. In the Danube section east of Vienna the most critical locations Regelsbrunn, Rote Werd, Petronell-Witzelsdorf and Treuschütt were surveyed monthly. As usual, a whole series of surveys was conducted in June prior to dredging activities in the months before the low water season.

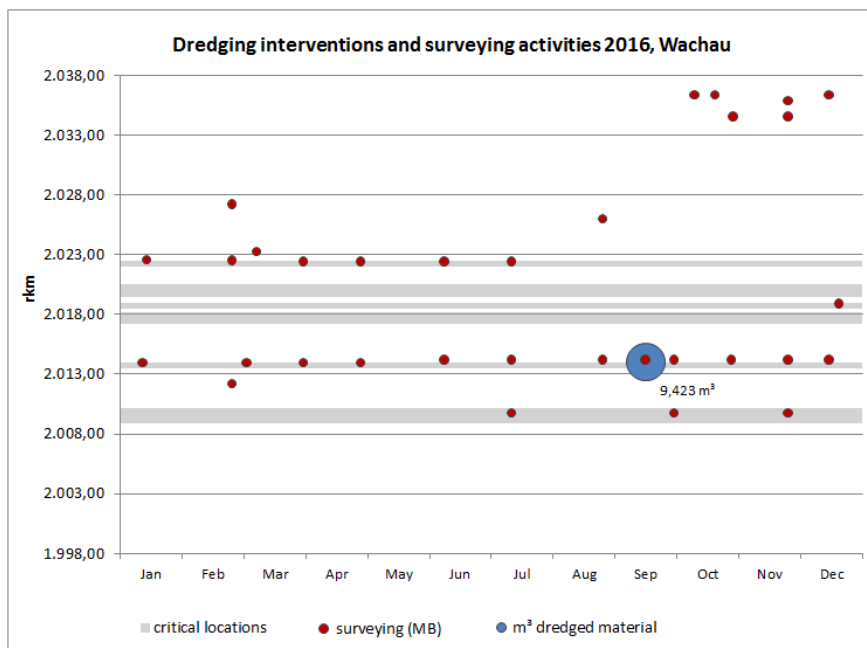
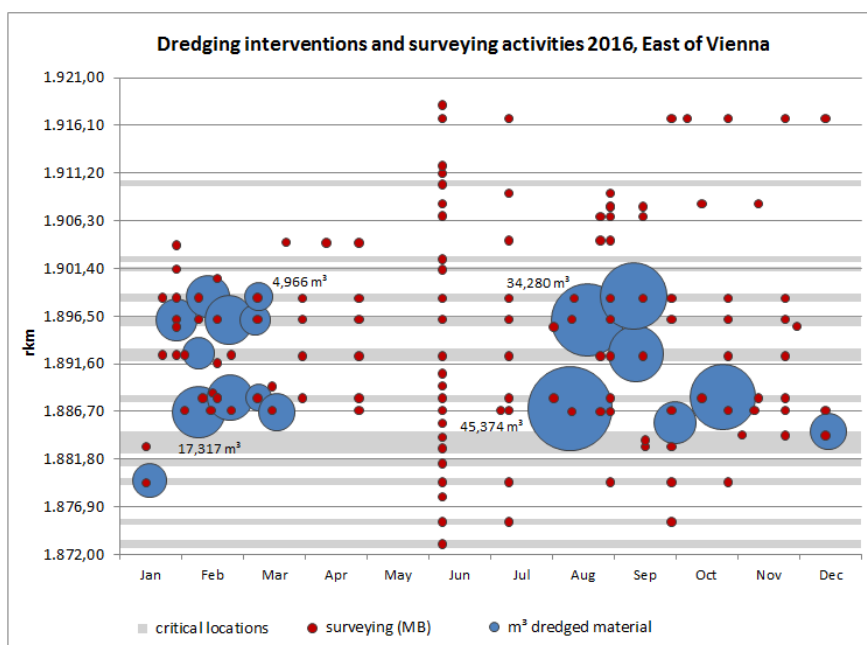
In the critical section Wachau only the critical location Weißenkirchen was dredged in autumn 2016. In the section east of Vienna several smaller dredging works were carried out from January to March, the most critical fords were also dredged from August to December.

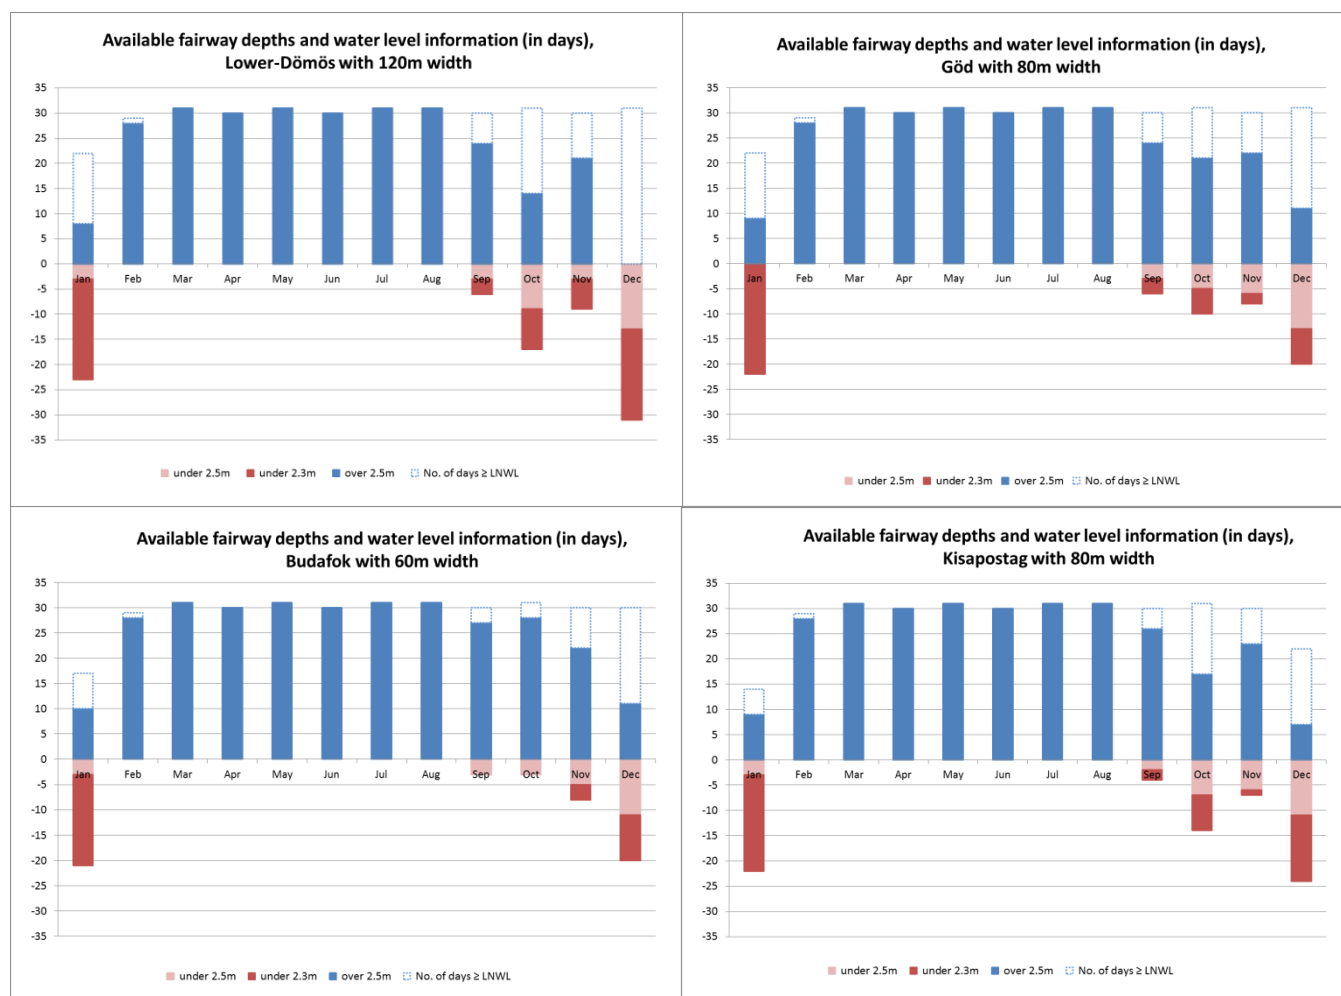
In 2016 a min. fairway depth of 2.5m was available in Middle-Danube section for 274 days/366 days (~89%).

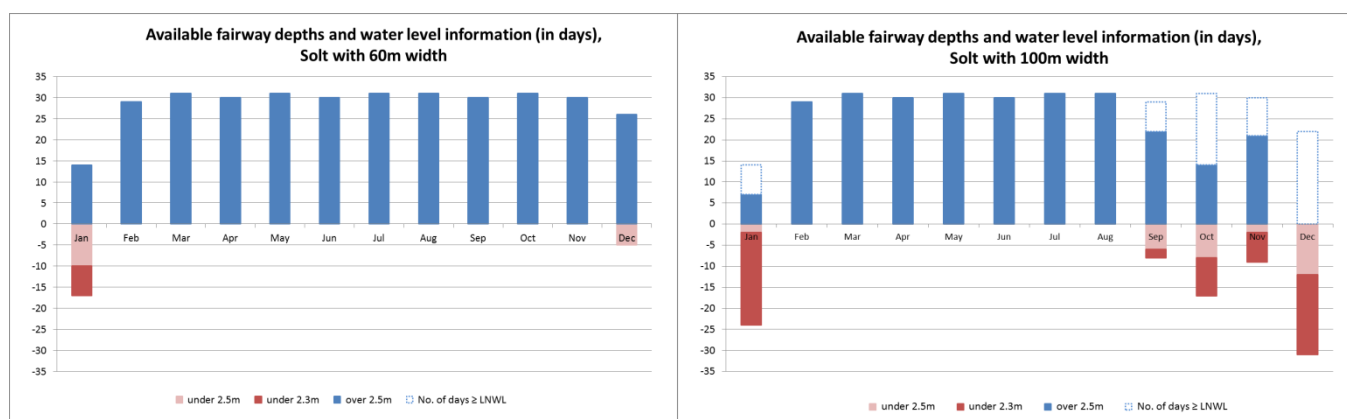
### Number of days with water level $\geq \text{LNWL}$ on main critical locations

Critical location	Reference gauges	2012	2013	2014	2015	2016
Solt	Dunaföldvár	366	364	358	270	339

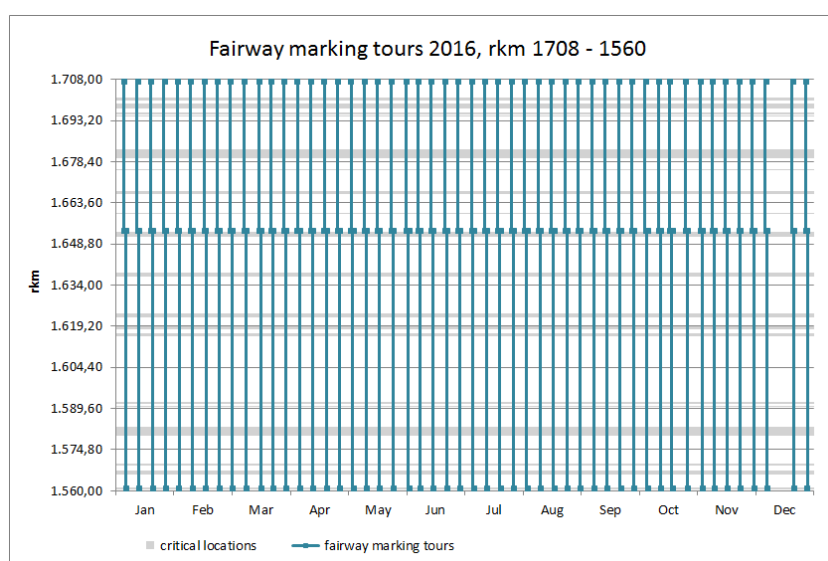
In KDVIZIG area (rkm 1708 – 1560) the actual dates of when the marking tours and fairway marking works were conducted are illustrated in the chart. The tours were conducted on a weekly basis.

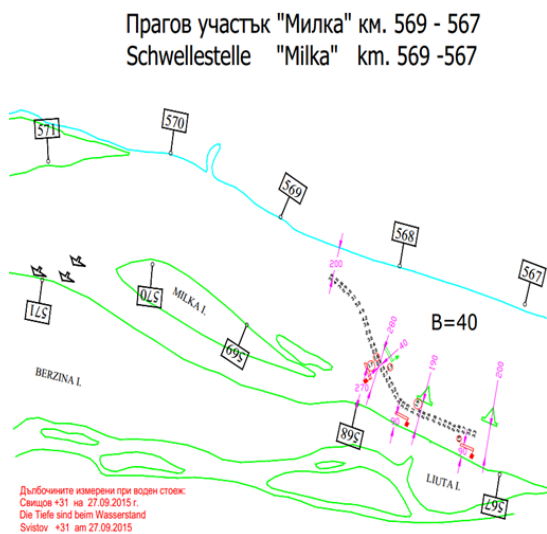
Minimum depth measured in the critical location Milka island - 2015:

- Depth less than 25 dm was observed in June 2015 at water level 220 cm at gauging station Svishtov;
- Number of days with depth <25 dm - 153;
- Number of days with water level under LNWL - 66.

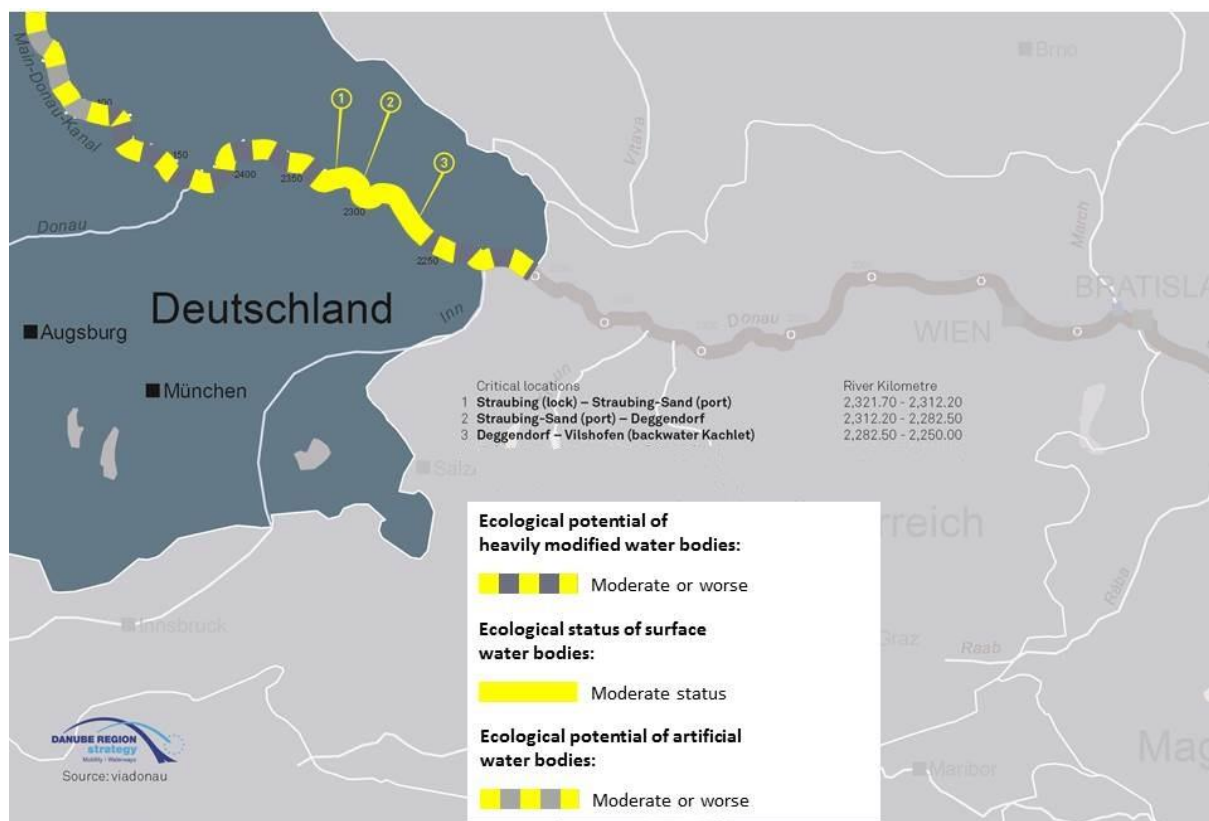
### **Ecological status and ecological potential of surface water bodies**

The following map displays the ecological status and ecological potential of the German Danube – according to the Danube River Basin Management Plan/Update 2015 – against the background of the critical navigation locations in Germany.

(Source: DRBM Plan – Update 2015)

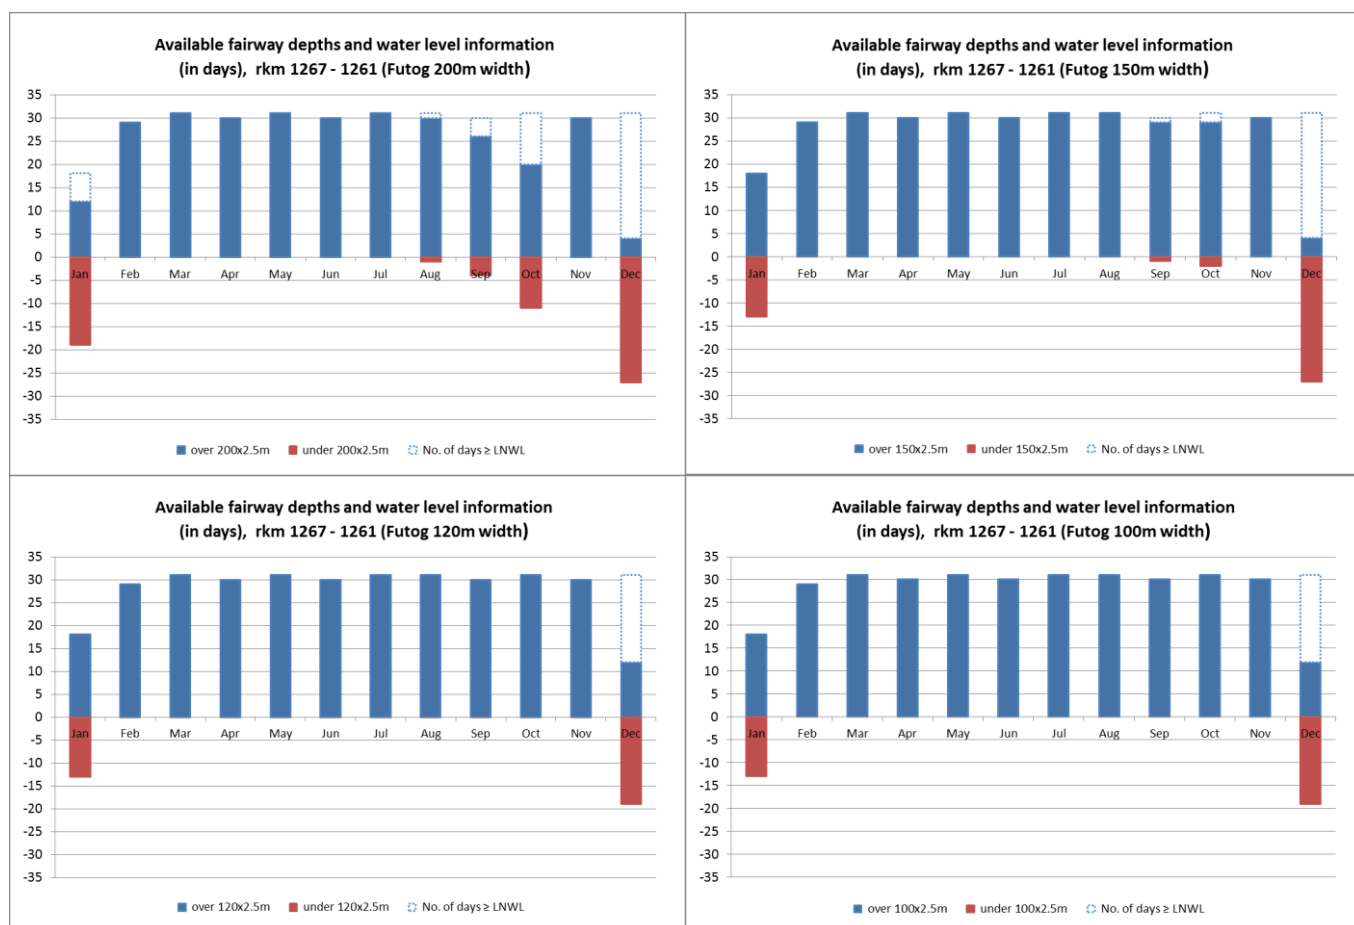
The situation at the critical location Futog was a bit worse in 2016 compared to 2015, having in mind available fairway depth and width. Fairway width is still reduced to the minimum Level of Service, which is 100 m. On the 100 m fairway width, fairway depth of 2.5 m was achieved for 327 days (89.3%). On the 120 m fairway width, fairway depth of 2.5 m was also achieved for 327 days in 2016 (89.3%).

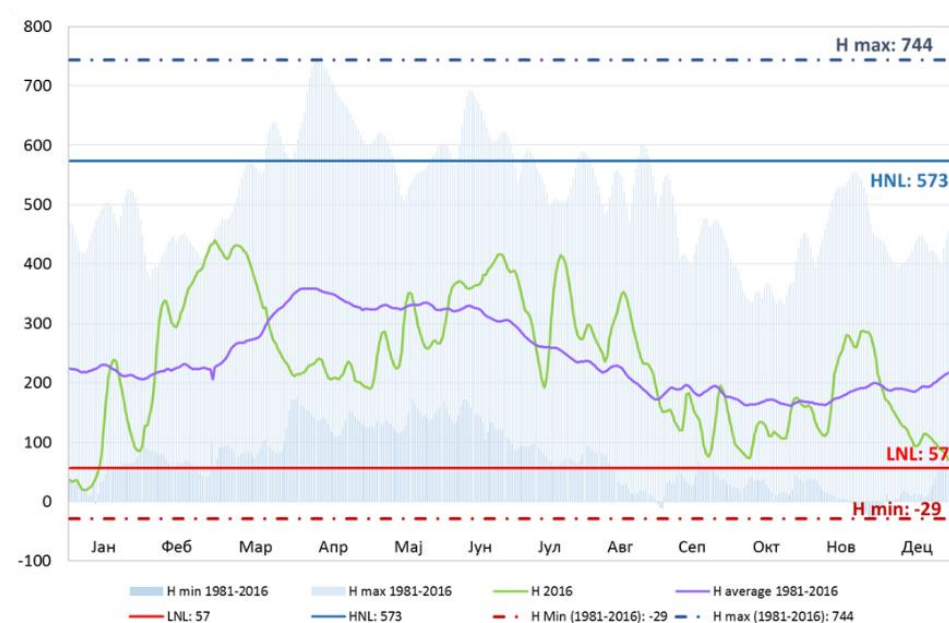
Water level data for the **gauging station Novi Sad** (which is the reference gauging station for the critical sector Futog): In 2016, 13 days with water levels below LNWL have been recorded. Multiannual hydrograph for the gauging station Novi Sad and water level data for 2016 are presented in the figure below.
