# **Fairway Rehabilitation and Maintenance Master Plan for the Danube and its navigable tributaries:**

## **NATIONAL ACTION PLANS**

**UPDATE MAY 2018**

Developed within the **EU co-financed project FAIRway Danube**

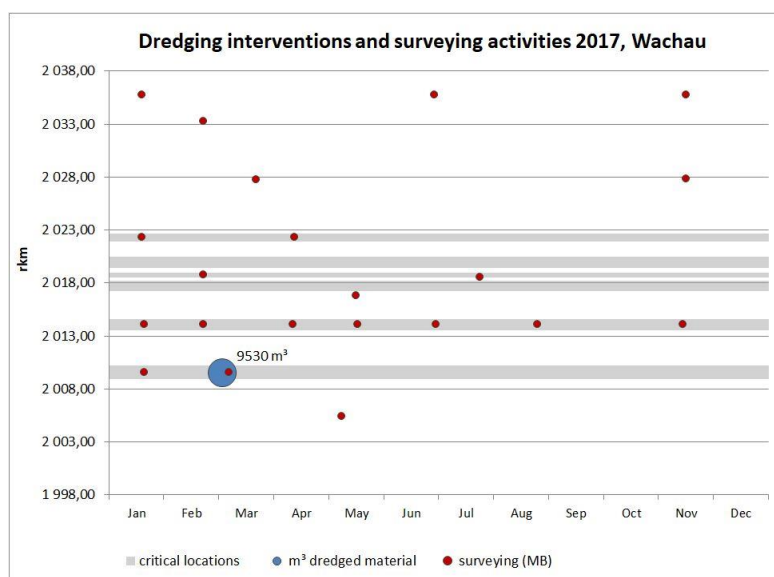
The dredging interventions are reported in combination with the surveying activities. This illustrates the strong dependency of dredging works on up-to-date surveying results. Prior to, during and after dredging works the respective critical locations were surveyed in addition to the regular surveying tours.

In the critical section Wachau only the critical location Dürnstein was dredged at the beginning of the year.

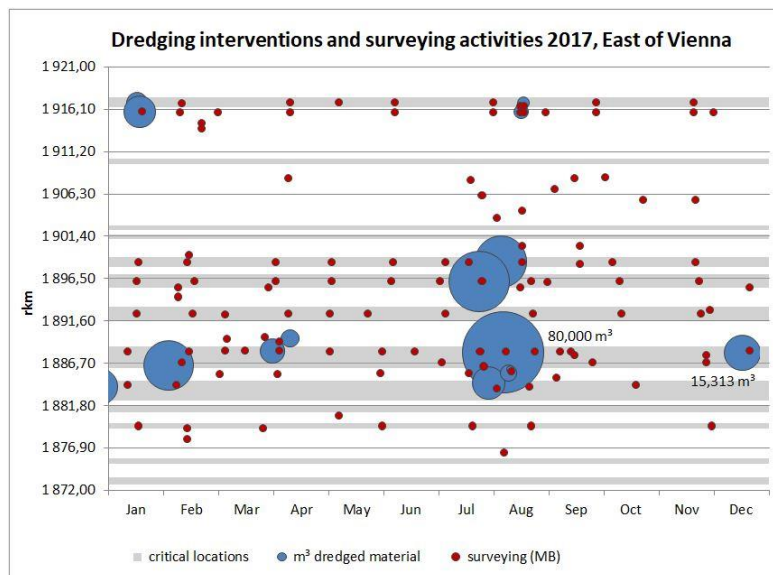
In the section east of Vienna several smaller dredging works were carried out from January to April, the most critical fords were dredged from July to September.

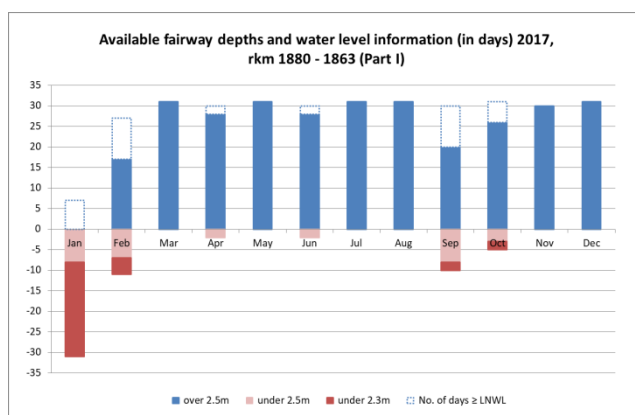
In 2017, for all three measured sections, Part I. (rkm 1880 – 1863) fairway depth of 2.5m and more were realised on 304 days (83,3%), for Part II. (rkm 1810 – 1785) on 324 days (88,8%) and for Part III. (rkm 1765 – 1710) on 303 days (83%).

In Part III., at the most critical section at rkm 1735.5 – 1733.7 – Cenkov (in HU language Nyergesújfalu), fairway depths were below 2.3m on 40 days. This is mostly due to the bad hydrological conditions in January and February. Other than that, the navigation conditions in the mentioned period were standard, no extreme deviations occurred.

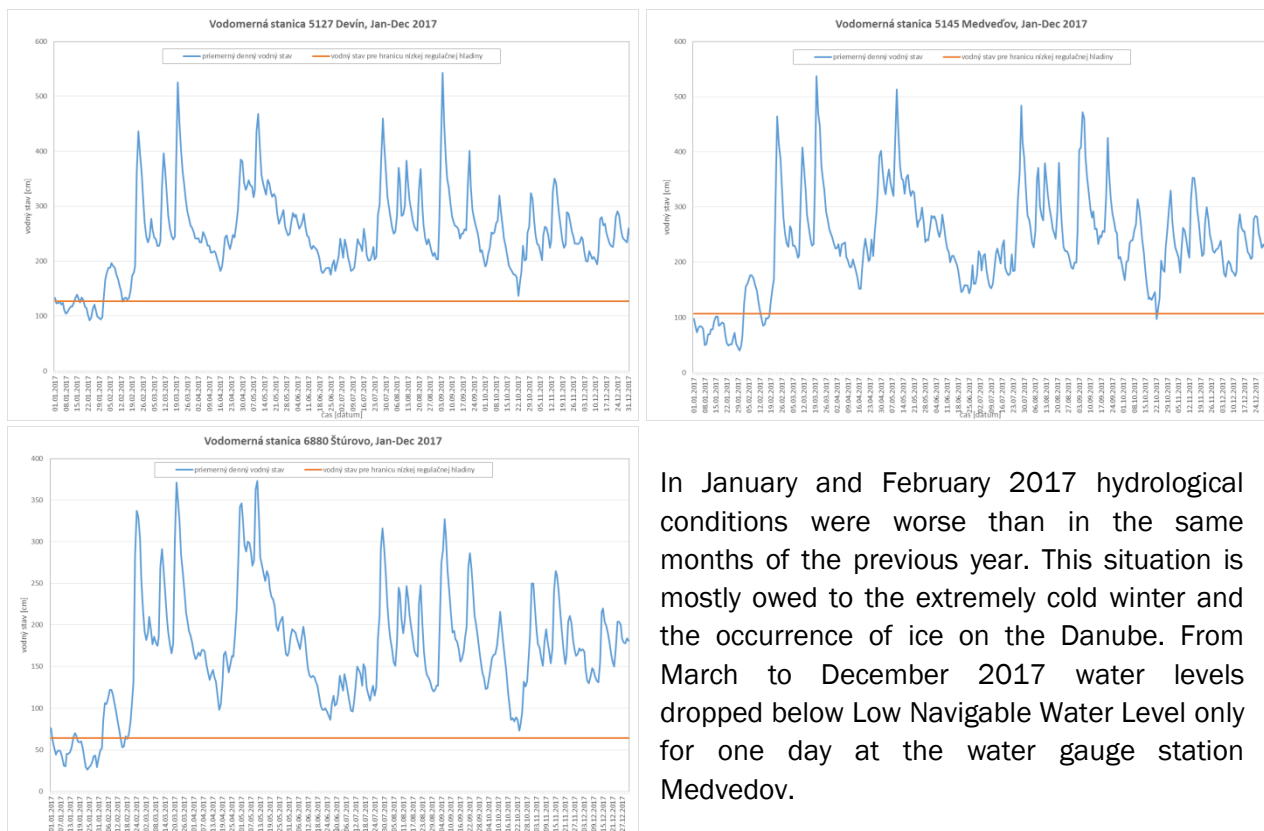
In January and February 2017 hydrological conditions were worse than in the same months of the previous year. This situation is mostly owed to the extremely cold winter and the occurrence of ice on the Danube. From March to December 2017 water levels dropped below Low Navigable Water Level only for one day at the water gauge station Medvedov.

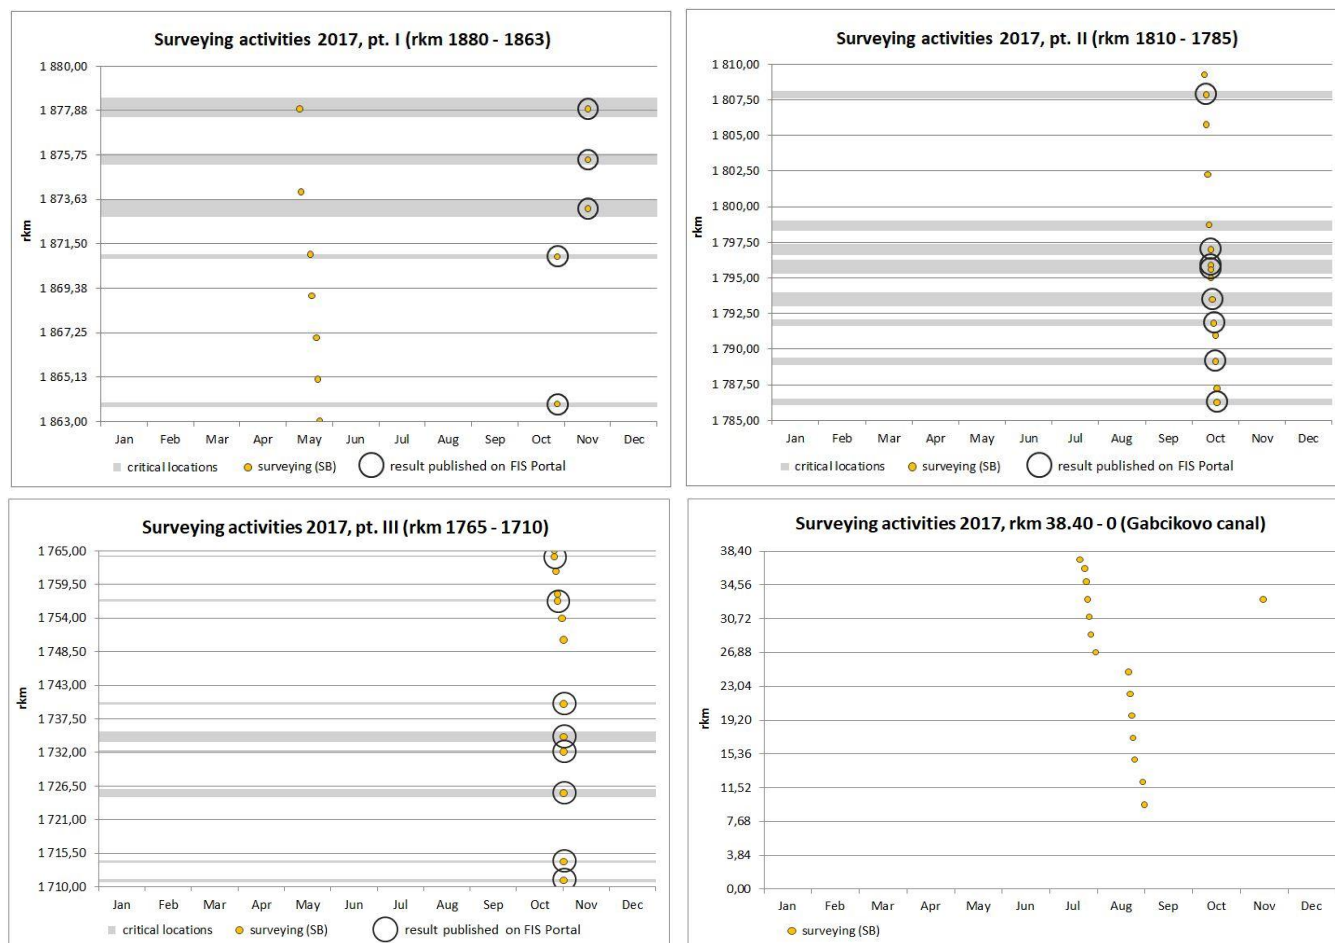
The following river bed surveying activities took place according to the annual procedure. Critical locations are monitored within the yearly measurement of the entire Slovakian stretch, but since 2015 SVP is performing extra measurements of the critical sections besides the entire stretch measurement. Surveying is conducted with a single-beam echo-sounder; the profiles are 50m apart.

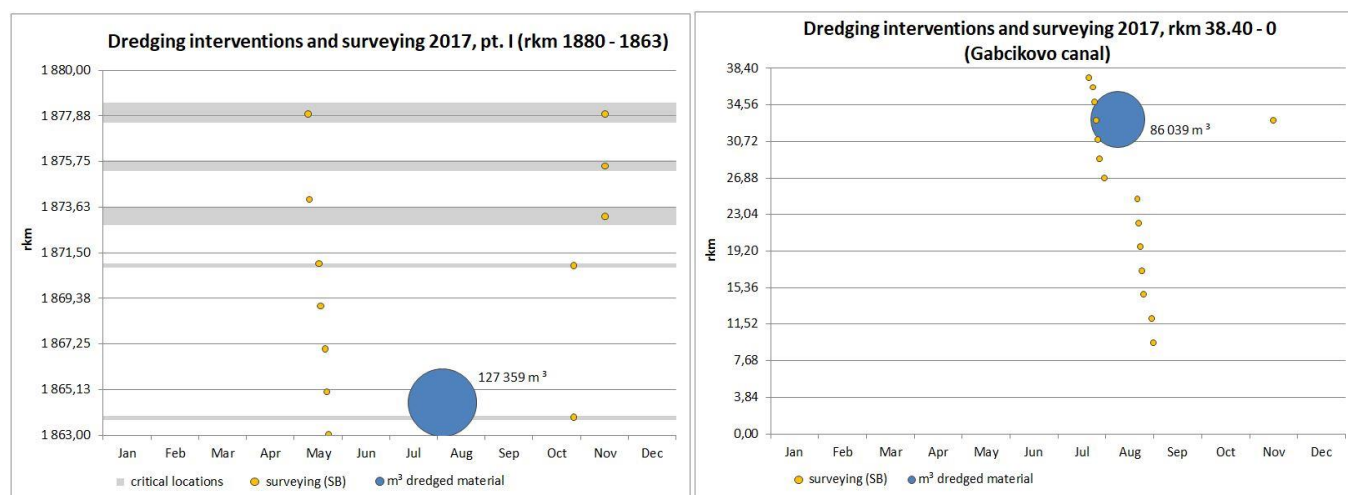
In total, 213 398m<sup>3</sup> were dredged for commercial navigation in 2017 in the two worst critical bottlenecks. (Both bottlenecks also had to be monitored daily during ongoing construction works in September and October – see section “fairway marking” above.)

Dredging from rkm 1865.5 – 1863.5 was conducted from April to December (127 359m<sup>3</sup>). Dredging in the Gabčíkovo canal from km 34 – 32 was conducted from April to November (86 039m<sup>3</sup>).

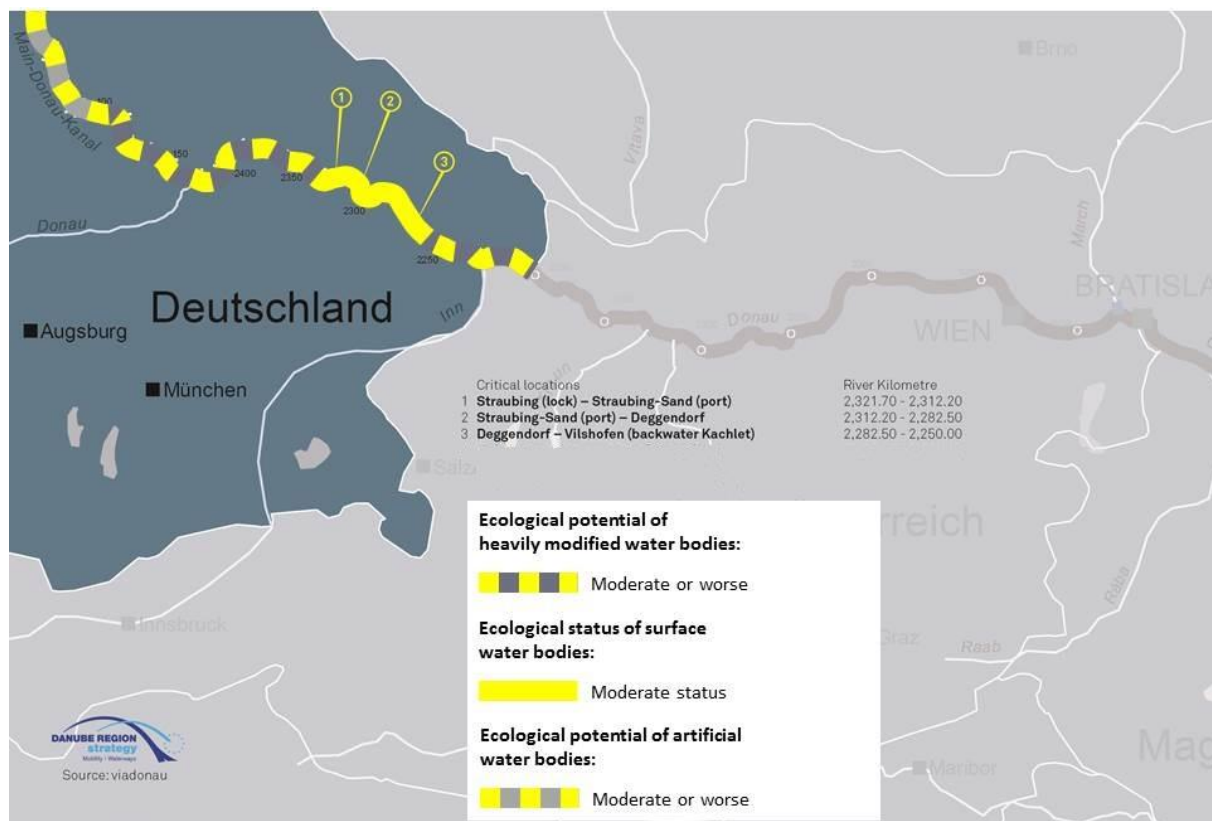
The following map displays the ecological status and ecological potential of the German Danube – according to the Danube River Basin Management Plan/Update 2015 – against the background of the critical navigation locations in Germany.

#### **Ecological status and ecological potential of surface water bodies**

(Source: DRBM Plan – Update 2015)

As regards the Danube corridor there are all classifications of surface water bodies for the German waterway section. The Main-Danube Canal is classified as artificial and heavily modified water body, respectively. The main stretch of the German Danube is impounded and therefore declared as heavily modified while the free flowing section between Straubing and Vilshofen is designated as natural water body.
