Fairway Rehabilitation and Maintenance Master Plan for the Danube and its navigable tributaries:

NATIONAL ACTION PLANS

UPDATE MAY 2019

Developed within the **EU co-financed project FAIRway Danube**

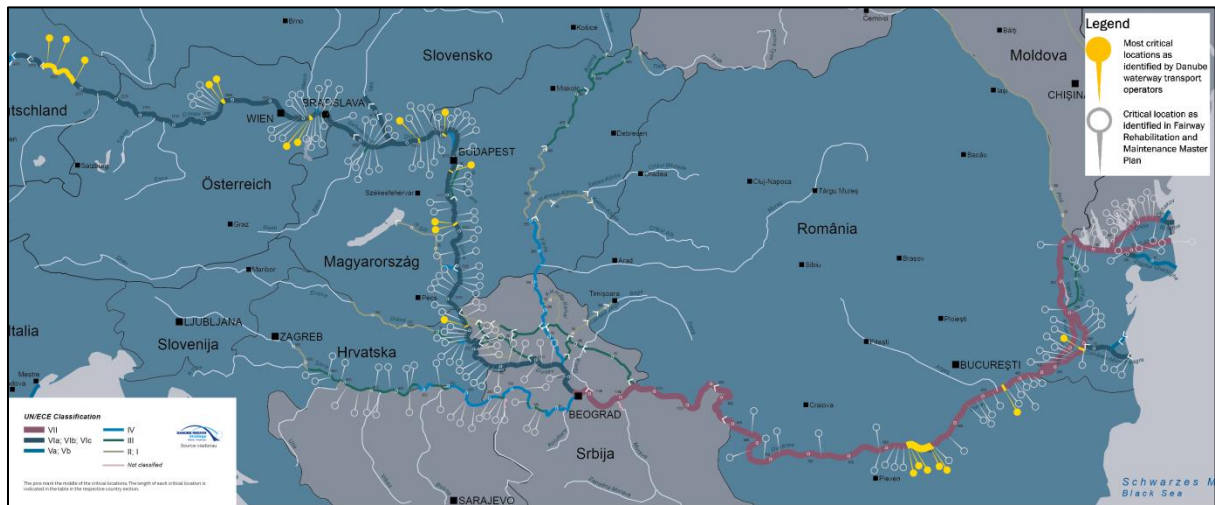
location and length (km)			right bank / left bank	name of section or location
river-km (from - to)		length		
2,321.70	2,312.00	9.50	DE / DE	Straubing (lock)–Straubing-Sand (port)
2,312.00	2,282.50	29.70	DE / DE	Straubing-Sand (port)–Deggendorf
2,282.50	2249,90	32.50	DE / DE	Deggendorf – Vilshofen (backwater Kachlet)
2,014.60	2,013.50	1.10	AT / AT	Weißenkirchen
2,010.20	2,008.90	1.30	AT / AT	Dürnstein
1,888.60	1,887.60	1.00	AT / AT	Treuschütt
1,885.00	1,883.50	1.50	AT / AT	Hainburg
1,735.50	1,733.70	1.80	HU / SK	Nyergesújfalu
1,698.00	1,697.00	1.00	HU / HU	Dömös
1,638.40	1,637.40	1.00	HU / HU	Budafok
1,559.80	1,559.70	0.10	HU / HU	Dunaföldvár
1,558.50	1,557.50	1.00	HU / HU	Solt
1,408.20	1,400.00	8.20	HR / RS	Apatin
568,20	567,80	0.40	BG / RO	Milka Island
567,00	566,70	0.30	BG / RO	Belene Island
562,00	561,50	0.50	BG / RO	Coundur Island
541,60	541,00	0.60	BG / RO	Vardim Island
538,50	537,00	1.50	BG / RO	Giska Island

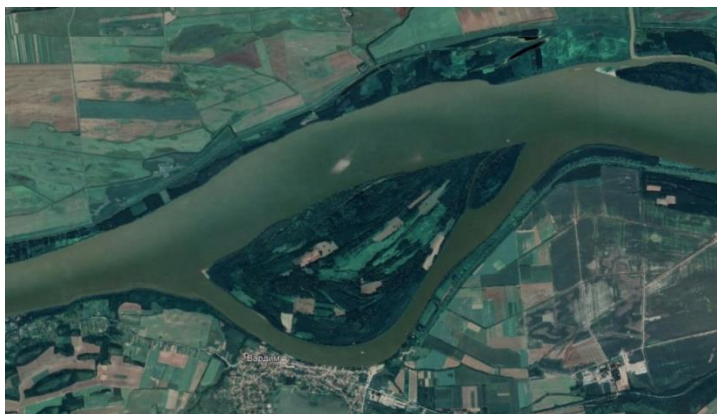
Dredging works in the area of Vardim island

Dredging works for fairway deepening with an area of intervention from km 545.000 to km 547.800 (critical location Vardim Island) began on 02.06.2018 and lasted till 14.06.2018.

The main activities included the removal of alluvial deposits in the fairway between km 545.000 and km 546.300 and their deposition near the Bulgarian coast between km 546.700 and km 547.800. The intervention was performed with 2 self-propelled suction dredgers, operated by a crew of 8 people all together. The capacity of the smaller dredger is 580 m³/2 hours and for the bigger - 1800 m³/4 hours. The dredging and deposition process was monitored by EAEMDR, facilitated by its surveying vessels.

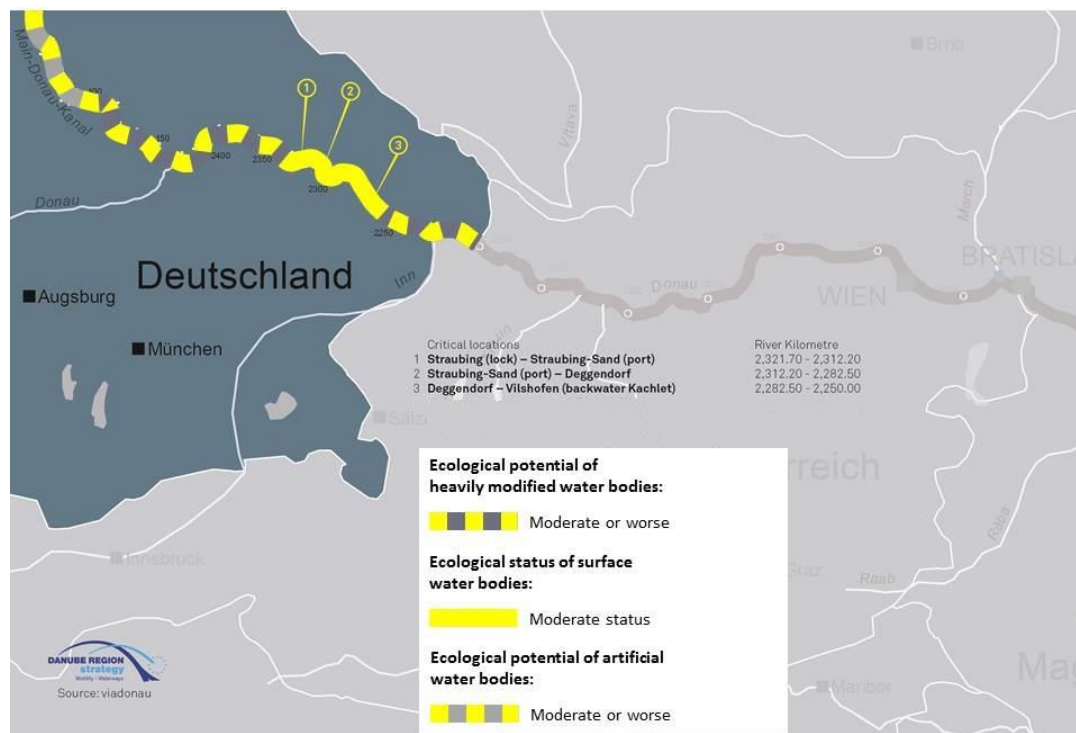
The map above displays the ecological status and ecological potential of the German Danube – according to the Danube River Basin Management Plan/Update 2015 – against the background of the critical navigation locations in Germany.
