Fairway Rehabilitation and Maintenance
MASTER PLAN
for the Danube and its navigable tributaries:

National Action Plans

Update October 2015

Version: final draft
Date: 14.12.2015

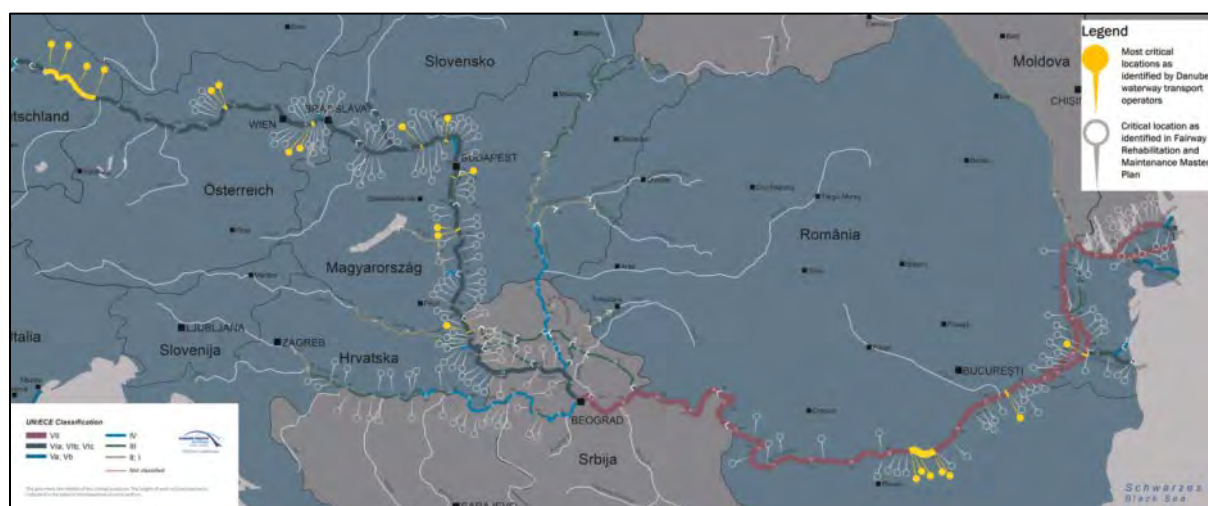
It focuses on the most critical sections as identified by a sample of 24 important shipping organisations in December 2014, as does the roadmap of June 2015. From the user perspective, the locations and stretches marked yellow in the map and listed in the table below cause the biggest navigational problems and should consequently be treated with the highest priority.

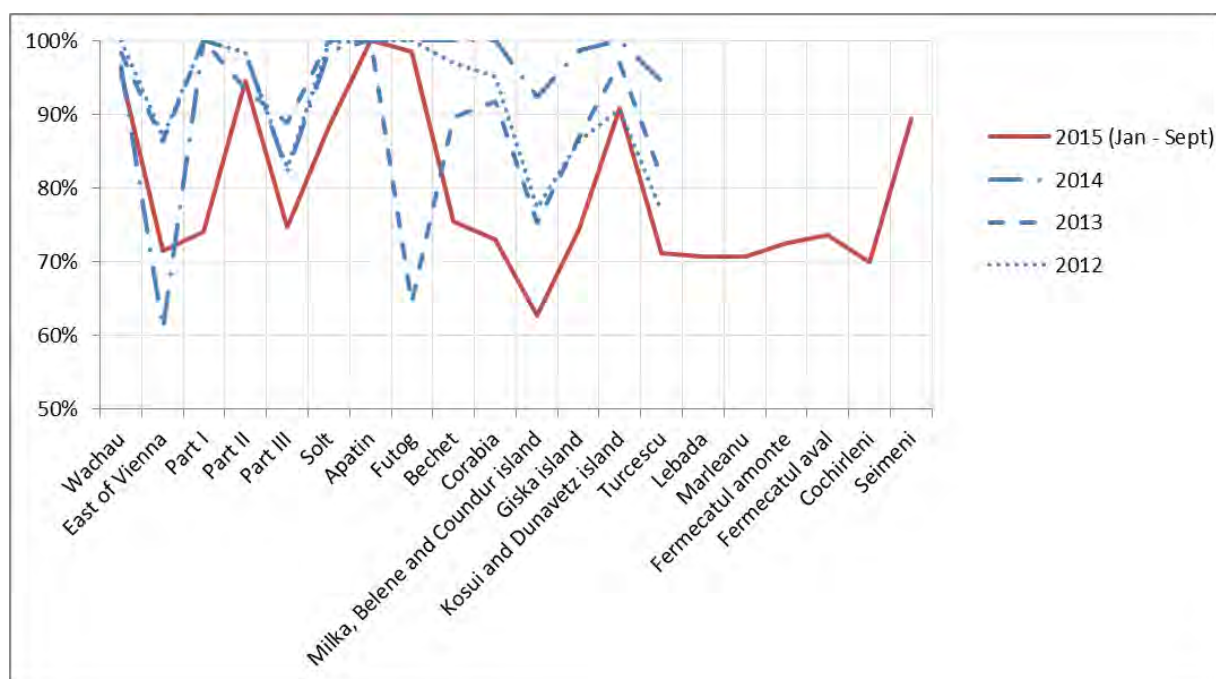
Comparing the latest data from January–September 2015 with the data of previous years (% of days with fairway depth > 2,50m), it can be observed that the most critical locations are dynamic and shift between the years. So far, the most critical locations were encountered on the Lower Danube in 2015, whereas the Upper Danube still offered comparably better fairway conditions until August 2015. The opposite picture could be observed in the year 2014. Whereas the worst sections on the Upper and Middle Danube are concentrated on a limited number of critical locations in 2015, the bad fairway conditions are generally applicable to large stretches of the Lower Danube. The worst locations in the first nine months of 2015 were concentrated in the Milka/Belene/Condour Island area.

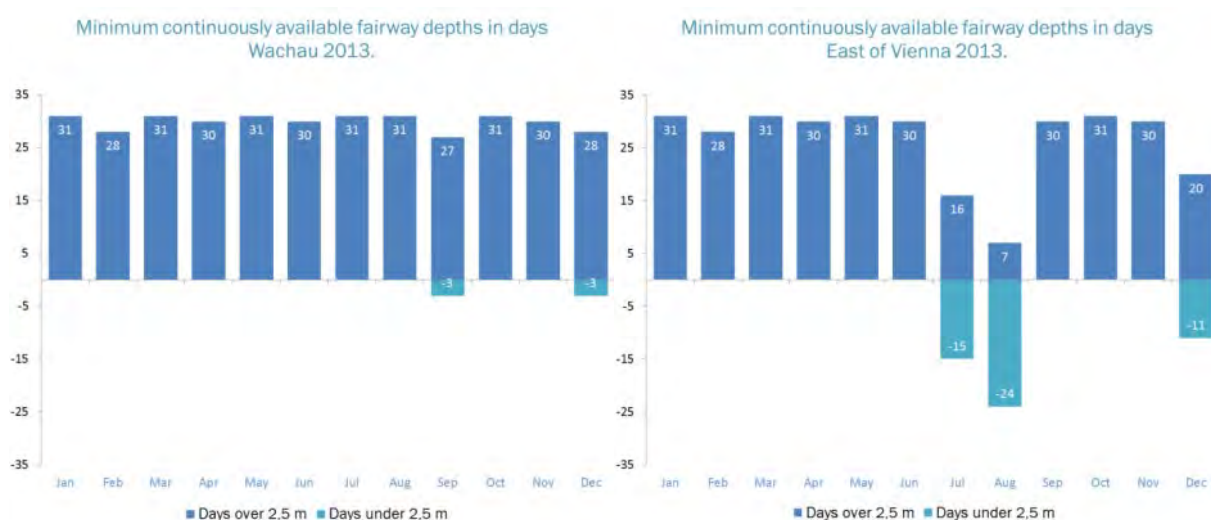
Status of critical locations 2013

In the first half of 2013 both free-flowing stretches of the Danube in Austria recorded the availability of consistent water depths of more than 2.5 metres in the main channel. This was also the case during the months of October and November, which are normally characterised by low water levels. The high waters in June caused sedimentation of approximately 1.3 million m³ of gravel and fine sediment in the fairway leading to restrictions on the availability of fairway depths to the east of Vienna during the following months of July and August when water levels fell. By the end of 2013 dredging carried out by viadonau had resulted in approximately 470,000 m³ of aggradation sediment being removed from the fairway.

The impact of the high water in June 2013 on the stretch east of Vienna was drastic. Decreasing water levels during the months of July and August led to a minimum water depth of 2.5 metres on just 36% of days. With average daily water levels of just 30 cm above low navigable water level (LNWL 2010) recorded at the Wildungsmauer reference gauge in the second half of the month of December, fairway depth in the deep channel was below 2.5 metres for 35% of days in this month.

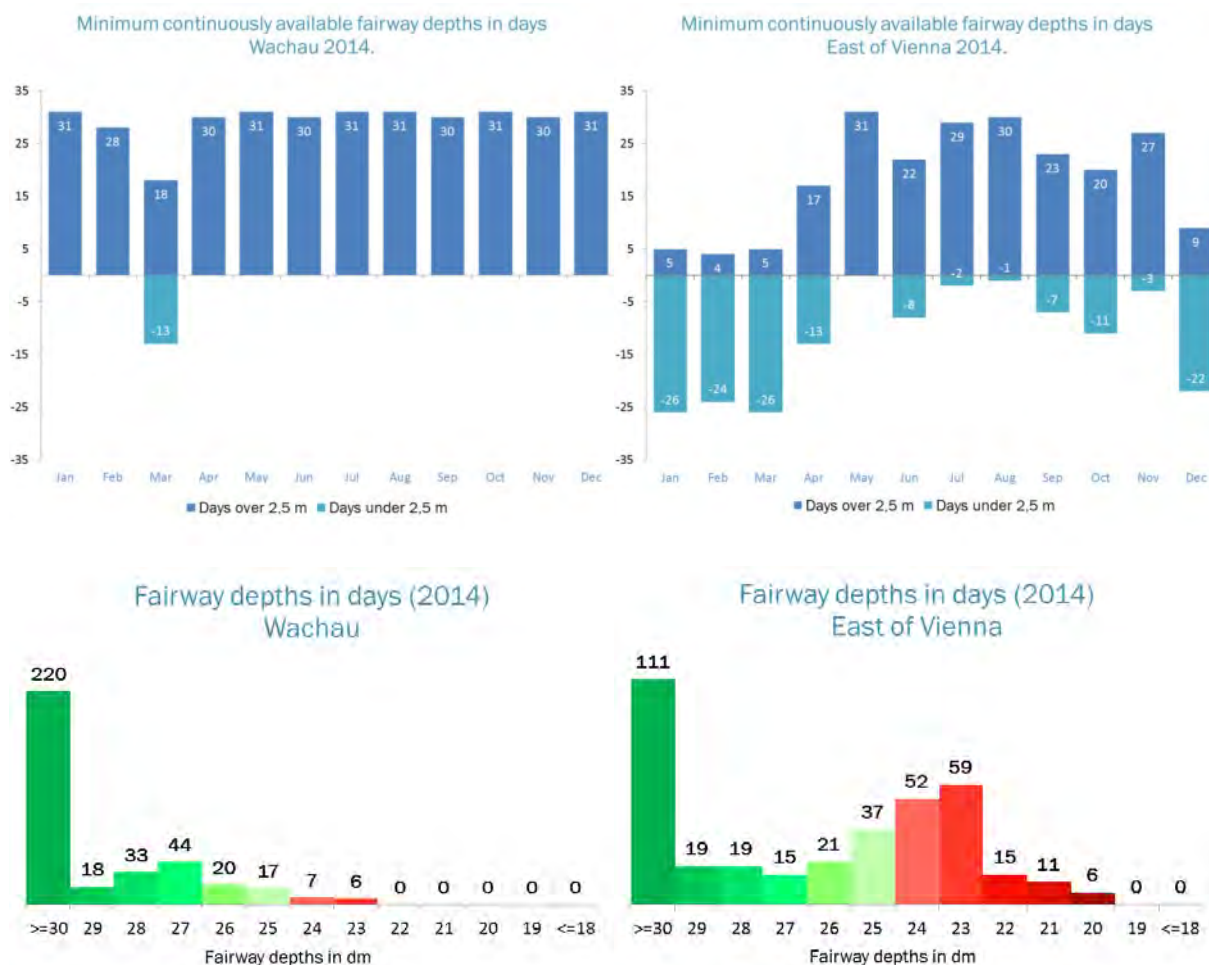
Status of critical locations 2014

In 2014, vessels in both free flowing sections of the Danube in Austria enjoyed constant fairway depths in excess of 2.5 metres, with the exception of six days in the four months of May, July, August and November. A comparison of long-term discharge data for the Austrian Danube (1981 to 2014) shows that water discharge during the months of January to April and December was significantly below average.

A minimum fairway depth of 2.5 metres was available in the Wachau section for 352 days, or about 96% of the year. Only on 13 days (in March) did the water depth in this section of the Danube fall below 2.5 metres. A water depth of at least 27 decimetres was available for navigation for 315 days on this stretch of the river.

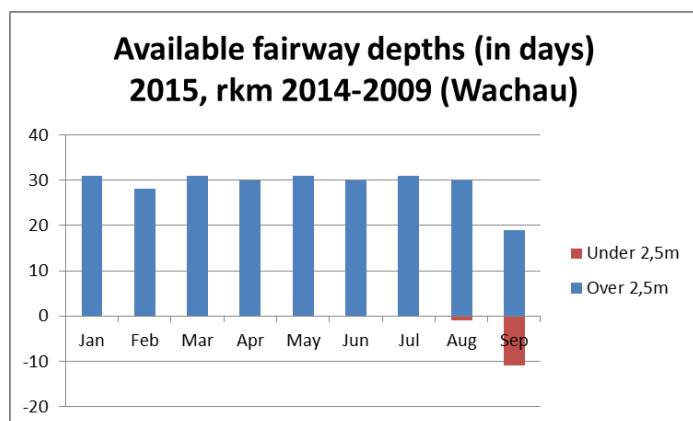
Status of critical locations January – September 2015

The first 9 months of 2015 were characterised by difficult waterway conditions in the free flowing section of the Austrian Danube between Vienna and Bratislava: in the spring season (between January and March) 22 days (or 24%) with a fairway depth less than 2,50 metres were registered. In the summer season (July – September) even 56 days (or 61%) with a fairway depth lower than 2,50 metres were recorded due to the low discharge levels (see next section).

The second free-flowing section – in the Wachau valley – was faced with comparably good conditions: in the months January until July 2015 a fairway depth of over 2,50 metres could be provided on all days (100%). Available fairway depth dropped below 2,50 metres on one day in August and on 11 days in September 2015.

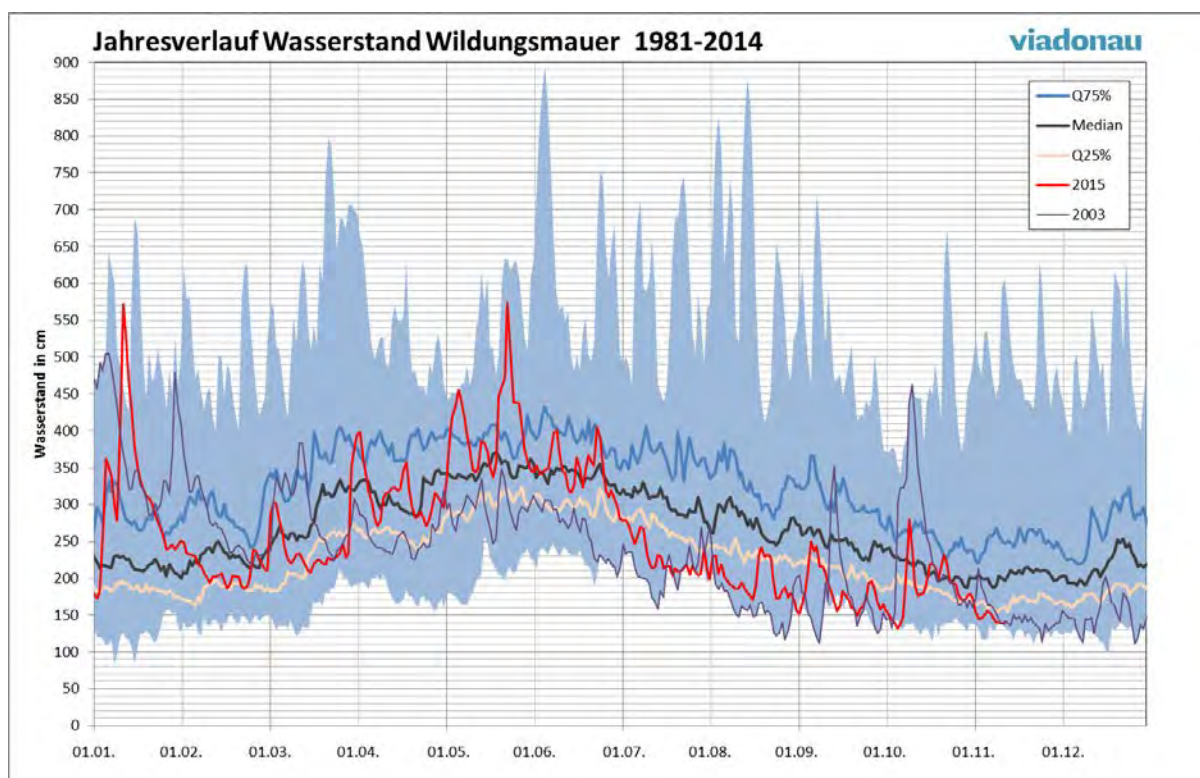
Water level gauge East of Vienna 1981 - 2014

In the period between January and September 2015 relatively bad conditions were encountered in the free-flowing and critical locations east of Vienna. Water level gauges fell below the median value in a large part of the year. The severest water level conditions were observed in the summer months of July until September 2015, with water levels that approach the low values of the one of the worst years in recent history, the year 2003. The statistically exceptional low water period of summer 2015 was followed by a continued low water season in autumn 2015.

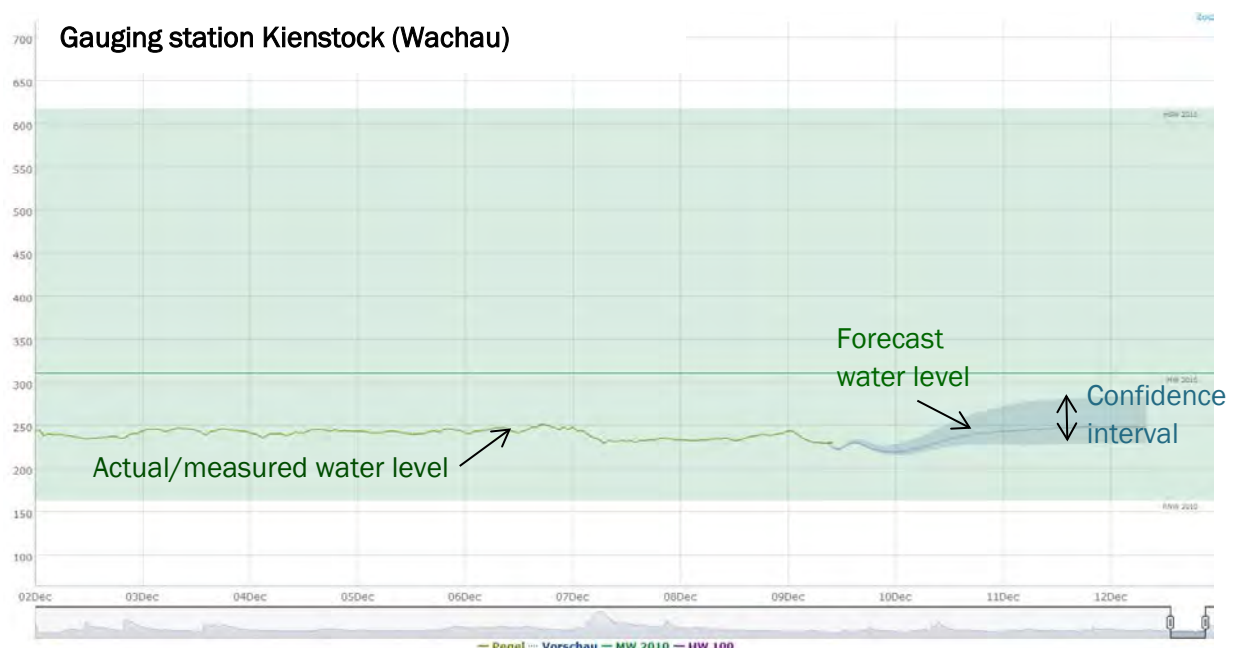
Low water level forecasts are provided online at www.doris.bmvit.gv.at/en/fairway-information/water-levels/ for the two Austrian critical locations Wachau (gauge Kienstock) and east of Vienna (gauge Wildungsmauer). Forecasts range from 24 hours to 72 hours in advance. The calculated forecast water level is displayed together with a confidence interval.

simulates the natural discharge of the river and does not display short-term influences and variations (e.g. as caused by operation of hydroelectric power stations).

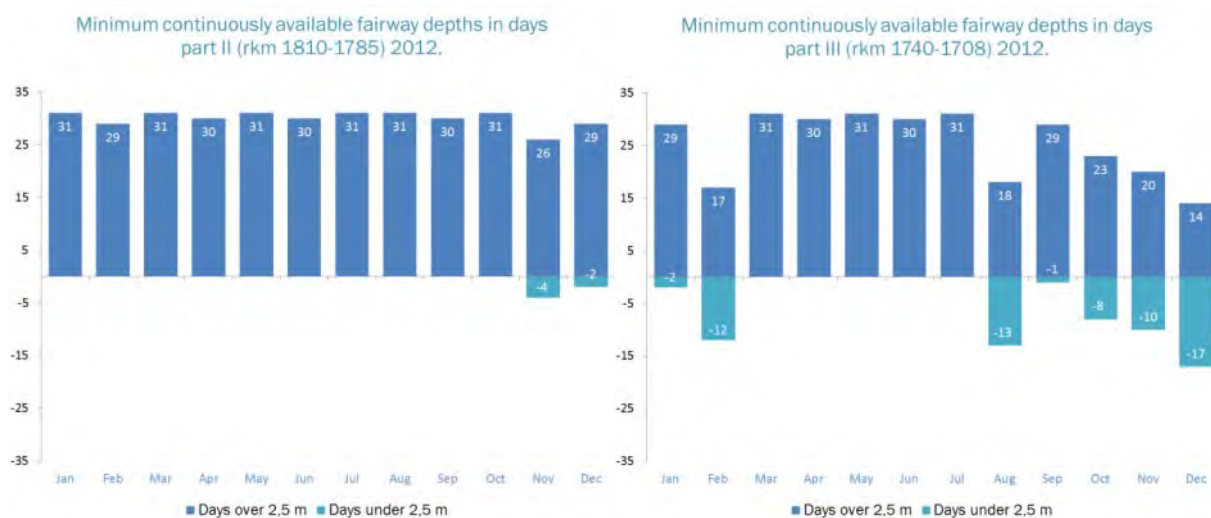
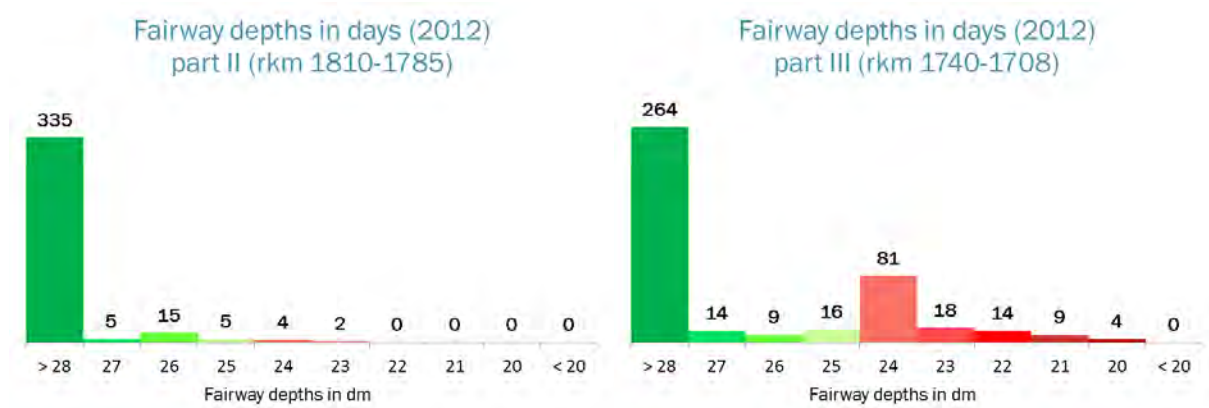
Status of critical locations 2012

In 2012, for the two critical sections defined based on measurements (Part II. rkm 1810 – 1785 and Part III. rkm 1740 – 1708) fairway depths of 2,5 m or more were realised on 360 days (98,4%) and 303 days (82,8%). Based on measurements no depth below 2,5 m in the Part I. – rkm 1880 – 1863) was measured and recorded in 2012. In graphs below also you can see the availability of the depths in both critical stretches, that was no day below 2,3 m in Part II. and 27 days below 2,3 m in Part III.

The main reasons for not meeting the level of service and availability of 2,5 m depth is that on both stretches the river bottom is from stone (stony riverbed or stony threshold – rocky bottom) which is actually not possible to remove via currently using technology for dredging (maybe detonation and removing of the stone after that).

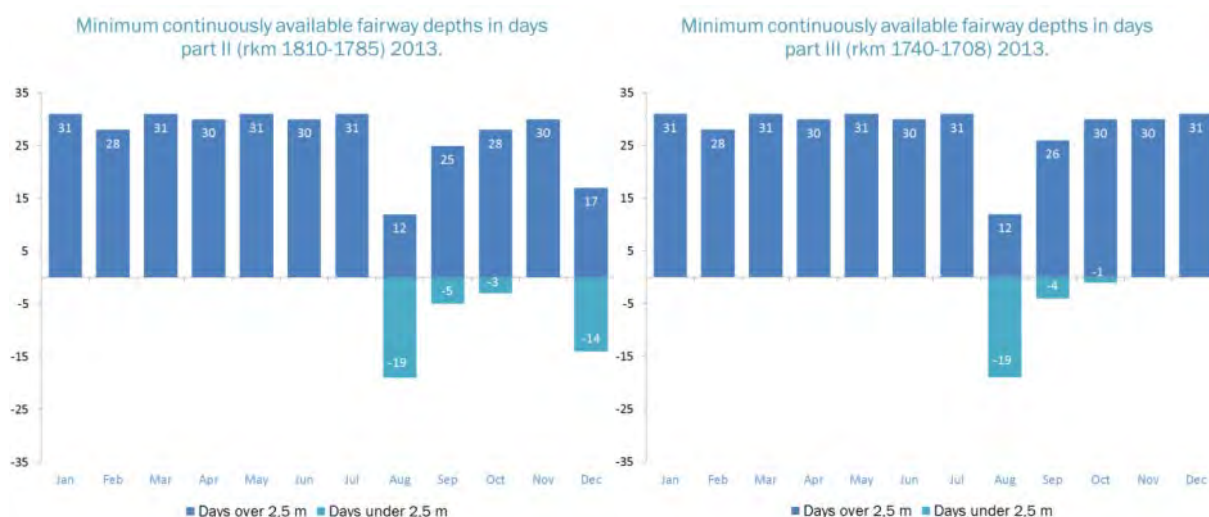
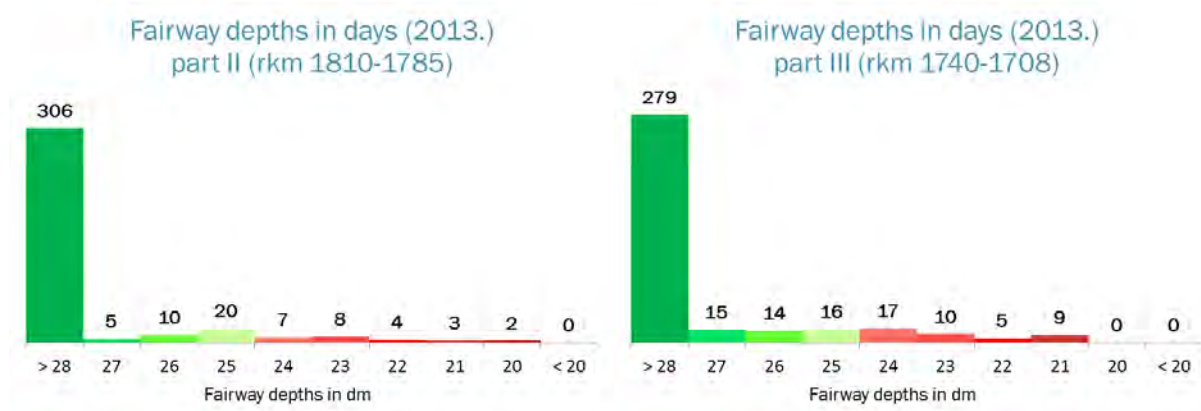
Status of critical locations 2013

In 2013, for the two critical sections defined based on measurements (Part II. rkm 1810 – 1785 and Part III. rkm 1740 – 1708) fairway depths of 2,5 m or more were realised on 341 days (93,4%) and 324 days (88,8%). Based on measurements no depth below 2,5 m in the Part I. – rkm 1880 – 1863) was measured and recorded in 2013. In graphs below also you can see the

availability of the depths in both critical stretches, that only 9 days was below 2,3 m in Part II. and 14 days below 2,3 m in Part III.

The main reasons for not meeting the level of service and availability of 2,5 m depth is that on both stretches the river bottom is from stone (stony riverbed or stony threshold – rocky bottom) which is actually not possible to remove via currently using technology for dredging (maybe detonation and removing of the stone after that). Comparing to the year before and after the 2013 was characterised by a high-water event which occurs every 100 years.

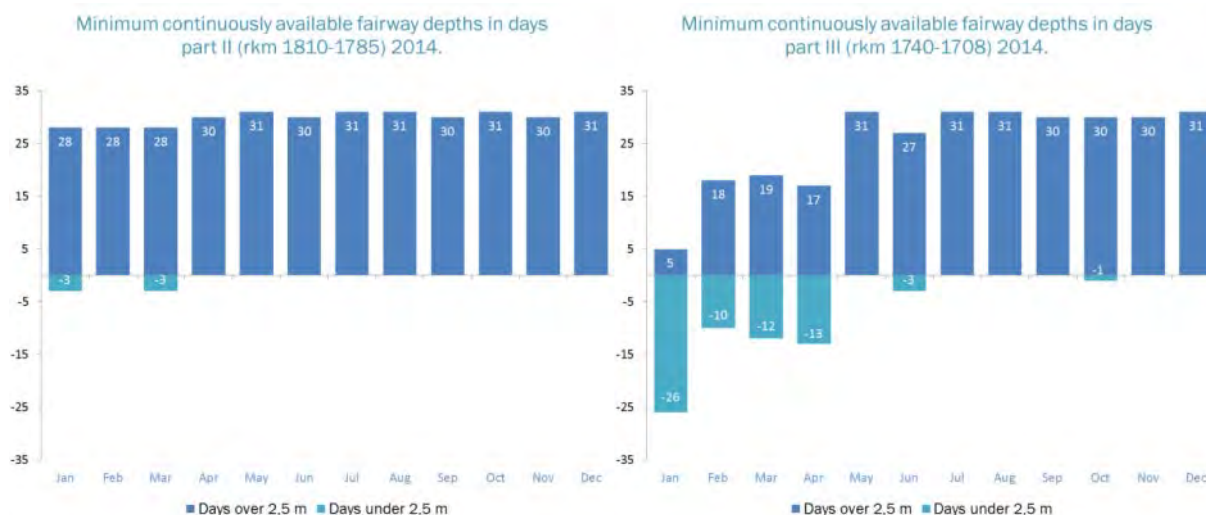
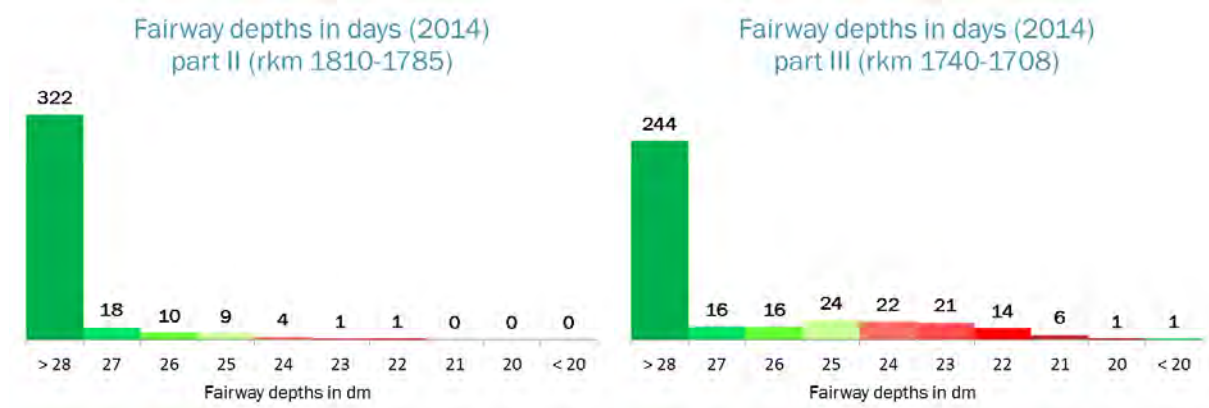
Status of critical locations 2014

In 2014, for the two critical sections defined based on measurements (Part II. rkm 1810 – 1785 and Part III. rkm 1740 – 1708) fairway depths of 2,5 m or more were realised on 359 days (98,3%) and 300 days (82,2%). Based on measurements no depth below 2,5 m in the Part I. – rkm 1880 – 1863) was measured and recorded in 2014. In graphs below also you can see the availability of the depths in both critical stretches, that only 1 day was below 2,3 m in Part II. and 22 days below 2,3 m in Part III. (1 day of 1,9 m of depth).

The main reasons for not meeting the level of service and availability of 2,5 m depth is that on both stretches the river bottom is from stone (stony riverbed or stony threshold – rocky bottom) which is actually not possible to remove via currently using technology for dredging (maybe detonation and removing of the stone after that).

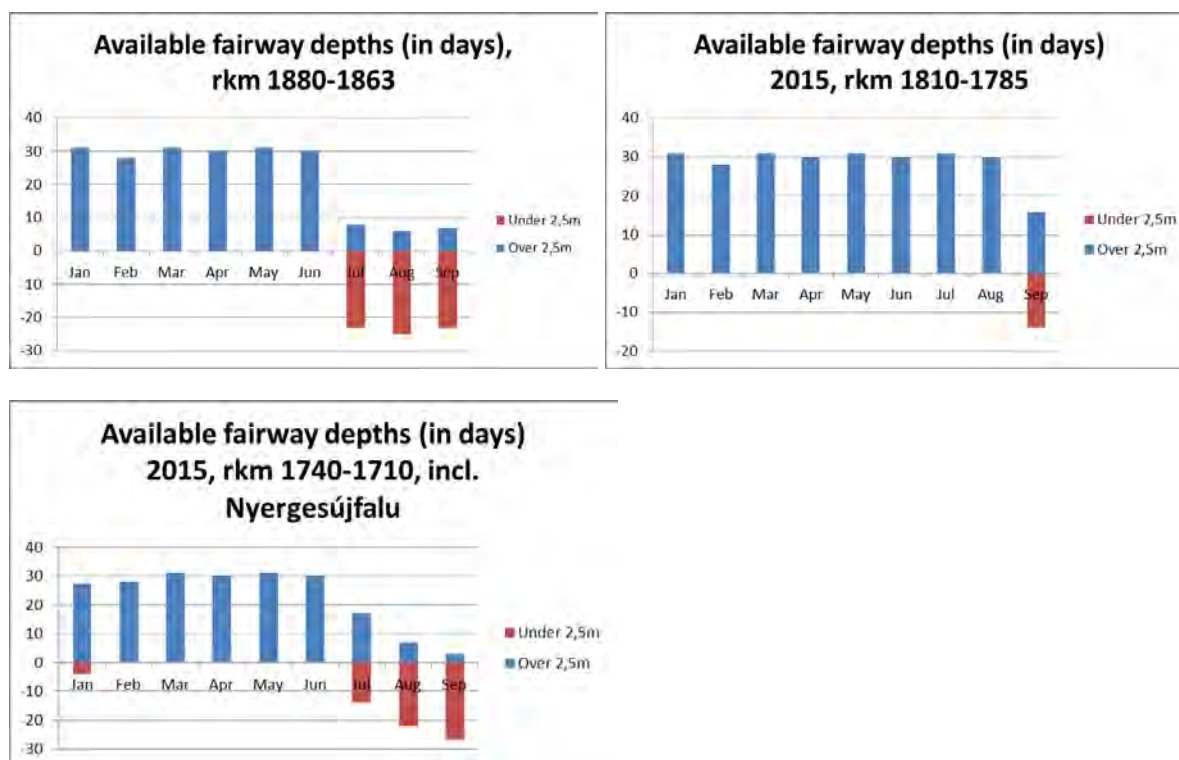
Status of critical locations January – September 2015

In 2015 (period January – September), for all three measured sections, Part I. (rkm 1880 – 1863) fairway depth of 2,5 m and more were realised on 202 (74%) days, for Part II. (rkm 1810 – 1785) on 258 (94,5%) days and for Part III. (rkm 1740 – 1710) on 204 (74,7%) days. In graphs also you can see the availability of the depths in all three sections in days, which were above or below the 2,5 m, in Part III. (the most critical section rkm 1735,5 – 1733,7 – Cenkov (in HU language – Nyergesújfalu)) also were 16 days below 2,0 m (3 days with 1,7 m of depth only).

The main reasons for not meeting the level of service and availability of 2,5 m depth is that on Part II. and Part III. the river bottom is from stone (stony riverbed or stony threshold – rocky bottom) which is actually not possible to remove via currently using technology for dredging (maybe detonation and removing of the stone after that). In Part I. the regular dredging intervention was done according to the plan.

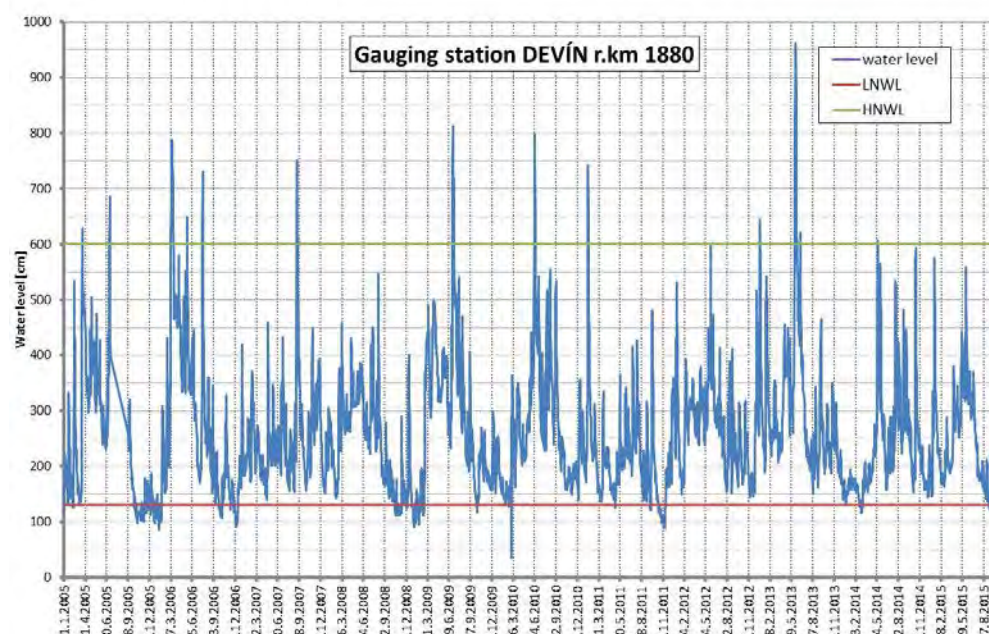
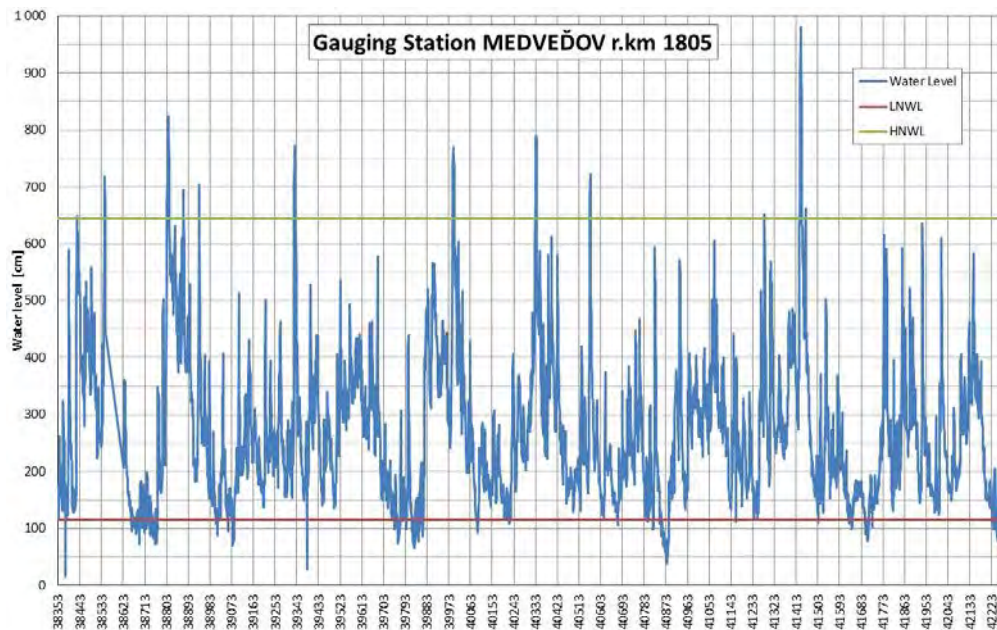
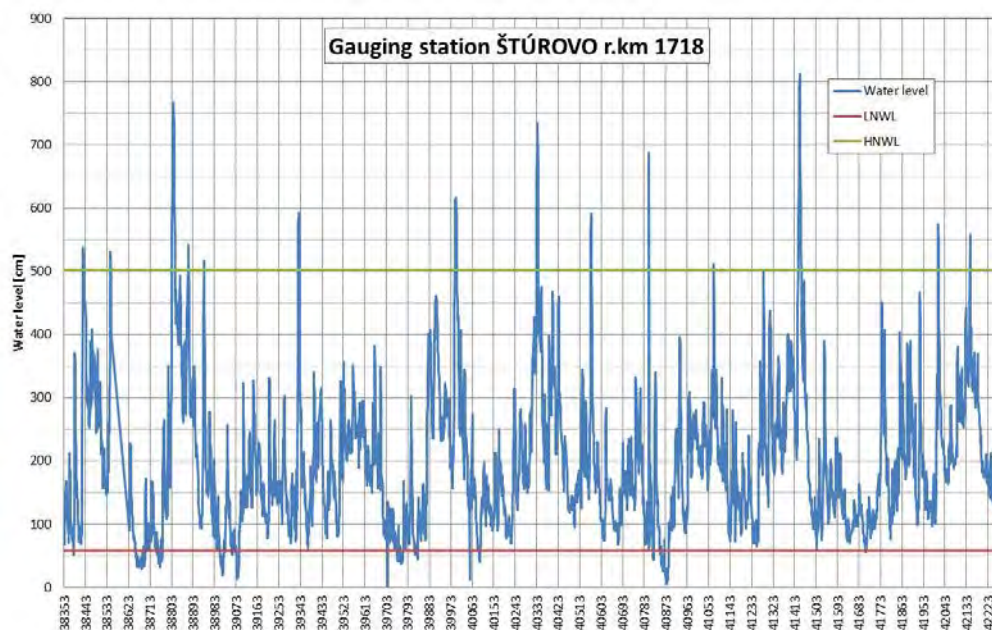
The following graphs represent the course of water level in particular gauging stations during the time period from 1.1.2005 till 30.9.2015. Values of LNWL and HNWL were provided by Danube Commission.

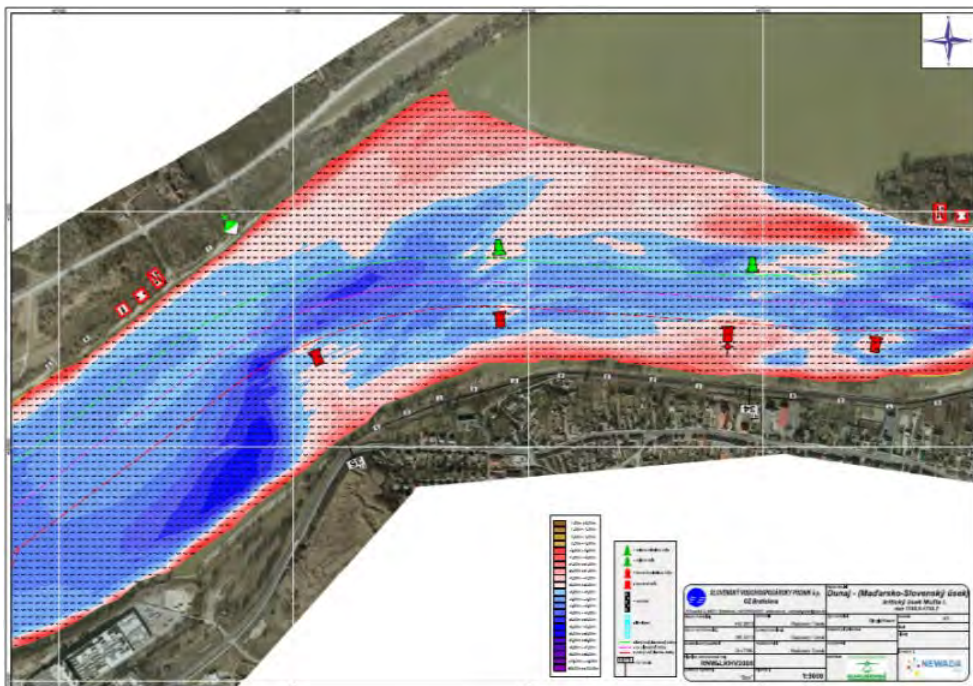
Monitoring of the fairway has been done on weekly basis. Each week two marking vessels are navigating on the Danube and controlling the position of the buoys and shoreline signs. Also the monitoring of the critical section is done by marking vessels in parallel with fairway monitoring activities. Critical section information has been provided daily based on information from the Hungarian partner Eduvizig and SVP Branch Gabčíkovo. Information from both branches is collected by SVP Dispatching in Bratislava which informs the Transport Authority, Division of Inland Navigation. The Transport Authority is the organisation responsible for the providing of the daily status of critical section on entire stretch of Danube (rkm 1880-1708). The web service for the providing of the critical section information is under development. The PDFs on critical sections are prepared by SVP, Hydrography Department and provided on FIS portal as the annex for the critical section. Depths are displayed based on LNWL. Estimated entire processing time starting with the measurement via data processing until the final result (availability of the depth information) is approximately 5 working days per 10 km of the river stretch.

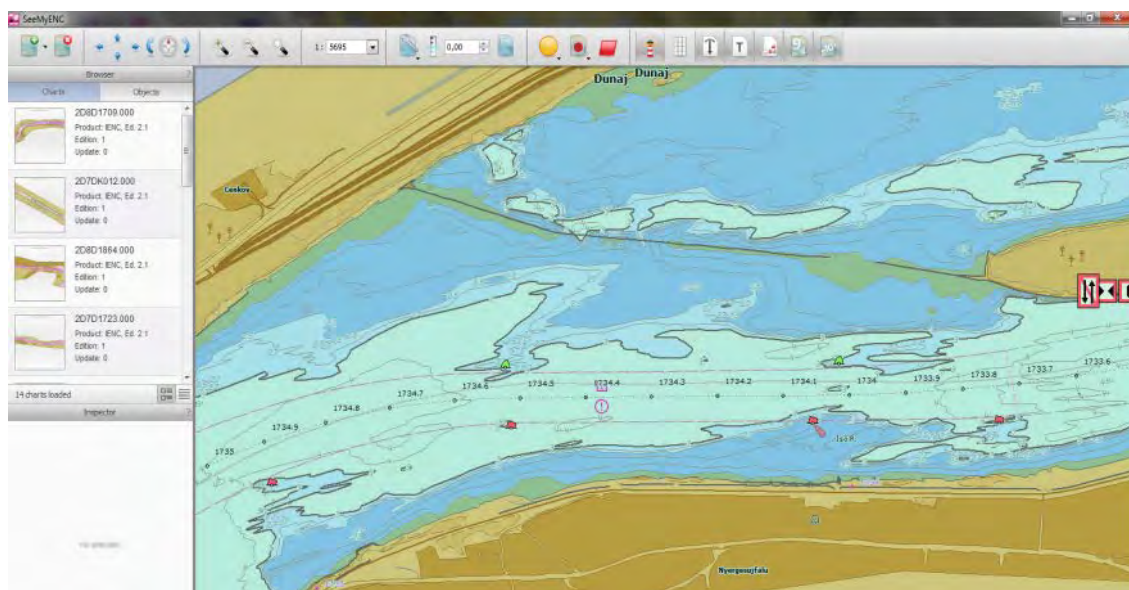
The Navigational Charts (Inland ENC) published by SVP (Slovak Water Management Enterprise) according to the law as the organisation responsible for maintenance has to create a update the Inland ENC for the navigable stretches of the waterways in Slovakia. Since 2013 we are producing the IENC charts also with depth information for the entire SK stretch of Danube (rkm 1880-1708). The Inland ENC charts have been updated once a year including the depth information. All the necessary information according to the IE standard has been included into the charts and also charts contain the RIS index information.

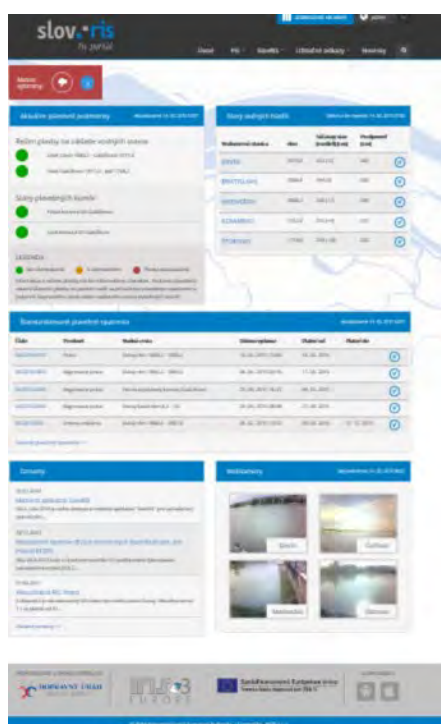
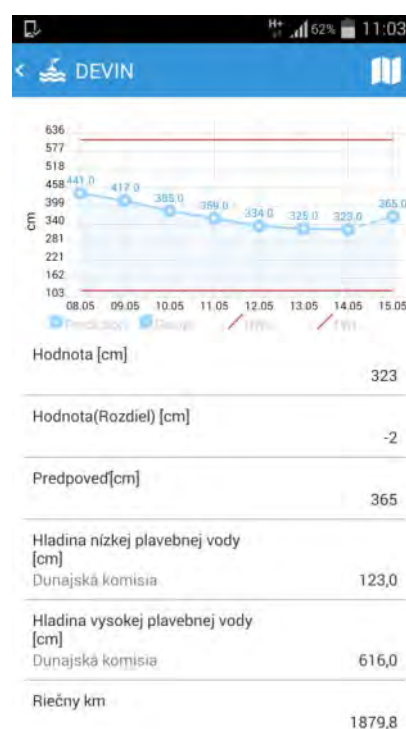
During the implementation of the IRIS EU projects (II & III) also the WLAN hotspots at the Captaincy building of Transport Authority in Bratislava, Port of Bratislava and Lock of Gabčíkovo were installed and available. Further the development of the application of Slovrís for the smartphone (Slovrís App) and also the development of the Slovak FIS (Fairway Information Service) Portal, which both display the water levels, notices to skippers, weather and ice information, weather warnings, operation status of the Lock Gabčíkovo and current navigability conditions on the Slovakian entire stretch of Danube (rkm 1880-1708). In 2012, the Slovakian NtS server was linked with Austrian and German systems.

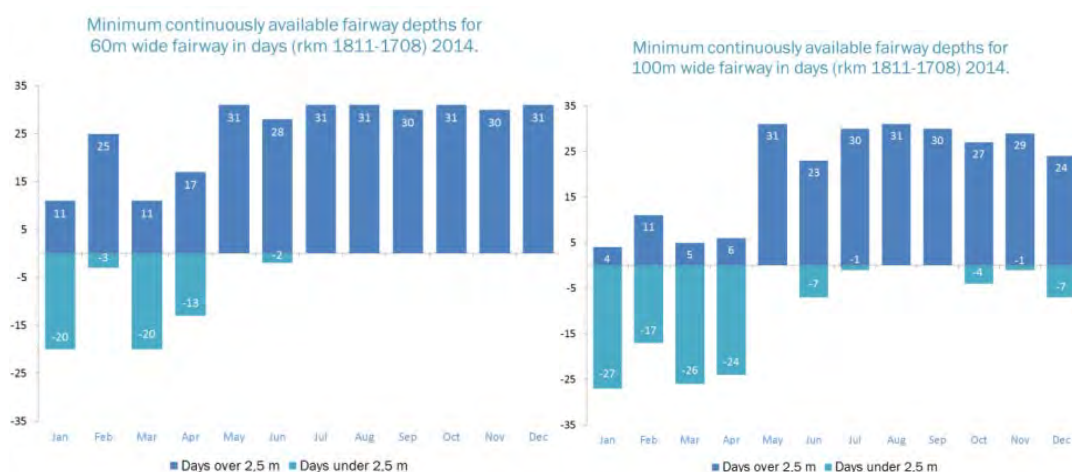
Critical location	2012	2013	2014
Nyergesújfalu critical location with 60 meters wide fairway	304	314	307
Nyergesújfalu critical location with 100 meters wide fairway	286	304	256

Fairway width (range of values accounts for different curve radii): 60 to 100 m in Slovakia and Slovak - Hungarian border section, 80 to 120 m in Hungarian Danube (rkm 1708-1433) section based on Fairway Rehabilitation and Maintenance Master Plan.

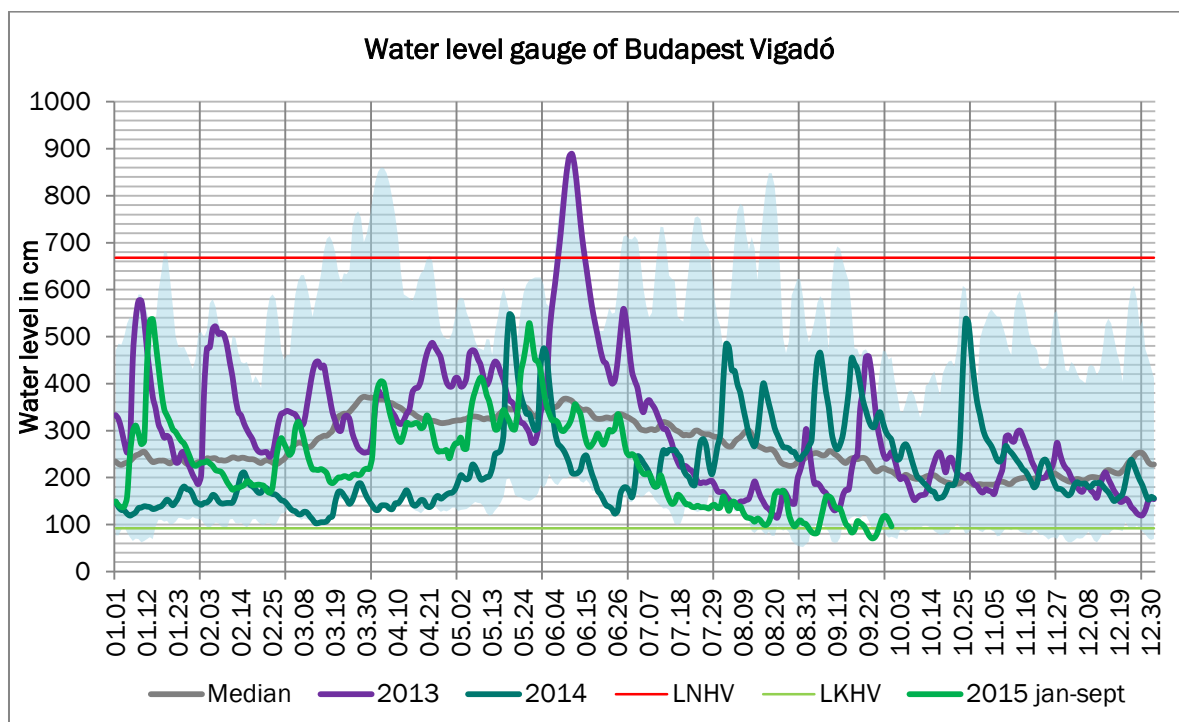
Critical location	Reference gauge	No of days above LNWL		
		2013	2014	2015*
Göd	Budapest	364	357	262

In hydrological terms, the years 2012, 2013 and 2014 saw very good fairway conditions along the Danube section of 1708 - 1506 rkm. But in 2015* (jan-sept) the daily water levels at the gauging station Budapest not exceeded the average water level (AWL 1981-2014) for around 80 % of the period.

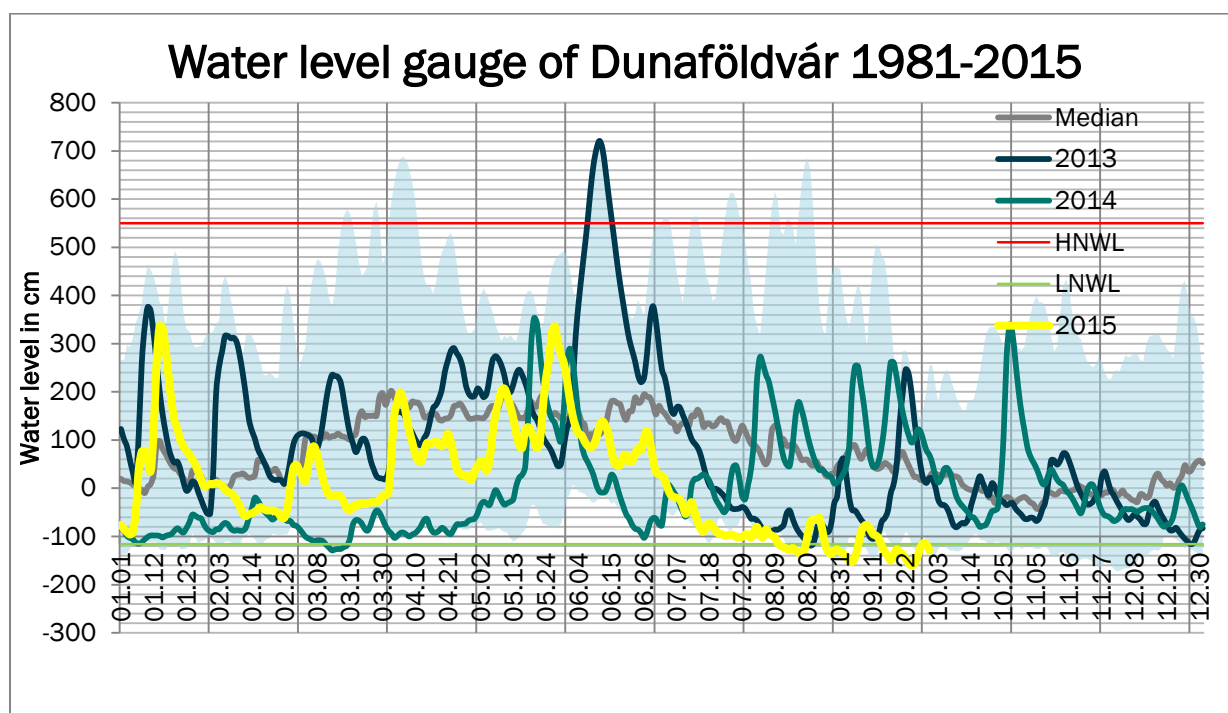
Critical location	Reference gauge	No of days above LNWL			
		2012	2013	2014	01.01.2015 - 30.09.2015
Solt	Dunaföldvár	366	364	357	236

In hydrological terms, the years 2012 - 2014 saw very good fairway conditions along the Danube section of 1506 - 1433 rkm. No single day of the year 2012 did water levels fall below the low navigable water level (LNWL 2010) and water levels are only 2 days below LNWL in 2013 and 8 days in 2014. In hydrological terms, in the summer of 2015 there was a low water period on the Danube. Along the Danube section of 1506-1433 rkm were the water levels more than 30 days below the LNWL.

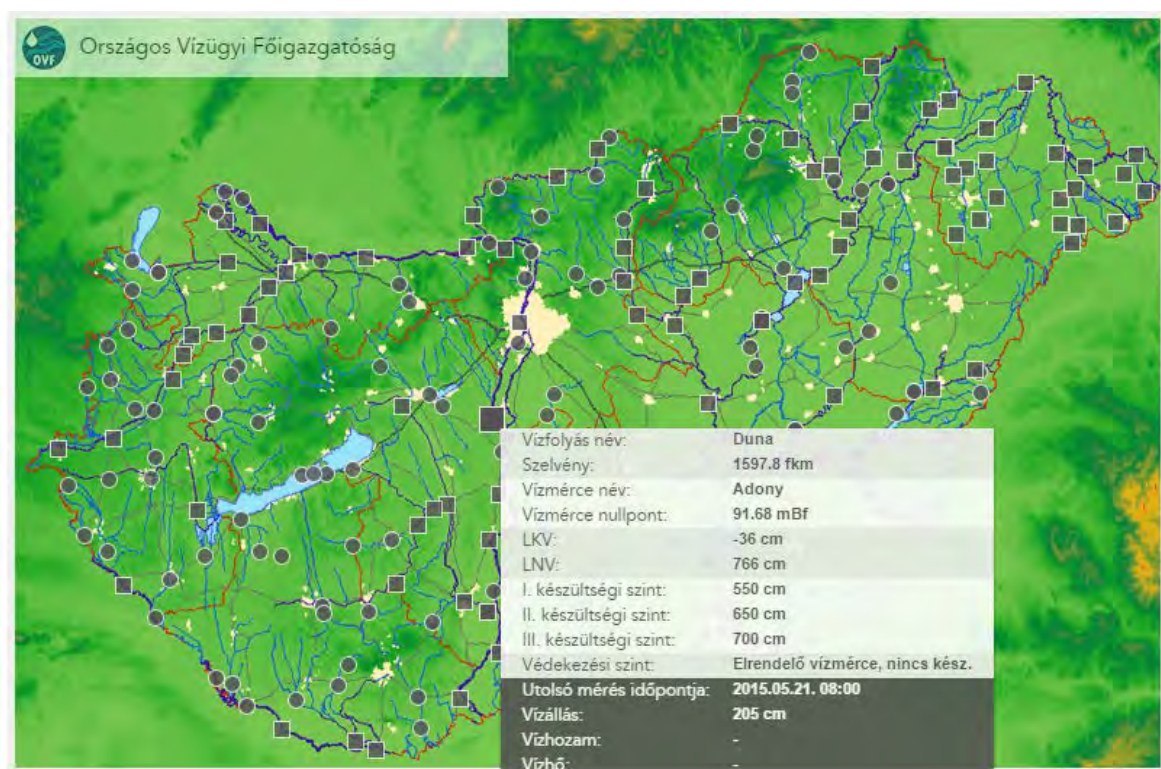
Water levels at www.vizugy.hu – OVF web page

HHFS produces water level forecasts for fifteen gauging stations **along the whole Hungarian Danube not only for critical locations**. However, equivalent water-levels methods can be used to estimate water level forecasts at critical locations. Relevant data are published online via www.hydroinfo.hu. Gauging data are **refreshed online daily**. Also data for all Danube gauge stations are published online via www.vizugy.hu and the Directorate webpages **refreshed online every hour**.

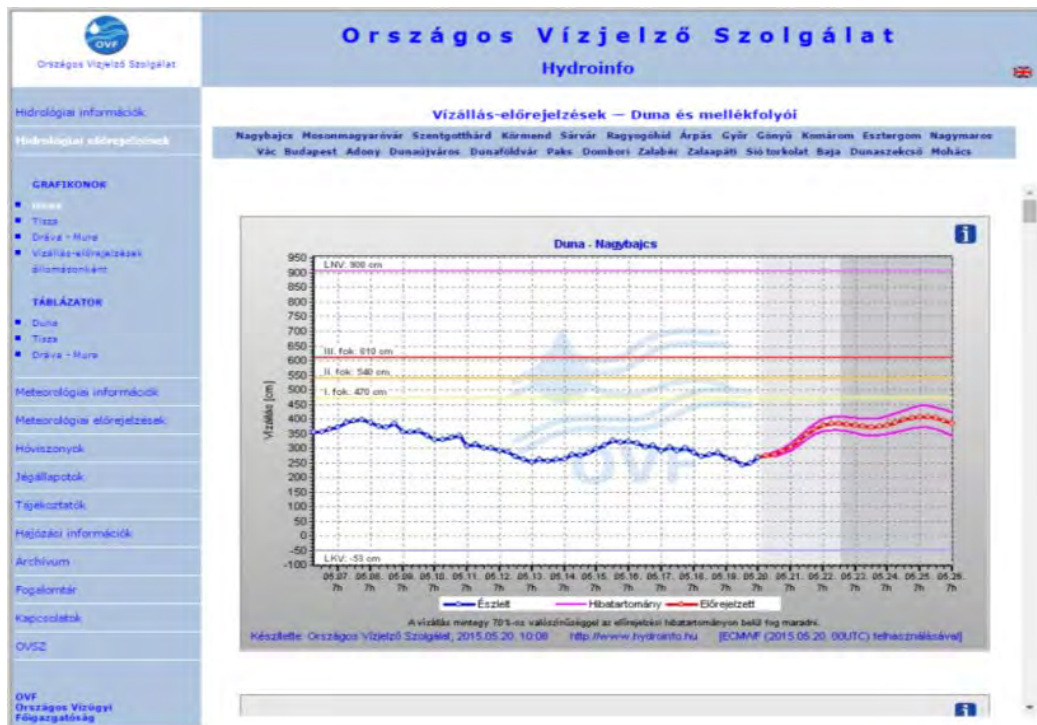
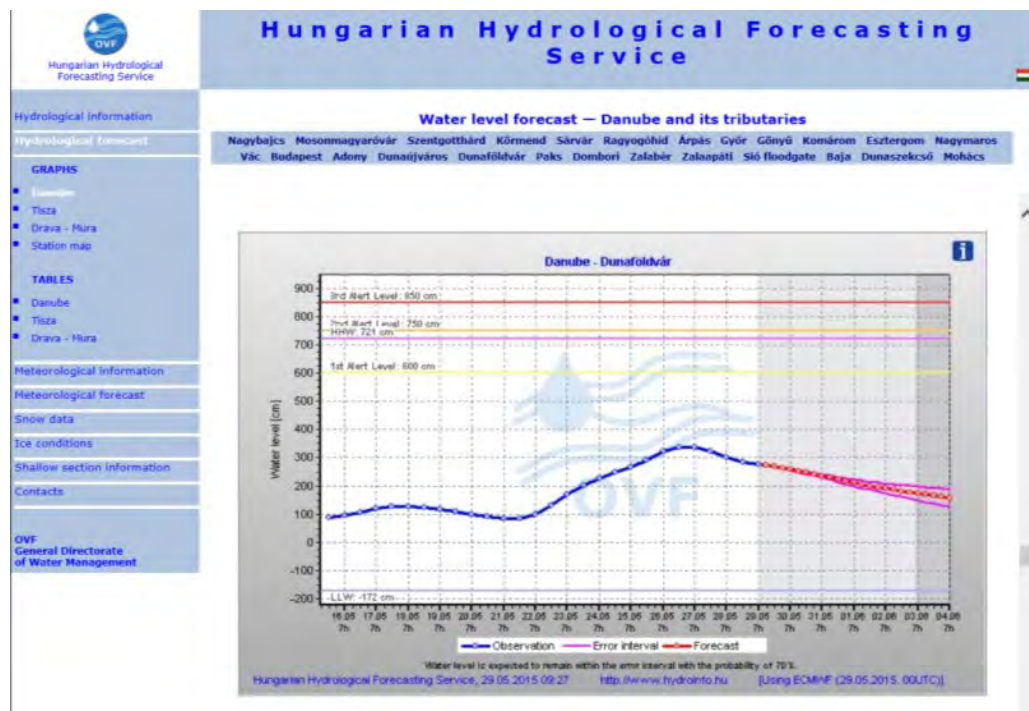
Water levels prognosis www.hydroinfo.hu – Hungarian Hydrological Forecasting Service (OVF web page – Hungarian and English language)

The forecasts are available both Hungarian and English language as well on the web page. English version of the water level forecasts for the fifteen gauging stations of the Hungarian Danube section is published online on www.hydroinfo.hu/en/hidelo/hidelo_graf_duna.html.

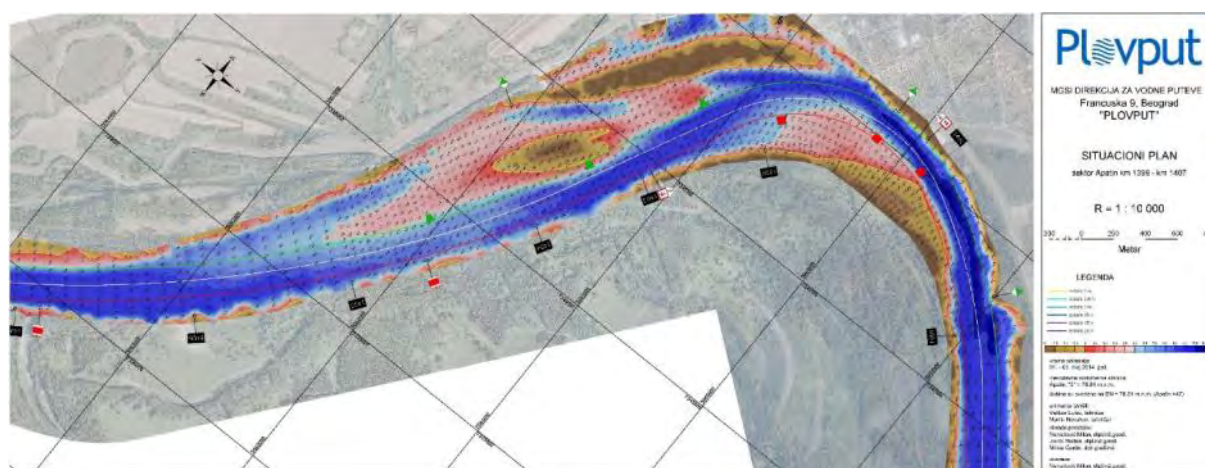
Figure 15: Apatin, layout, May 2014

The Layout of the critical sector Apatin from May 2014 is presented in the *Figure 15*. This sector was characterised by positive morphological developments in 2012, 2013 and 2014, compared to situation from the late 2011 (when navigation was completely stopped during the low water period, due to insufficient water depth).
