Fairway Rehabilitation and Maintenance
MASTER PLAN
for the Danube and its navigable tributaries:

National Action Plans

Update October 2015

Version: final draft
Date: 14.12.2015

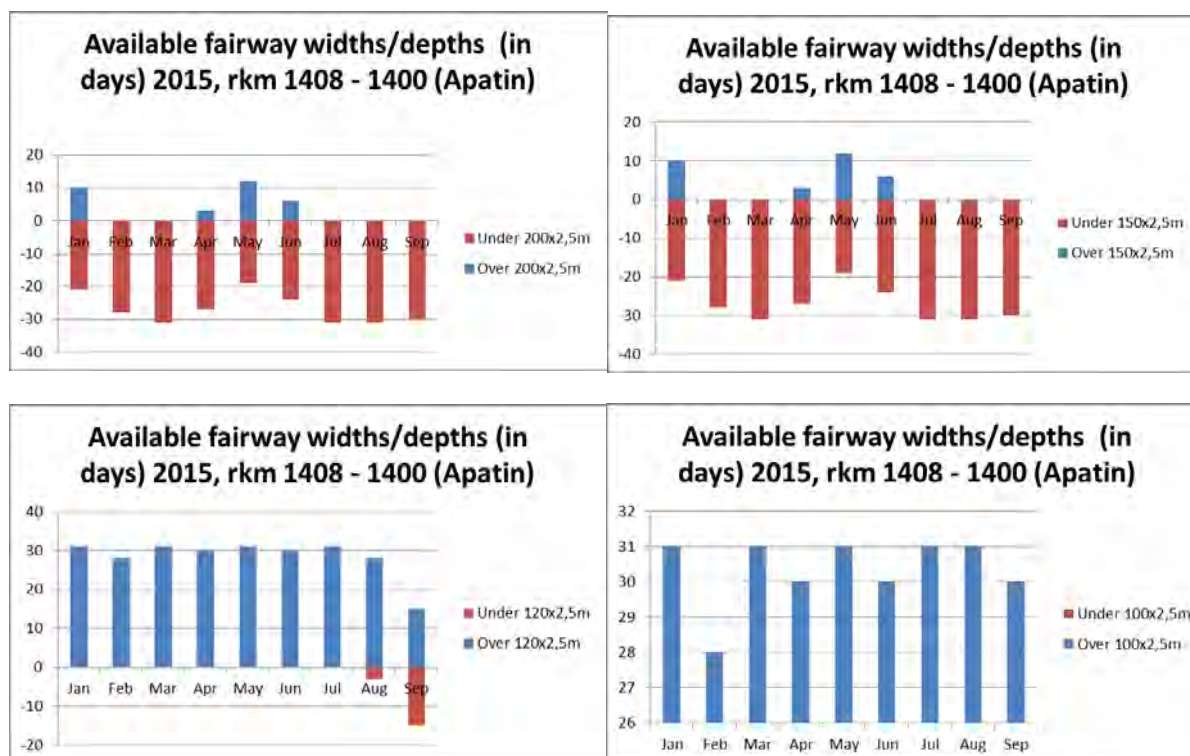
Status of critical locations in 2015

Critical sector in 2015	200 x 2,5	150 x 2,5	120 x 2,5	100 x 2,5
Apatin	242	242	18	0

During 2015, the situation in Apatin section was stable and there was no reallocation of the fairway as the most favourable depth was held throughout the year within the fairway limits of 100m.

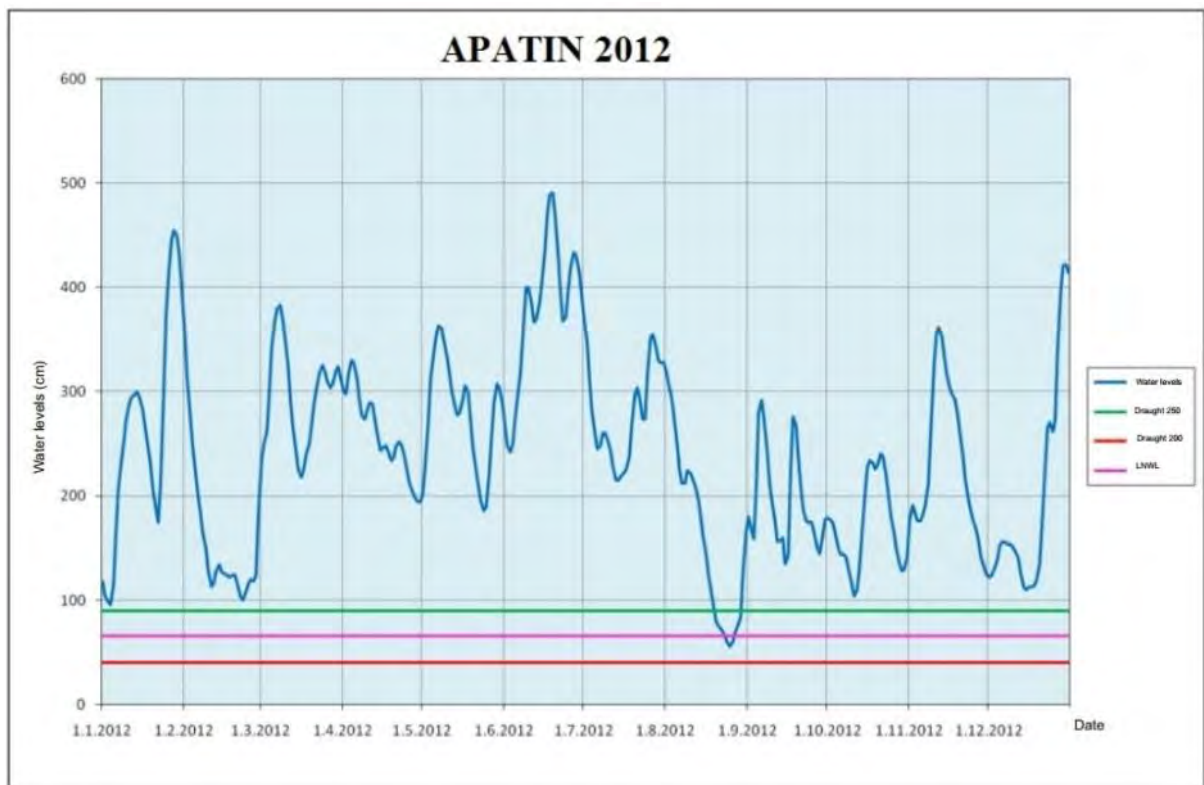
In 2012 at the gauging station Apatin the water level under low navigable water level was present only for a short period in August.

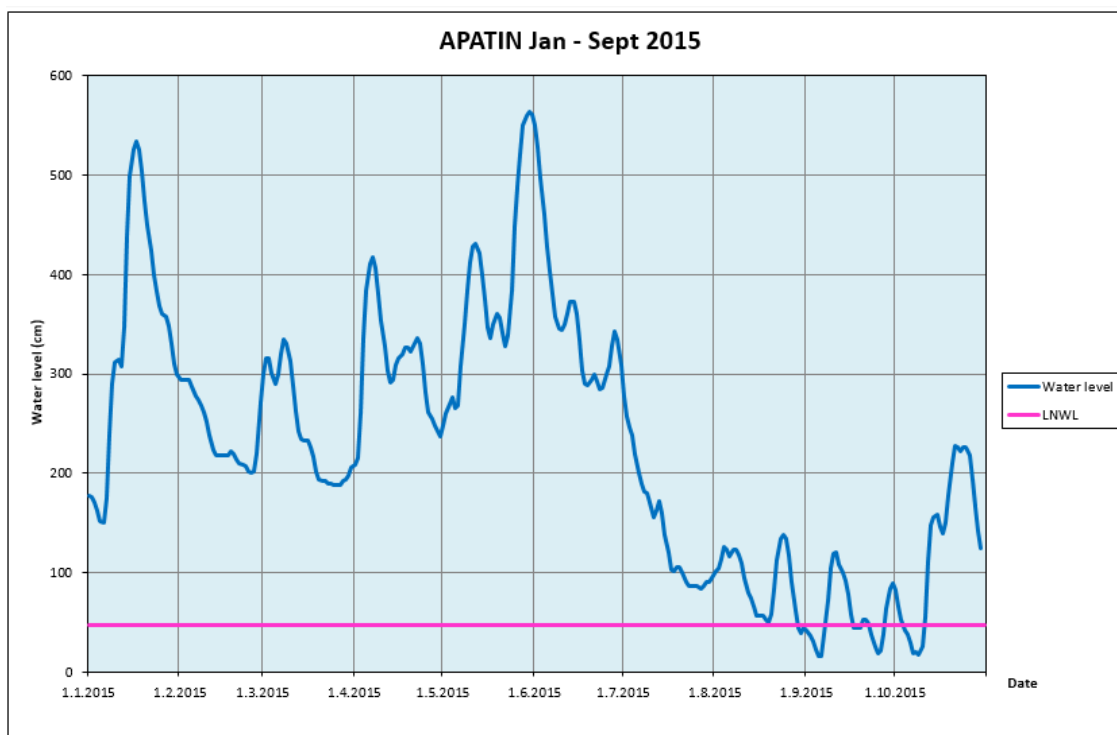
In 2015 (Jan- Sept) at the gauging station Apatin the water level under low navigable water level was present in short period in August and in September.

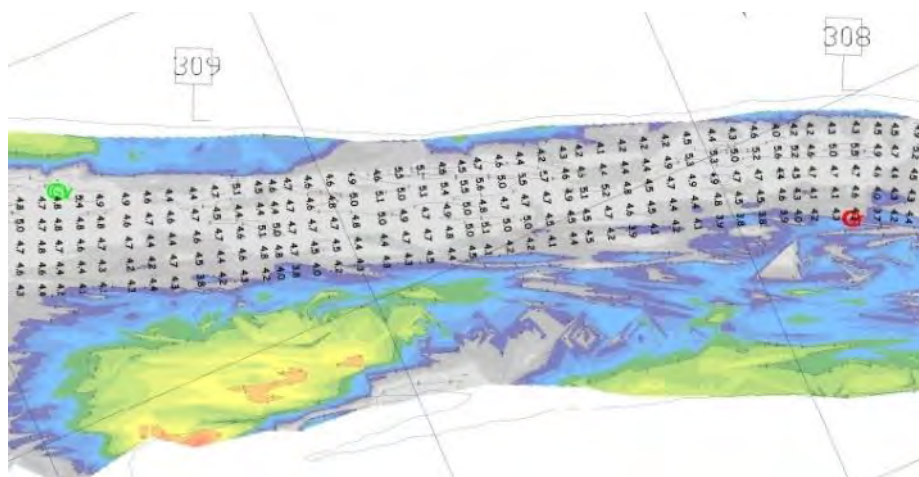
main goal is to be able to foresee navigation problems and prepare rapid interventions if needed. For this, critical areas are permanently monitored by measurements and marking works. When needed, dredging works (prepared in advance) are carried out. It is also important to provide updated information on the situation depths in critical areas. Information about water levels, depths, weather is published on a daily basis. Current information about shallow sections is presented in an easy way and is updated based on field verification (weekly, monthly, yearly). Users can have an overview on areas and easily observe problem areas, represented by different colour codes.

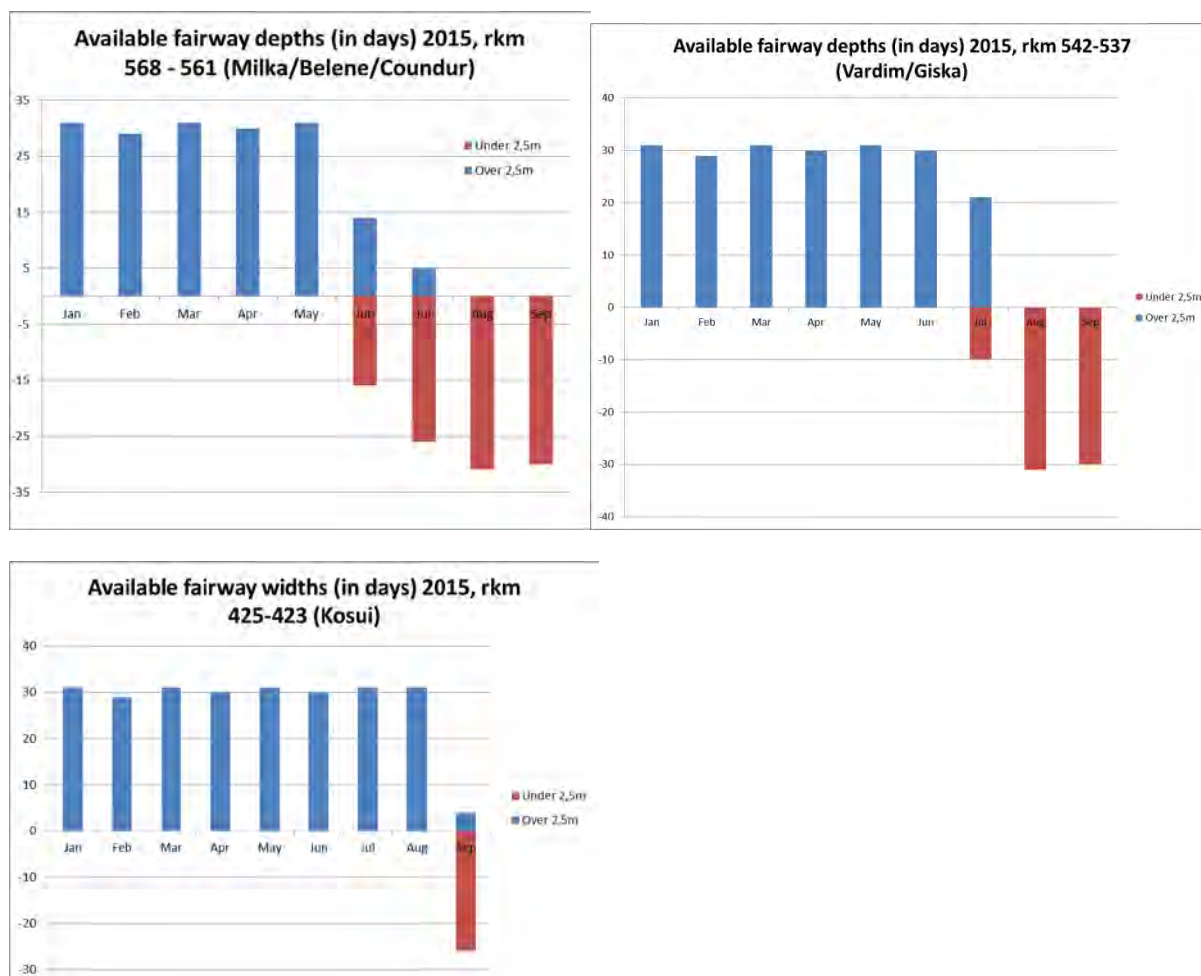
Status of critical locations Jan – September 2015

The low water levels in the months of June and especially in July, August and September had a drastic effect on the navigation in the Bulgarian part of the Danube River. In June 2015 the total amount of days with available fairway depth over 2.5 m was 14 days. However, a water depth of 23 and 24 decimetres could still be used for navigation in this section. The situation became worse in July, August and September, while the water depth was under 2.5 m respectively 26, 31, 30 days. The navigation was not totally stopped but some restrictions to the convoys were imposed.

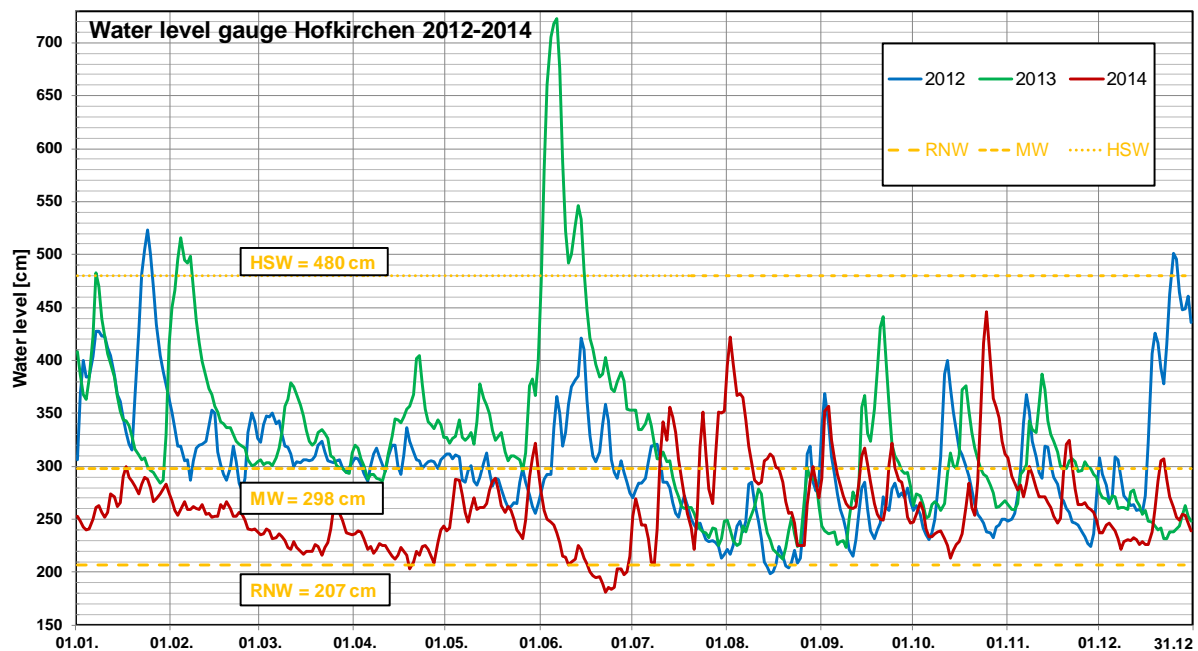
Number of days with water levels above LNWL (in Germany: RNW)

From a hydrological point of view, 2013 was a wet year for the German Danube, which also includes a flood event in June 2013 (cf. 2.2), which is only likely to occur approximately every 40 years (reference gauge Hofkirchen: upstream effects from dike break in Deggendorf and confluence river Isar). While there were few low water periods in 2012, there were remarkable low water periods in 2014 above all for the section Straubing–Deggendorf (upstream confluence Isar).

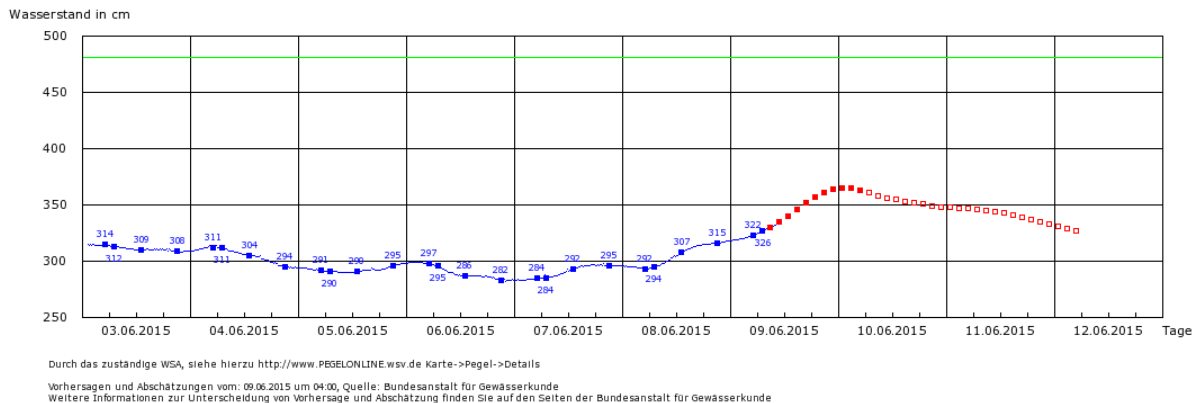
HOFKIRCHEN

Wasserstände der vergangenen 7 Tage und Wasserstandsvorhersage am 09.06.2015 12:15 Uhr

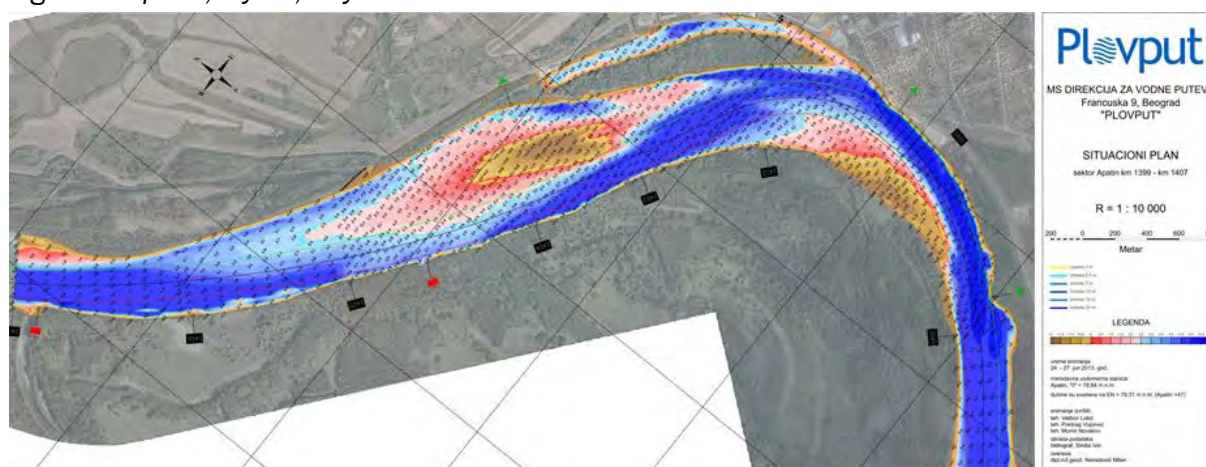
Figure 1: Apatin, layout, July 2013

Layout of the critical sector Apatin from July 2013 is presented in the *Figure 1*. This sector was characterised by positive morphological developments in 2012 and 2013, compared to situation from the late 2011 (when navigation was completely stopped during the low water period, due to insufficient water depth).

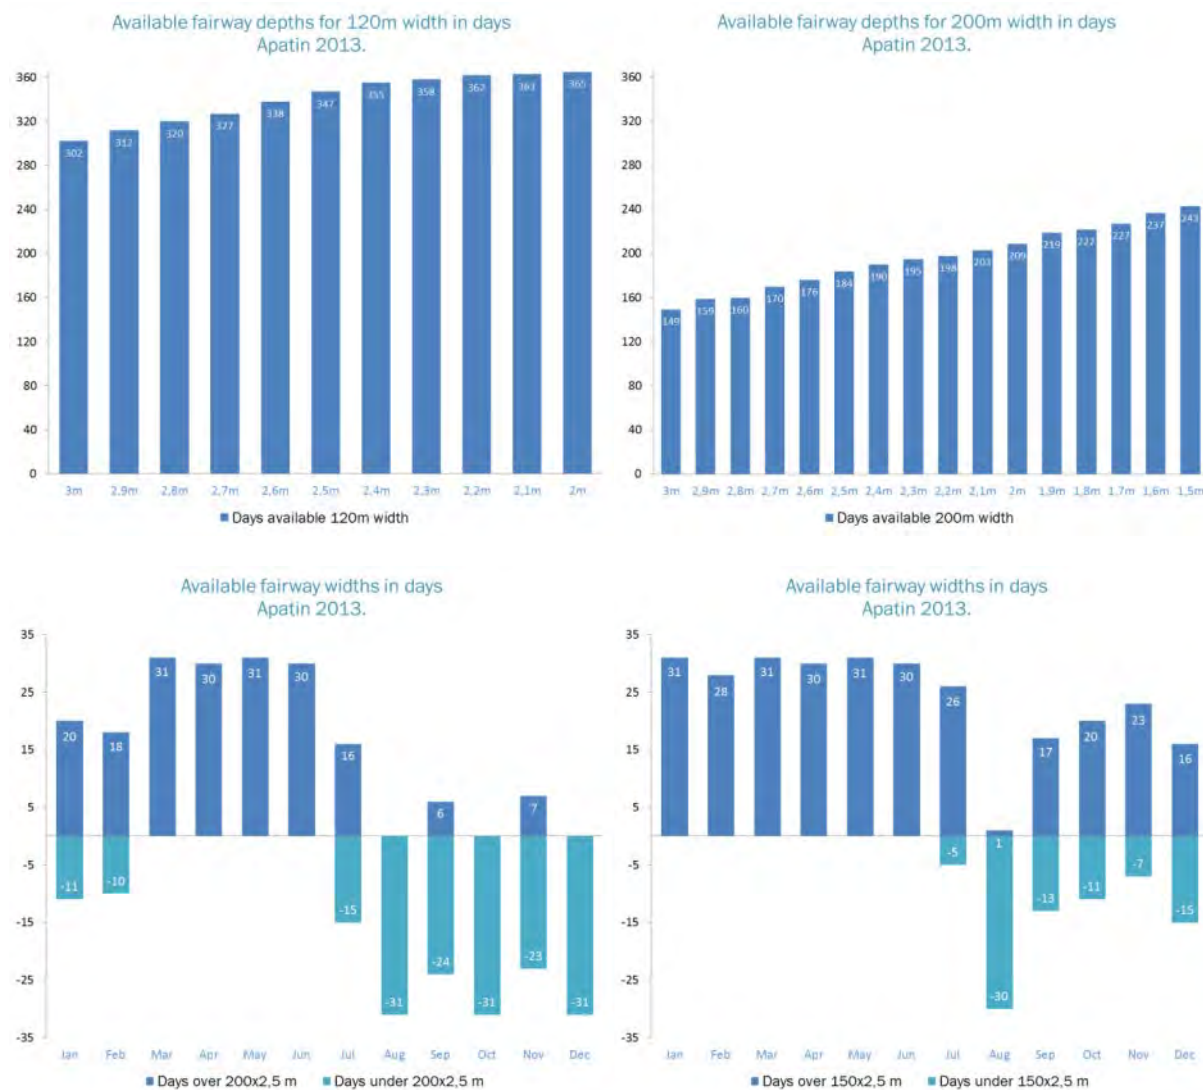
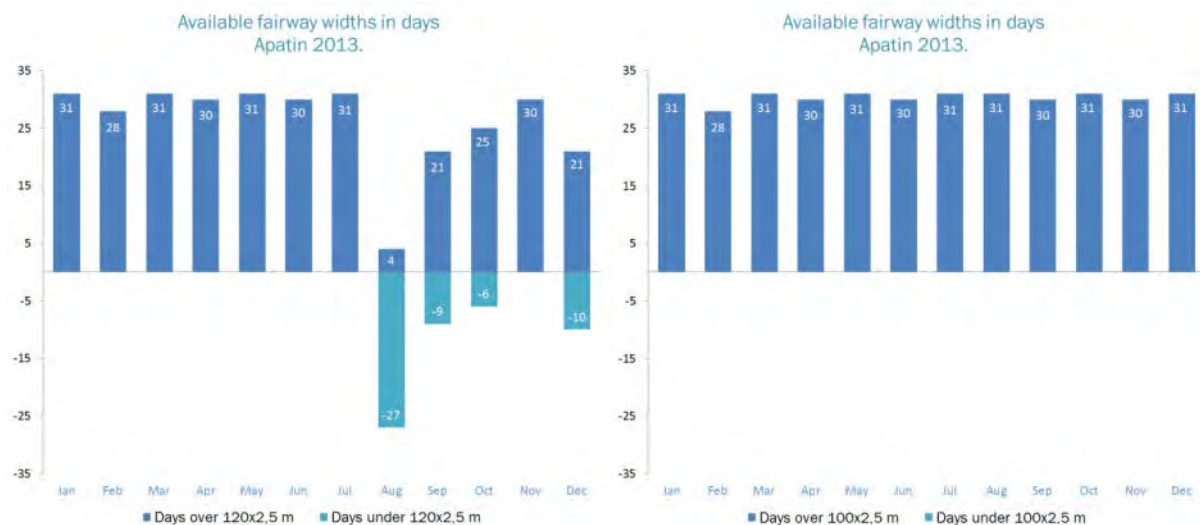
Number of days in 2013 with available fairway parameters are presented in *Figures 2-7*. For reduced fairway width of 100 m, which is the minimum Level of Service for the Republic of Serbia, over the whole year 3.0 m depth was available.

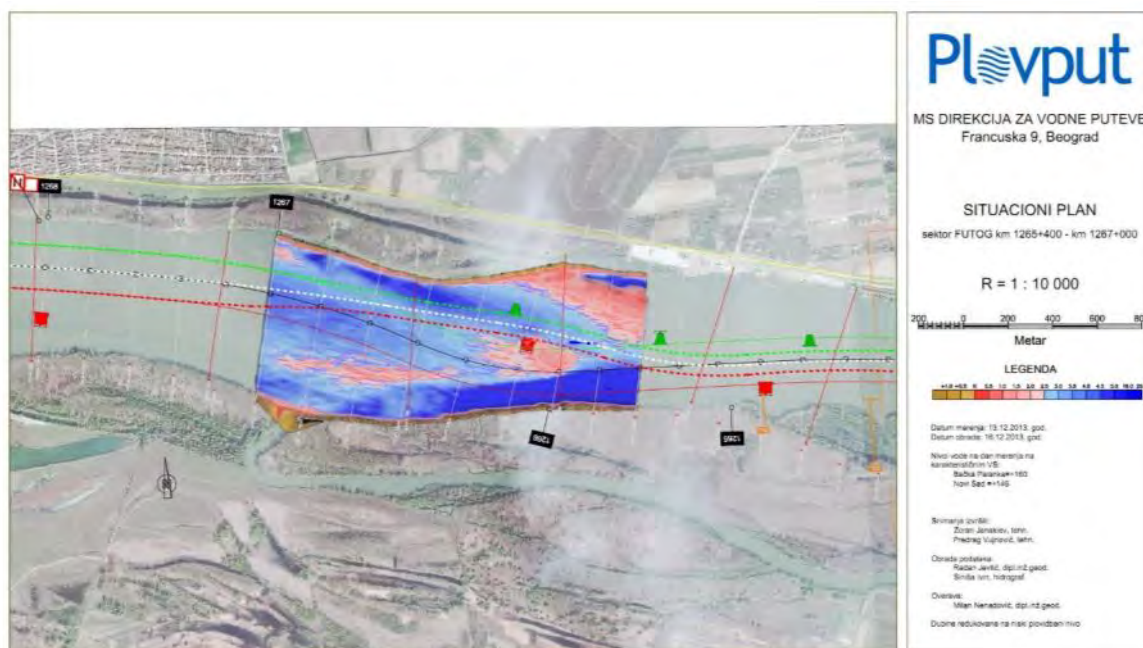
Figure 8: Futog, layout, December 2013

Layout of the critical sector Futog from December 2013 is presented at the *Figure 8*.

depth, due to specific morphological characteristics of this critical sector, which is the reason why this sector is the most critical one for navigation, in terms of available fairway parameters.

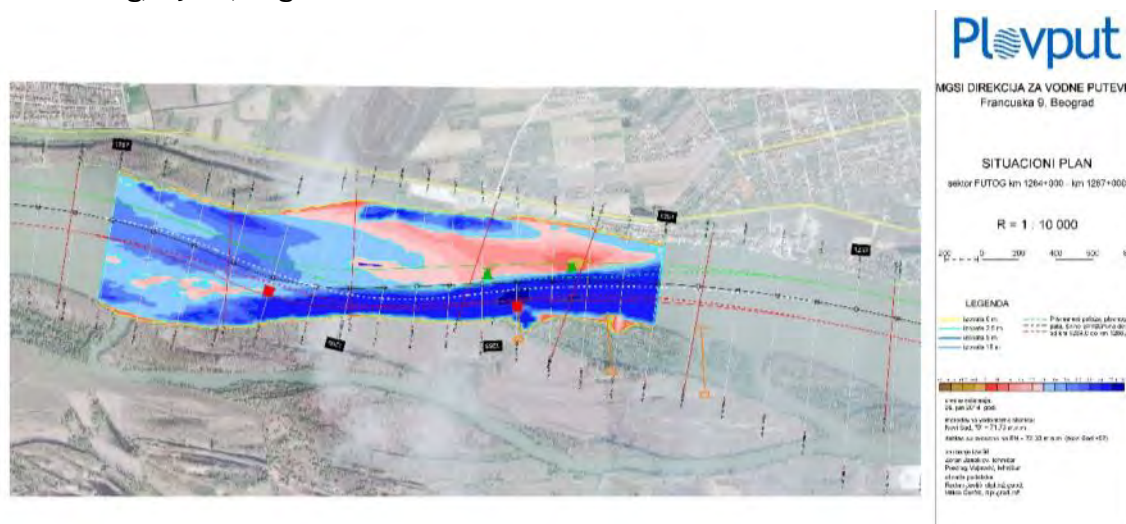
Figure 19: Futog, layout, August 2014

Layout of the critical sector Futog from August 2014 is presented at the Figure 19.

Situation on the critical sector Futog was better in 2014 compared to 2013, having in mind available fairway depth and width. Fairway width is still reduced to the minimum Level of Service, which is 100 m, but fairway depth of 2.5 m was achieved throughout the whole year (365 days), while 2.5 m depth on 120 m width was available for 337 days. Data for 2014 are presented at Figures 20-25, while comparison of data from 2014 and 2013 is given at the Figure 26.

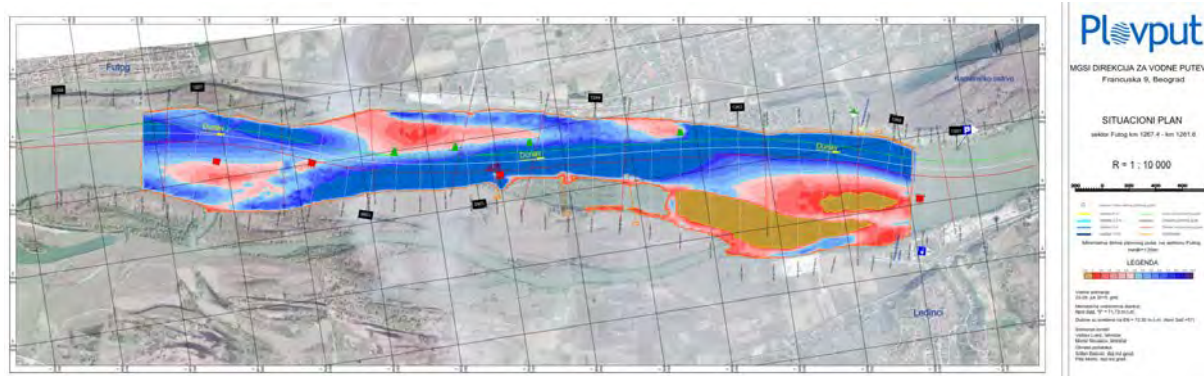
Figure: Futog, layout, July 2015

The situation on the critical sector Futog was a bit worse in the period January-September 2015 compared to respective period of 2014, having in mind available fairway depth and width.

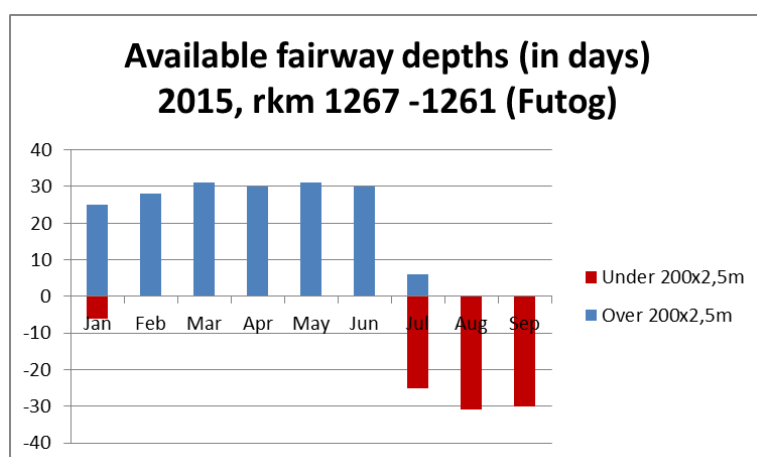
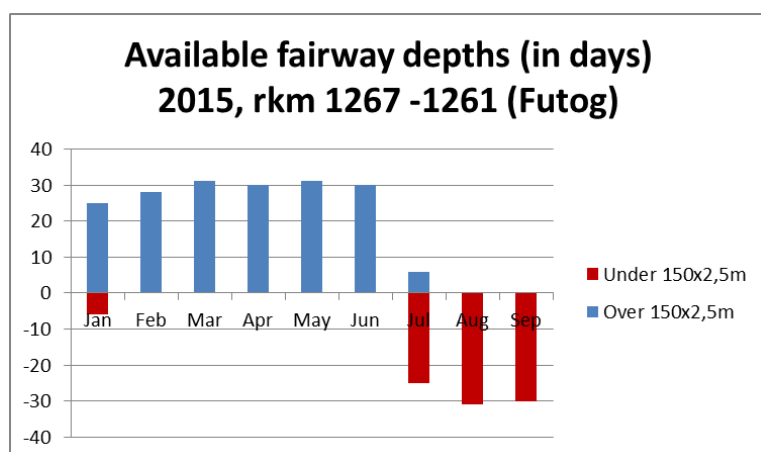
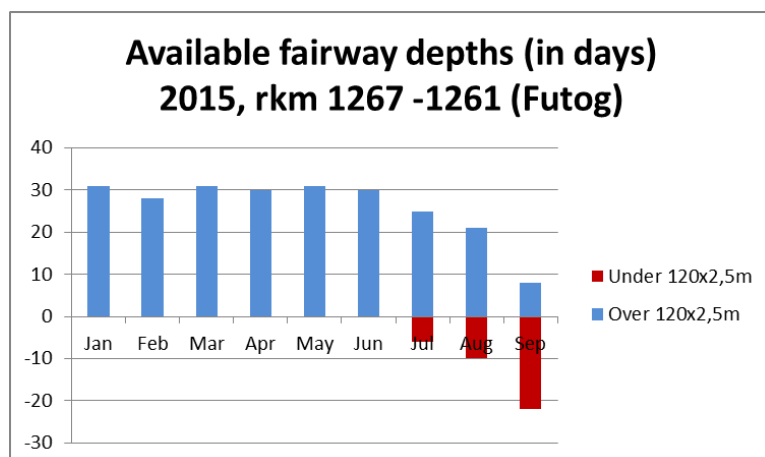
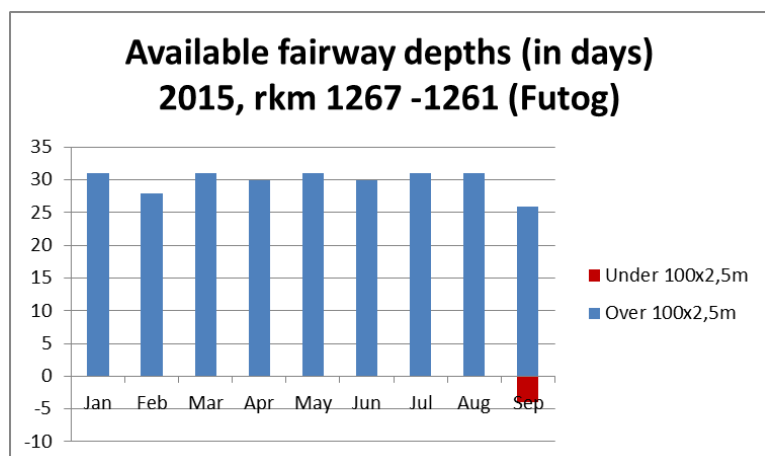
Fairway width is still reduced to the minimum Level of Service, which is 100 m. On the 100 m fairway width, fairway depth of 2.5 m was achieved for 269 days out of 273 days in the period January-September (98.5%). On the 120 m fairway width, fairway depth of 2.5 m was achieved for 233 days out of 273 days in the period January-September (85.3%).

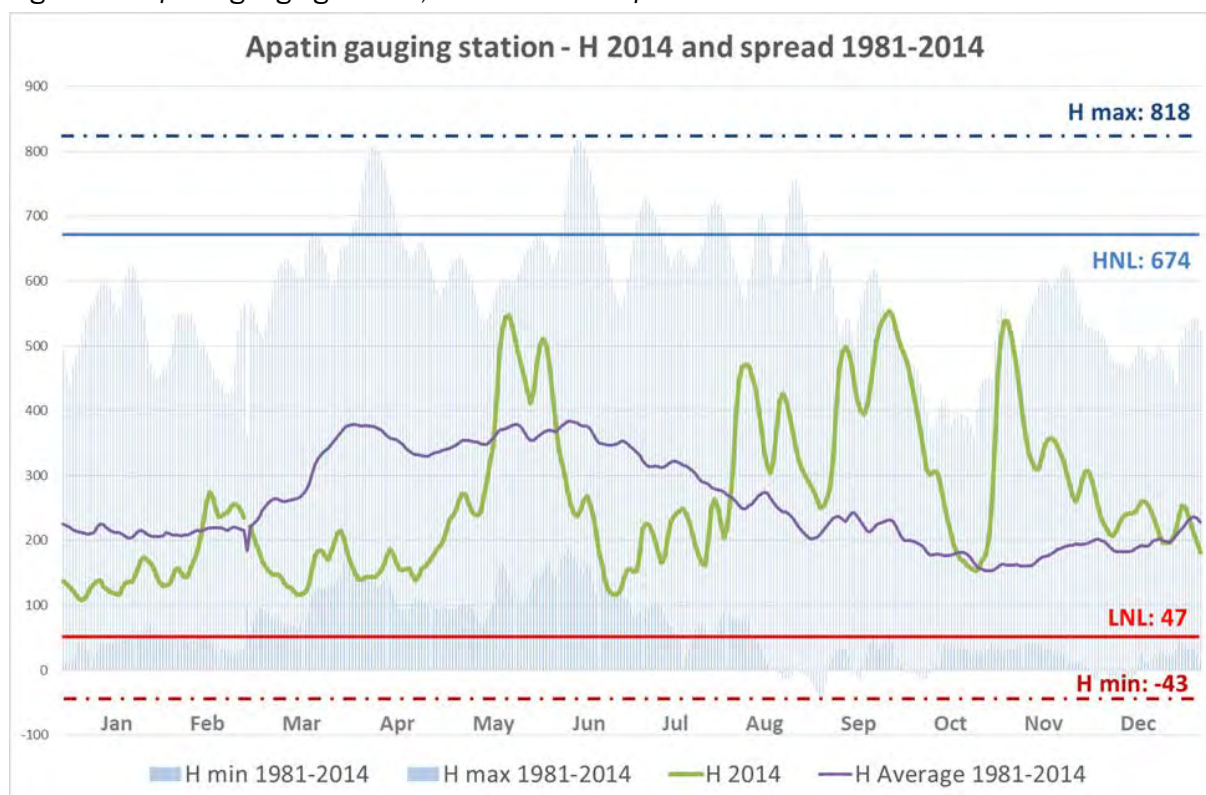
Figure 27: Apatin gauging station, H 2014 and H spread 1981-2014

Water level data for the **gauging station Apatin** are presented in the Figure 27.

For Apatin gauging station, no days below LNWL were recorded for 2012, 2013 and 2014, meaning that hydrological conditions were favourable for navigation. In the period January-September 2015, 18 days with water levels below LNL have been recorded.

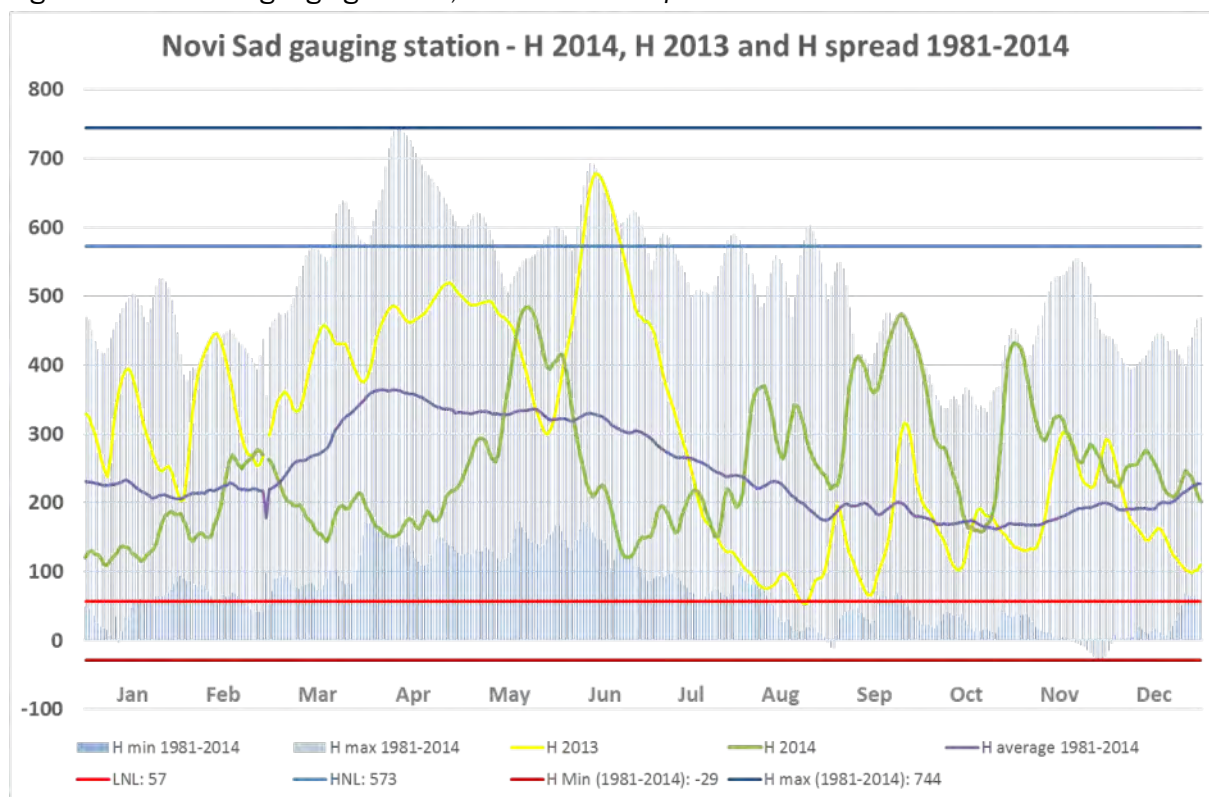
Figure 28: Novi Sad gauging station, H 2014 and H spread 1981-2014

Water level data for the **gauging station Novi Sad** (which is the reference gauging station for the critical sector Futog) are presented in the Figure 27.

For Novi Sad gauging station, no days below LNL were recorded for 2012 and 2014, while only 2 days below LNL were recorded in 2013, confirming that hydrological conditions were favourable for navigation. In the period January-September 2015, 21 days with water levels below LNL have been recorded.
