# **Fairway Rehabilitation and Maintenance Master Plan for the Danube and its navigable tributaries:**

## **NATIONAL ACTION PLANS**

**UPDATE OCTOBER 2017**

Developed within the **EU co-financed project FAIRway Danube**

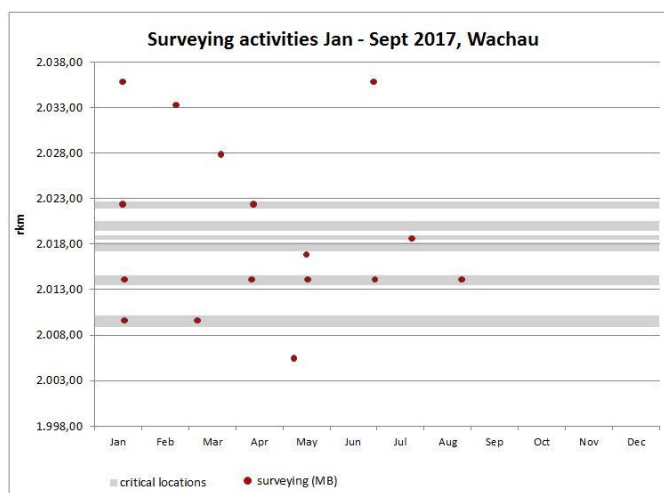
During the first nine months of 2017, the following hydrographic surveys were carried out according to the surveying plan.

In the section Wachau only the most critical location Weißenkirchen (rkm 2013.50 – 2014.60) was surveyed five times.

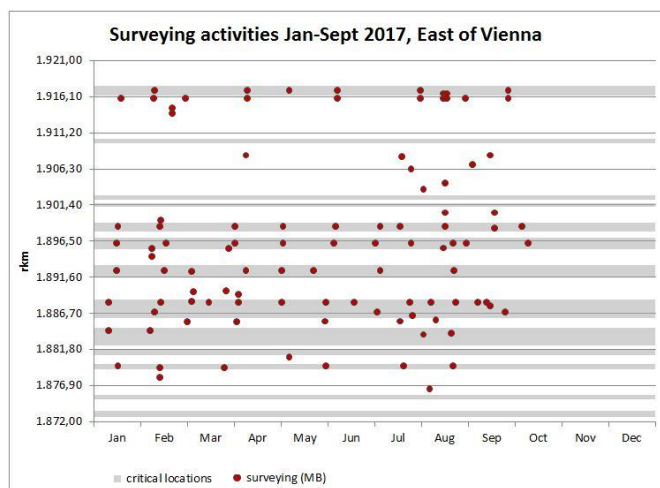
In the Danube section east of Vienna the most critical locations Regelsbrunn, Rote Werd, Petronell-Witzelsdorf and Treuschütt were surveyed monthly. The new critical location Lobau at rkm 1916.30 – 1917.50 is also monitored intensively.

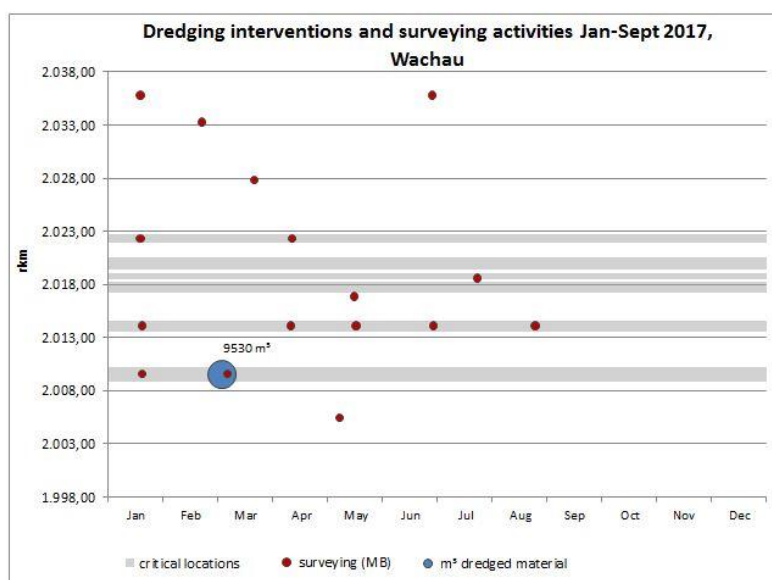
In the period January – September 2017, 243,336 m<sup>3</sup> were dredged for commercial navigation.

The dredging interventions are reported in combination with the surveying activities. This illustrates the strong dependency of dredging works on up-to-date surveying results. Prior to, during and after dredging works the respective critical locations were surveyed in addition to the regular surveying tours.

In the critical section Wachau only the critical location Dürnstein was dredged at the beginning of the year.

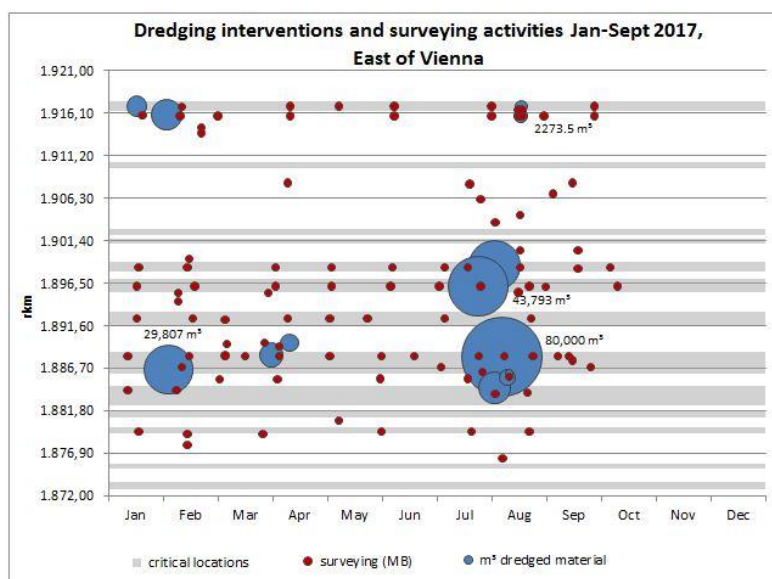
In the section east of Vienna several smaller dredging works were carried out from January to April, the most critical fords were dredged from July to September.

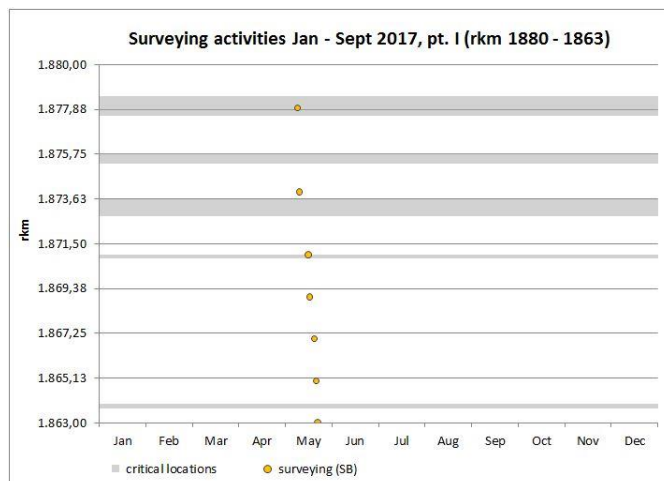
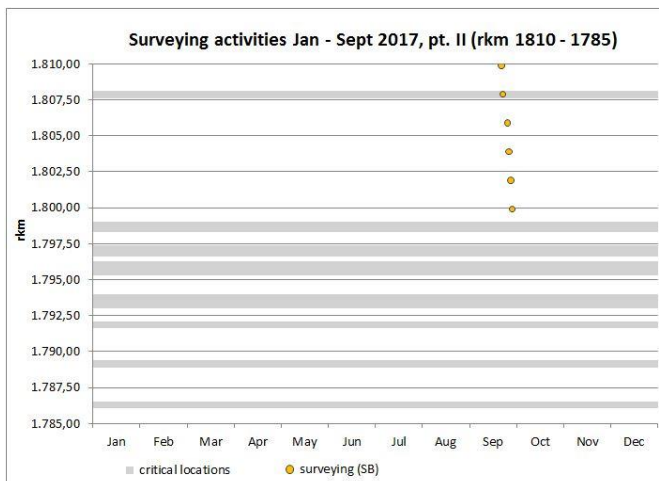
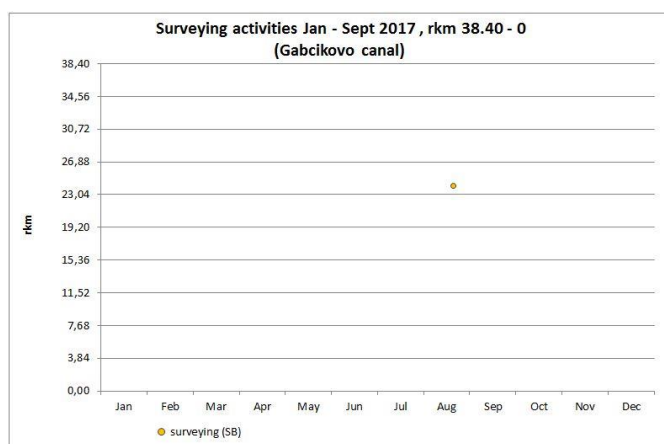
The following river bed surveying activities took place according to the annual procedure. Critical locations are monitored within the yearly measurement of the entire Slovakian stretch, but since 2015 SVP is performing extra measurements of the critical sections besides the entire stretch measurement. Surveying is conducted with a single-beam echo-sounder; the profiles are 50m apart.

The surveys represented in the charts only depict finished surveying tours. Additional tours are ongoing or planned for the next months and will therefore be reported in the next update.

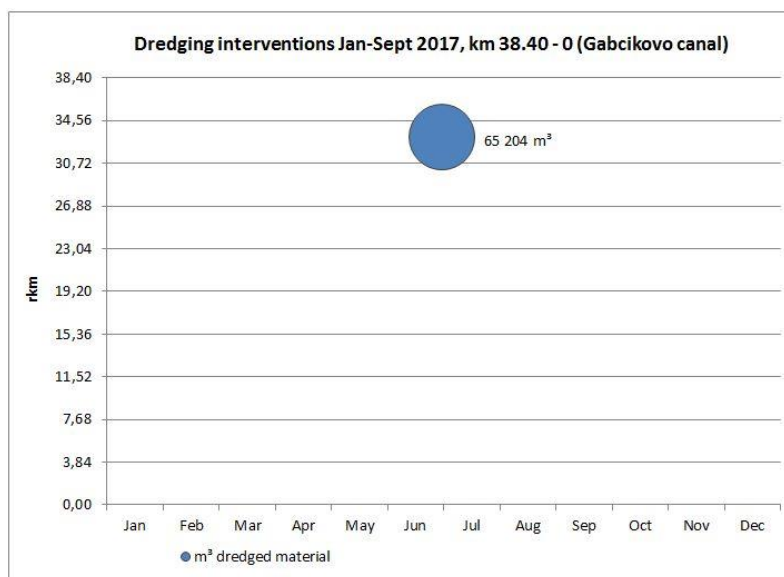
In total, 144 521m<sup>3</sup> were dredged for commercial navigation in period January-September 2017. Dredging from rkm 1865.4 – 1864.5 was conducted from April to September. Dredging in the Gabčíkovo canal from km 34 – 32 was conducted from April to September.

SVP is doing the maintenance of the fairway based on the parameters of the fairway which have to be guaranteed, width of the fairway on rkm 1790 -1880 is 120m (depth 2.5m + 0.2m) and on rkm 1790 – 1709.8 is 150m (depth 2.8m + 0.2m).

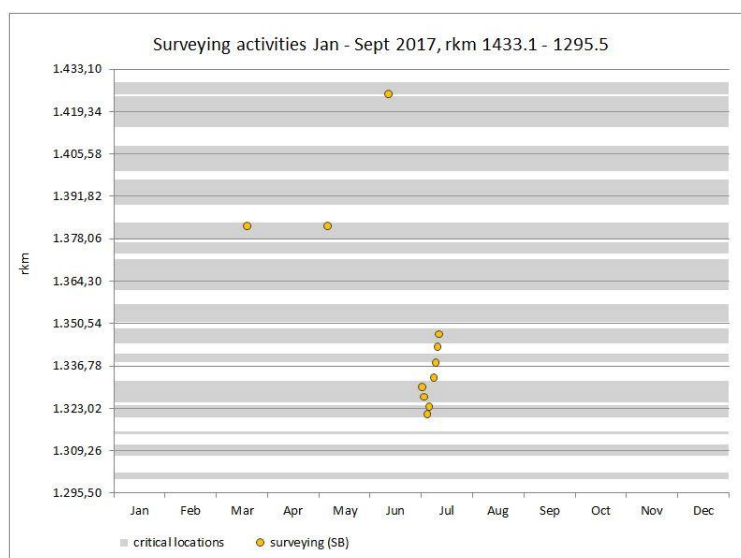
#### Danube

The river bed surveying is done according to an annual surveying plan. This plan consists of annual surveying of the whole Danube sector (single-beam) with main surveying of critical locations and waterway objects on which the maintenance works are planned. The plan also contains surveying of fairway locations for the production of geodetic and morphological surfaces in order to update the technical documentation.

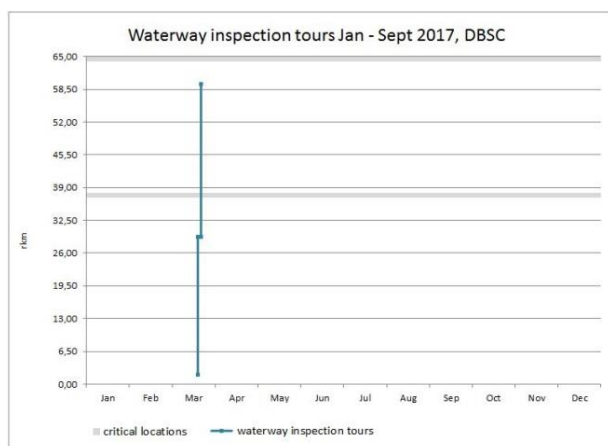
The first inspection tour took place in March 2017 and lasted 4 days. The inspection tour took place both on the Danube-Black Sea Canal and the Poarta Alba-Midia Navodari Canal; the vessel travelled along the longitudinal axis.

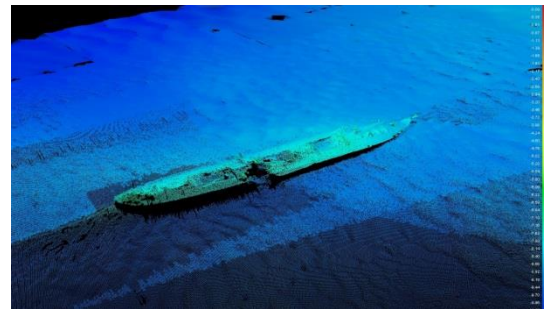
Sunken vessel in the area of Ruse (LiDAR system)

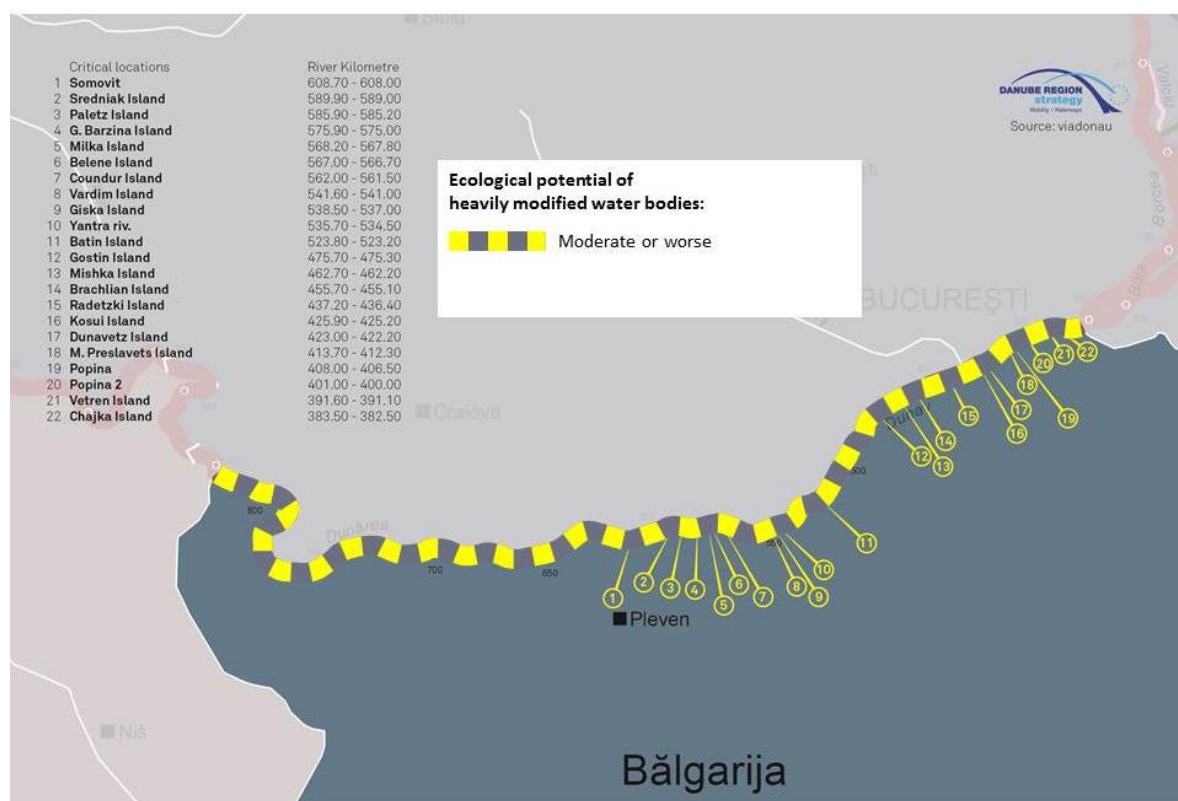
The following map displays the ecological status and ecological potential of the Bulgarian Danube – according to the Danube River Basin Management Plan/Update 2015 – against the background of the critical navigation locations in Bulgaria.

### **Ecological status and ecological potential of surface water bodies**
