Report on Good Navigation Status

(update December 2024)

Project Title:	Fairway Danube II
Project Acronym:	22-EU-TC-FAIRway Danube II and 22-EU-TG-FAIRway Danube II
Project ID :	101122575 and 101122576
Deliverable No:	D2.2
Deliverable Name:	2nd Update of the reports on Good Navigation Status (2024)
Work Package No:	Task 2.2
Due Date:	31.12.2024
Delivery Date:	17.12.2024
Lead Beneficiary:	AT-VIA
Main author:	Viktoria Weissenburger
Dissemination Level:	public (PU)

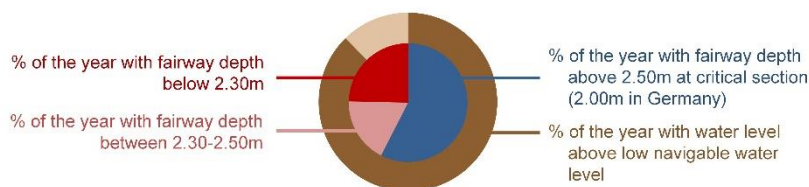
Fairway availability at critical locations along the Danube 2023

The chart provides a status overview of the most important critical locations on the Danube in 2023. For each critical location, the figure illustrates the situation regarding fairway availability (inner circle) in relation to reference water levels (outer circle). The maintenance target is to provide fairway depths equal to or exceeding 2.5 m on at least as many days per year as the statistical Low Navigable Water Level (LNWL). This situation corresponds to the inner blue circle reaching the level of the outer dark brown circle. It is also important to include depths of just under 2.5 m when interpreting the status of critical locations. These allow for a slightly reduced level of navigability although not reaching a depth of 2.5 m.

On some sections of the fairway depths of 2.4 m or 2.3 m (light-red colour in the inner circle) were available on some of the days.

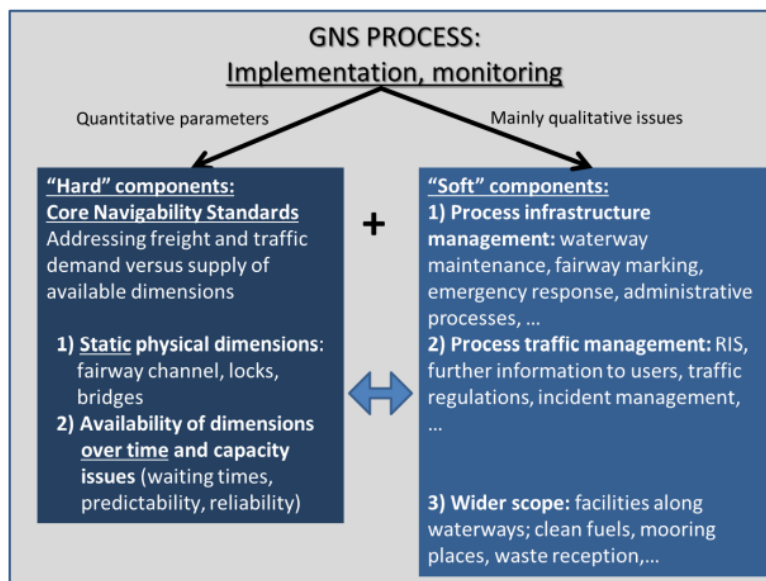
Figure 1: Scheme of the GNS Process (source: Guidelines towards achieving a Good Navigation Status, 2018, Directorate-General for Mobility and Transport Directorate D Waterborne)

Apart from the physical waterway infrastructure, GNS has to be considered in the wider socio-economic scope of waterway management. Thus, to achieve and maintain GNS, both “hard” and “soft” components must be taken into account as illustrated by the following scheme:

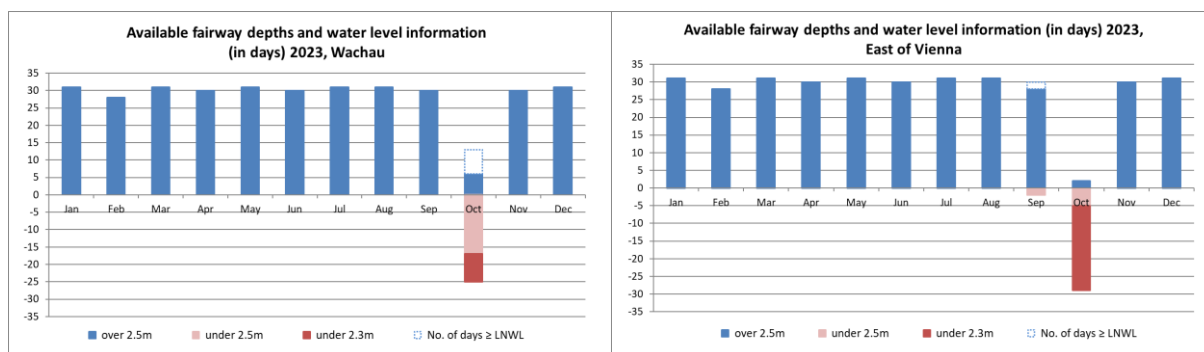
The water discharge in the two free-flowing stretches of the Danube was perfectly average in 2023. The year started with low water levels (yet still above the defined Low Navigable Water Level (LNWL)) and remained above LNWL all through summer. Only in October water levels dropped significantly. LNWL was not reached for 18 days in the critical sector Wachau and for 29 days in the sector East of Vienna.

The critical section East of Vienna is the most problematic section on the Austrian Danube stretch with several fords determining the availability of the navigation channel. In the free-flowing section Wachau, one ford in particular (“Weißkirchen”) determines the availability of the navigation channel.

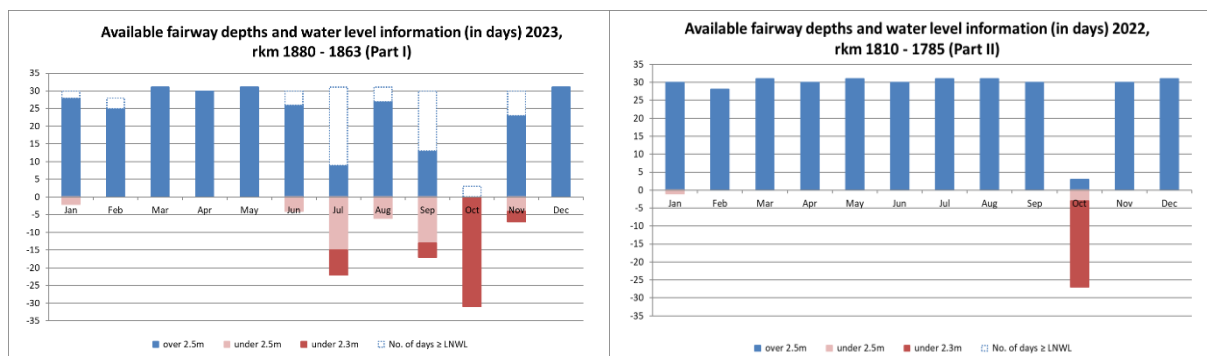
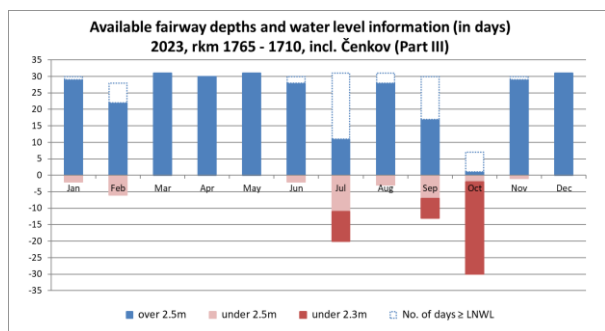
In Slovakia the common Danube stretch with Hungary contains the most critical bottlenecks. In 2023, the most critical bottleneck for navigation was the sector upstream the Gabčíkovo locks (where the target fairway depth of $\geq 2.50\text{m}$ was not achieved for over 90 days) as well as again the location Čenkov (1735,50 – 1733,70; “Nyerges gázló” in HU).

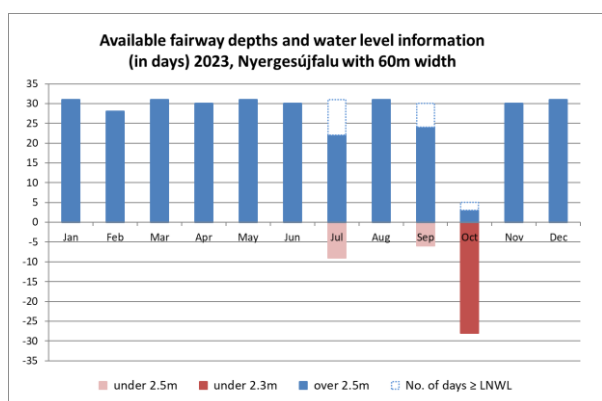
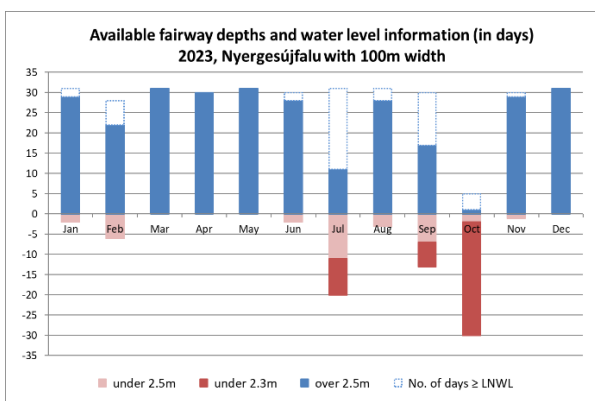
In the critical location Nyergesújfalu or Nyerges gázló (1735,50 – 1733,70; “Čenkov” in SK) the riverbed consists not of gravel but rocky bottom and maintenance activities soon reach their limits; only physical intervention could solve the problem. Whenever water levels drop this location becomes a major obstacle for navigation. A reduction of the fairway width is thus often the only option.

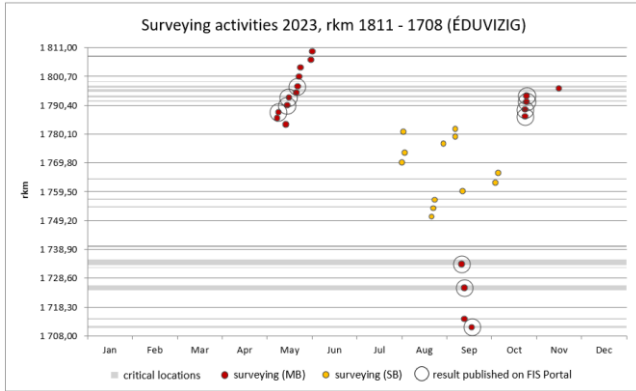
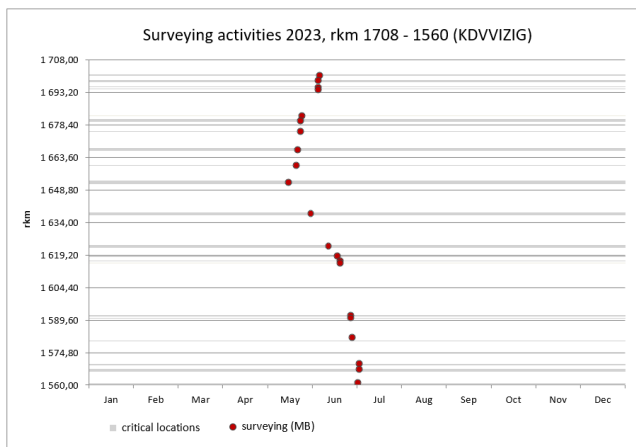
Riverbed surveying activities 2023

The (timely) publication of surveying results on the FIS Portal is lacking. Bathymetric data on bottlenecks is however published on PannonRIS. No data from ADUVIZIG. However, in the lower part of the Hungarian Danube the critical location “Solt” was surveyed twice in 2023.

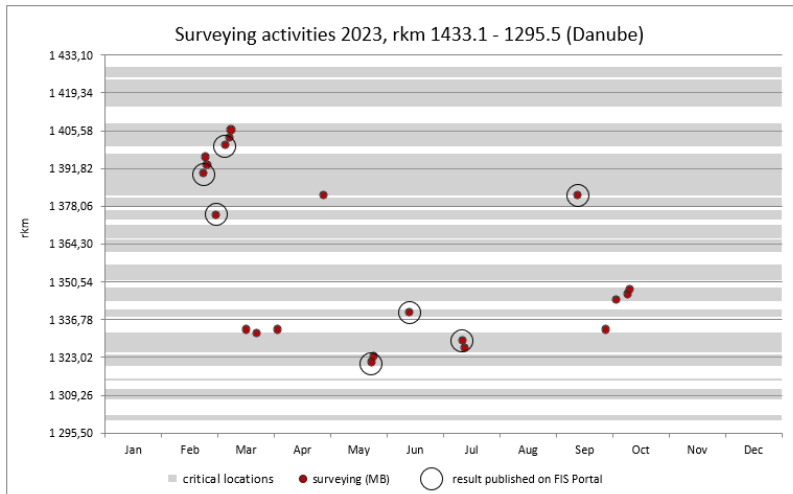
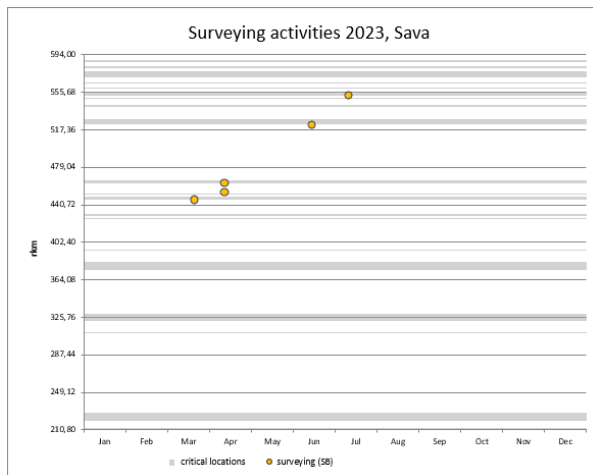
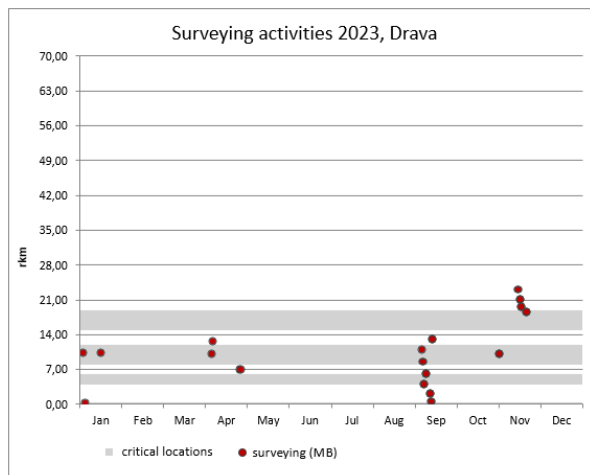
Regular monitoring of the fairway is performed approximately every two weeks by means of single-beam technology as part of the regular marking tours (with marking vessels) in order to control fairway dimensions, critical locations for navigation and the positioning of navigation marks.

Detailed riverbed surveying is performed when required on specific sections in order to determine the detailed riverbed morphology.

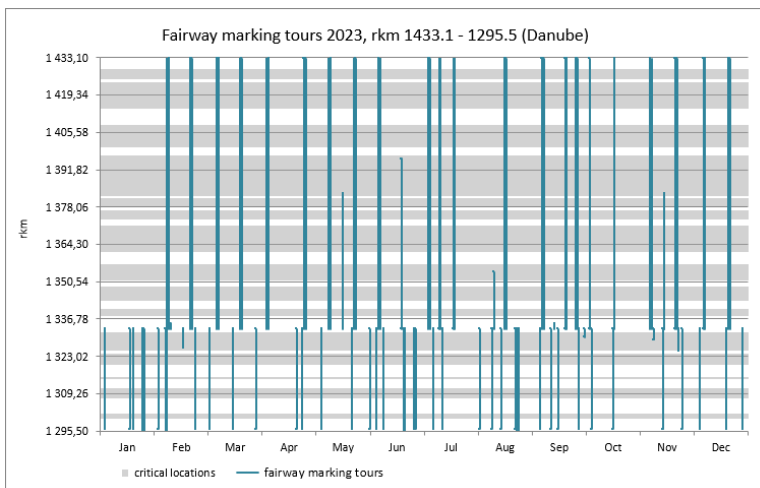
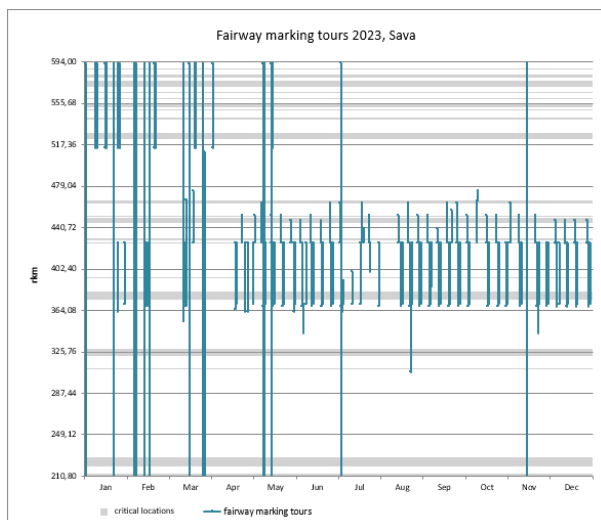
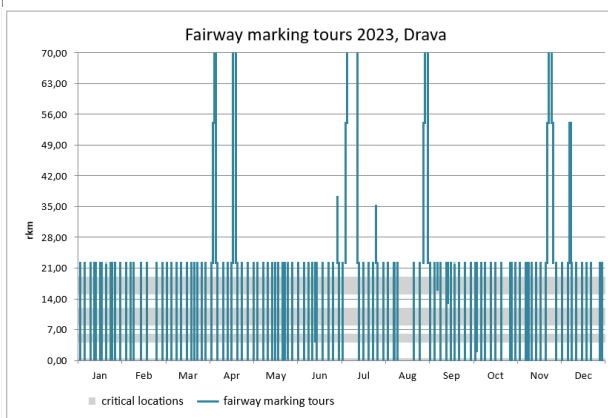
Fairway marking activities 2023

The marking vessel is equipped with an echo-sounder, so the marking tours also serve as quick checks of the fairway. Nevertheless, data is not post-processed but used solely for the purpose of marking. The fairway marking is done approximately every two weeks on the Danube and Sava, based on a work plan.

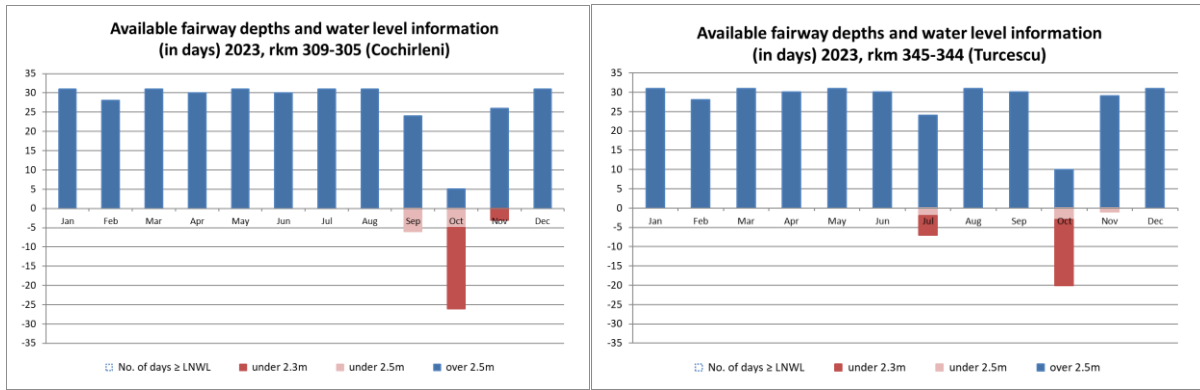
In the downstream sector of Calarasi (Caragheorghe and Cochirleni), depths below 2.50m have been encountered only for October and few days in September, amounting to 37 days in the most critical location Cochirleni. In the maritime sector of the Danube the year 2023 showed good navigation conditions. It is noteworthy that in this sector the minimum navigation depth is 7.32m (24 feet).

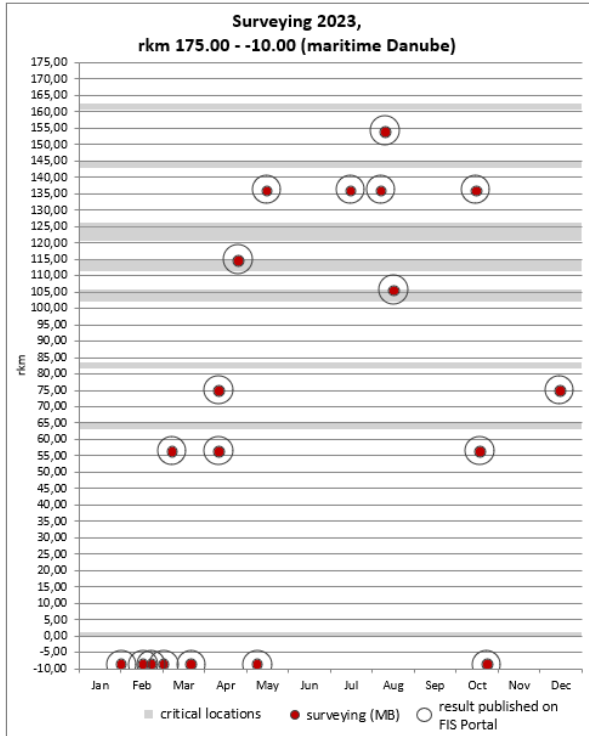
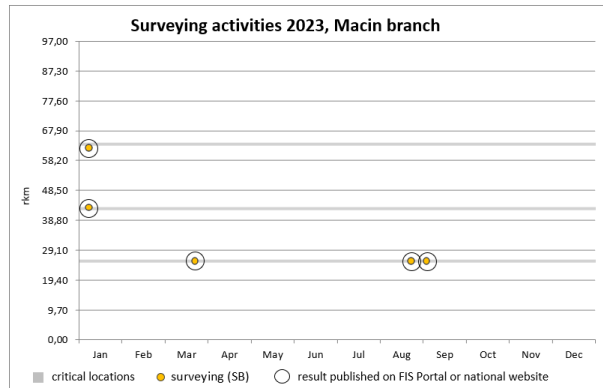
Riverbed surveying activities 2023

Altogether, over 140 surveying tours were conducted on the entire Romanian Danube sector. Most surveying results were published soon afterwards on FIS Portal.

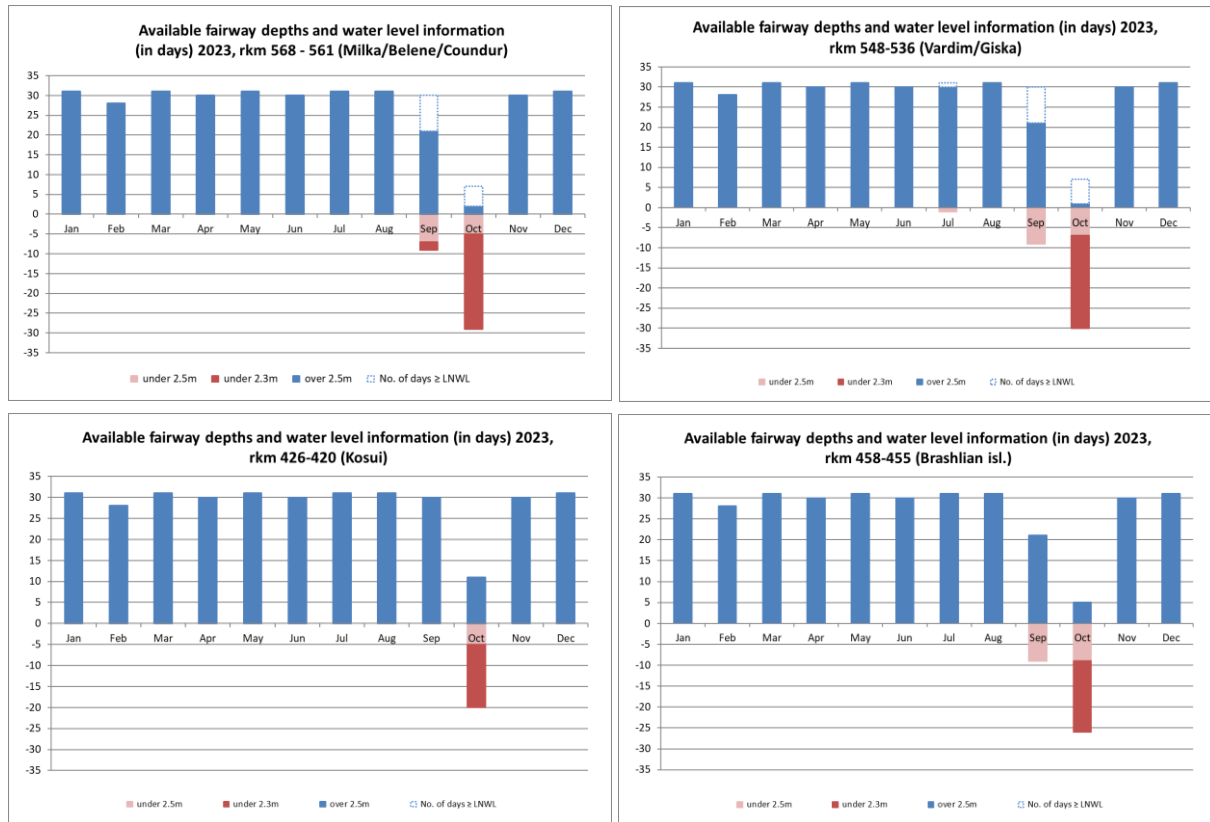
For the sector between Ruse and Somovit limiting bottlenecks were Belene and Vardim (rkm. 565.000 – 563.000 and rkm. 547.000 – 544.000), while for the sector between Ruse and Silistra limiting bottlenecks were Mishka and Brashlyan (rkm. 463.000 – 460.000 and rkm. 458.000 – 455.000).

In 2023, the target fairway depth of 2.50m was achieved on 325 days for 80m fairway width and on 362 days for 60m fairway width.

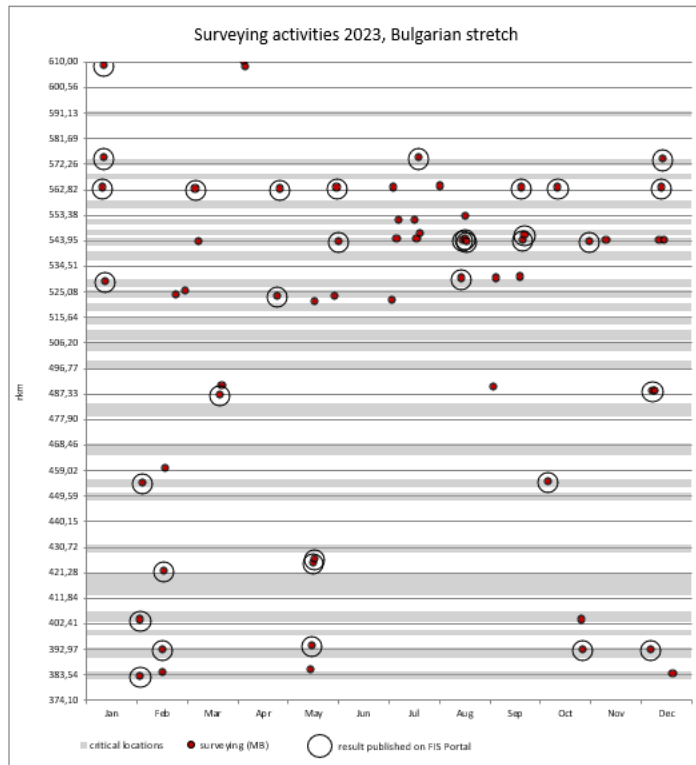
Riverbed surveying activities 2023

In 2023 EAEMDR received a new multibeam echo-sounder and LiDAR, purchased within the project "Improvement of the navigation conditions on the Danube river through delivery of hydrographic equipment" under the Operational Programme "Transport and transport infrastructure". EAEMDR performed 64 hydrographic surveys in 2023. The obtained data is processed and published on the agency's website, WAMOS, and on the Danube FIS Portal. It has to be mentioned that additionally, also data from the marking tours is published on FIS Portal, if it is more recent.
