# FAIRway Danube II Next step towards Good Navigation Status on the Danube (twinned project)

Deliverable number :	D2.1 - D9
Deliverable name :	(T2.2) 1st Update of the reports on Good Navigation Status (2023)
Work Package number :	WP2
Due date :	31 Dec 2023
Delivery date :	22 Dec 2023

# **Report on Good Navigation Status**

Status 2022

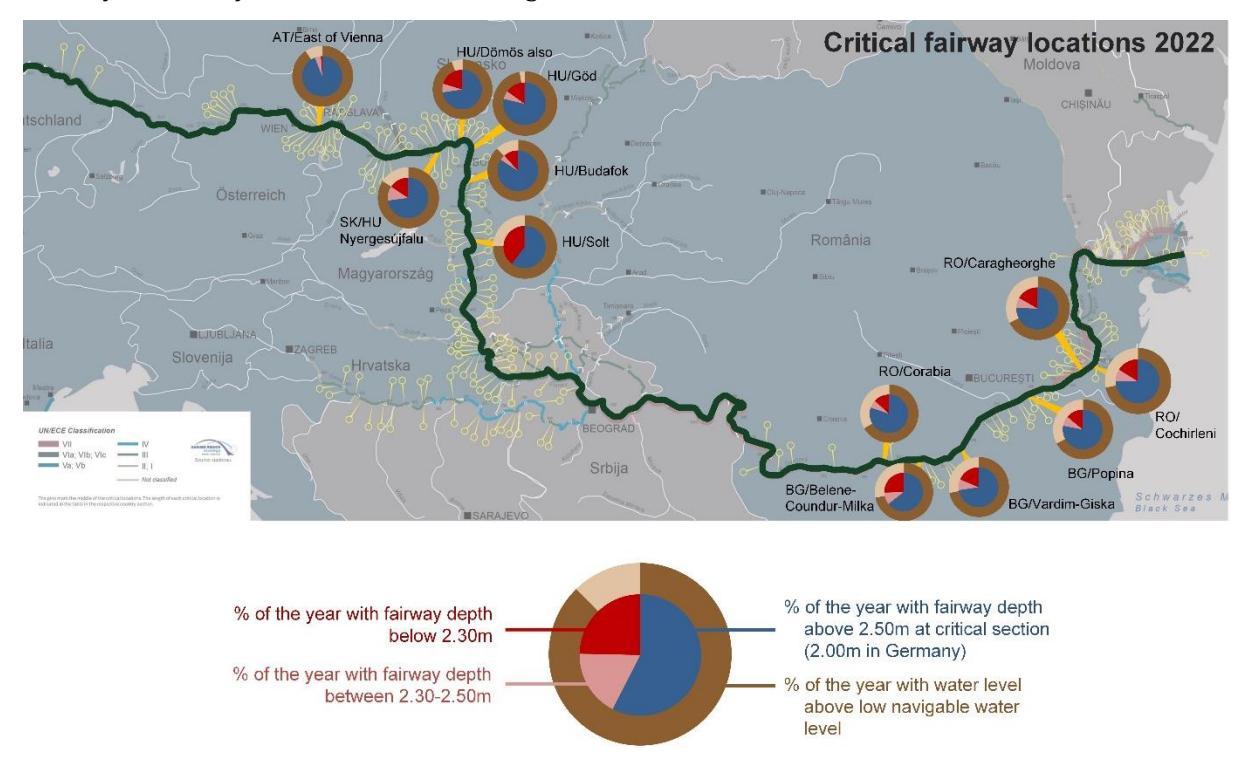
Fairway availability at critical locations along the Danube 2022

The chart provides a status overview of the most important critical locations on the Danube in 2022. For each critical location, the figure illustrates the situation regarding fairway availability (inner circle) in relation to reference water levels (outer circle). The maintenance target is to provide fairway depths equal to or exceeding 2.5 m on at least as many days per year as the statistical Low Navigable Water Level (LNWL). This situation corresponds to the inner blue circle reaching the level of the outer dark brown circle. In 2022, this maintenance target was not achieved in several critical locations along the Danube.

It is also important to include depths of just under 2.5 m when interpreting the status of critical locations. These allow for a slightly reduced level of navigability although not reaching a depth of 2.5 m. On some

sections of the fairway depths of 2.4 m or 2.3 m (light-red colour in the inner circle) were available on some of the days.

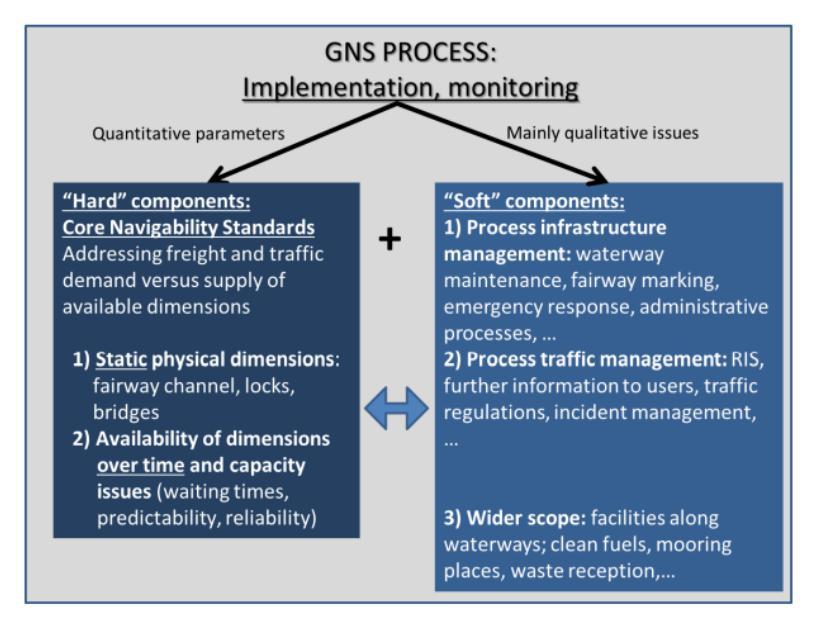
Figure 1: Scheme of the GNS Process (source: Guidelines towards achieving a Good Navigation Status, 2018, Directorate-General for Mobility and Transport Directorate D Waterborne)

The GNS "hard" components relate to the physical waterway infrastructure as a direct output of waterway management. Indicators for the "hard" components are measurable parameters which describe the physical dimensions of the navigation channel in rivers, canals and lakes (e.g. depth) and of locks, ship lifts and bridges, as well as their availability over time (e.g. closures).

The GNS "soft" components relate to management aspects of both infrastructure (e.g. fairway maintenance) and traffic (e.g. RIS), as well as the availability of wider facilities along waterways and in ports (e.g. mooring places, waste disposal facilities) which contribute to the Level of Service on and along the waterways. The "Fairway Rehabilitation and Maintenance Master Plan" contains an overview of existing critical waterway sections or locations to be monitored and defines – for each riparian state – the key issues and

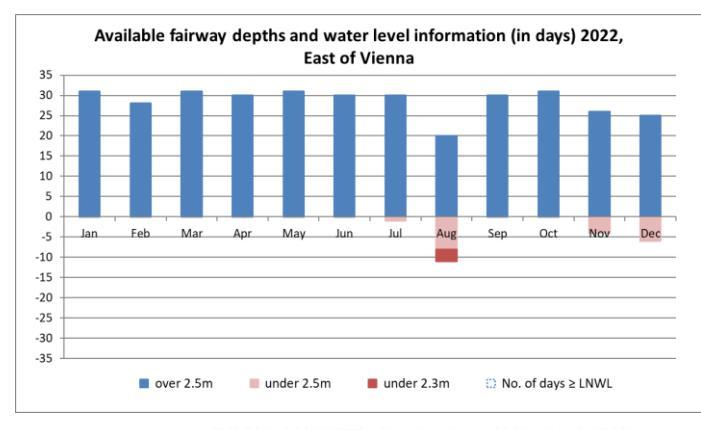
The water discharge in the two free-flowing stretches of the Danube was below average in 2022: In six months of the year, individual days were characterised by low water. The water discharge was below mean water on about 85 % of the days of the year. In 2022, the water level at the Wildungsmauer gauge (LNWL at 162 cm) in the free-flowing section east of Vienna fell below the defined low navigable water level on 35 days. At the Kienstock gauge in the free-flowing section of Wachau, the defined low navigable water level (at 164 cm) was not reached on 5 days.

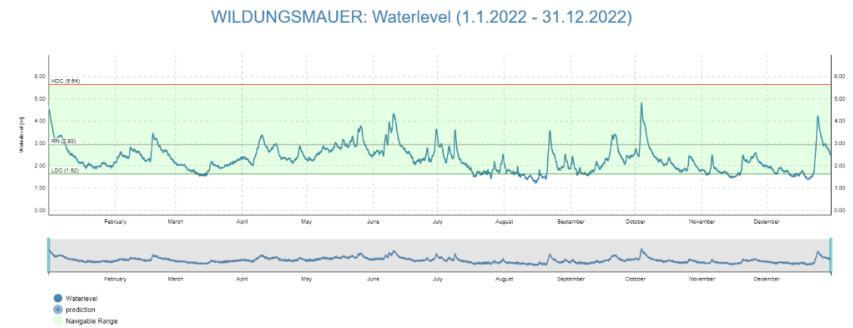
The critical section East of Vienna is currently the most problematic section on the Austrian Danube stretch.

In the free-flowing section Wachau, one ford in particular ("Weißenkirchen") determines the availability of the navigation channel.

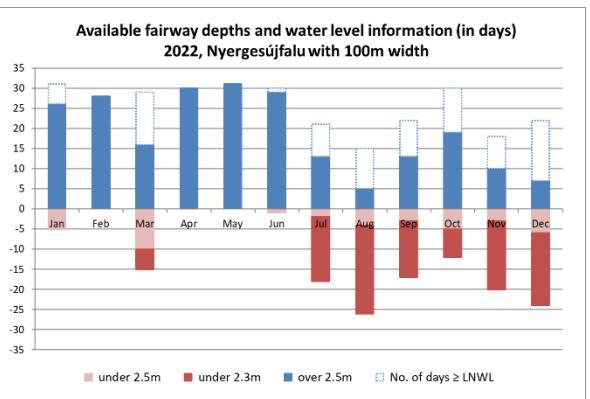
In the critical location Nyergesújfalu or Nyerges gázló (1735,50 – 1733,70; "Čenkov" in SK) the consists not of gravel but rocky bottom and maintenance activities soon reach their limits; only physical intervention could solve the problem. Whenever water levels drop this location becomes a major obstacle for navigation.

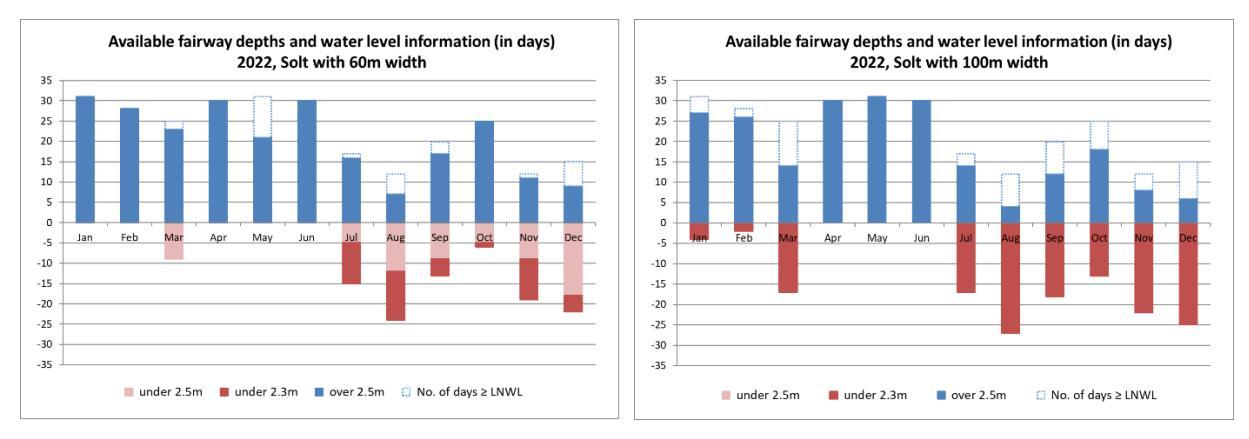
Even after fairway widths were reduced to 60m 2.50m fairway depth were only achieved for 223 days in the navigation channel.

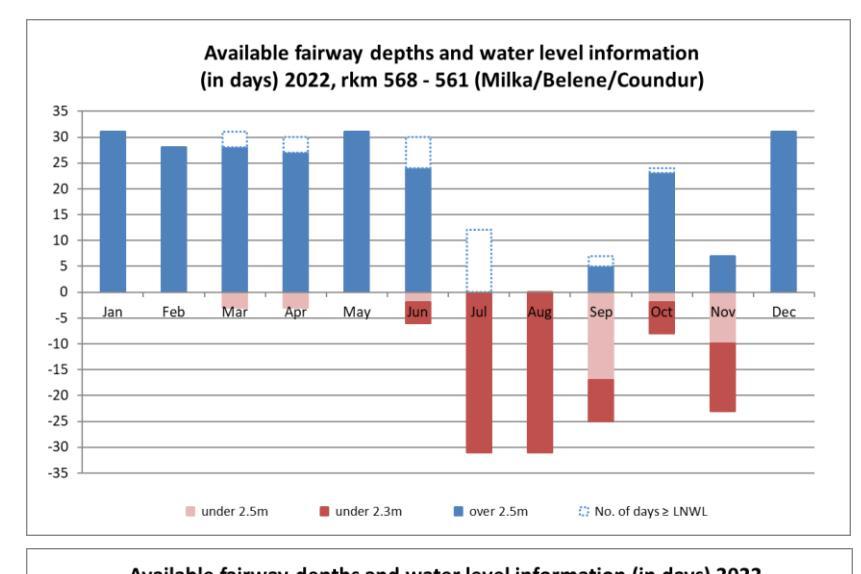
Number of days with recorded water levels under LNWL: 105 days (which is 31% of the year 2022). Number of days with below normal water level/below the multiyear average for the day: 277 days (which is 76% of the year).

On 69 days historically low water levels were recorded for that specific day. The lowest water level for Ruse station (-) 72 cm was recorded on 22.08.2022 and 23.08.2022, which is only one centimeter for absolute minimum the measured in 2003. For the Svishtov gauging station, the lowest water level was (-) 29 cm, which was recorded on 20.08.2022, 21.08.2022 and 23.08.2022, bringing us closer to the absolute minimum of (-) 55 cm, measured in 2003.

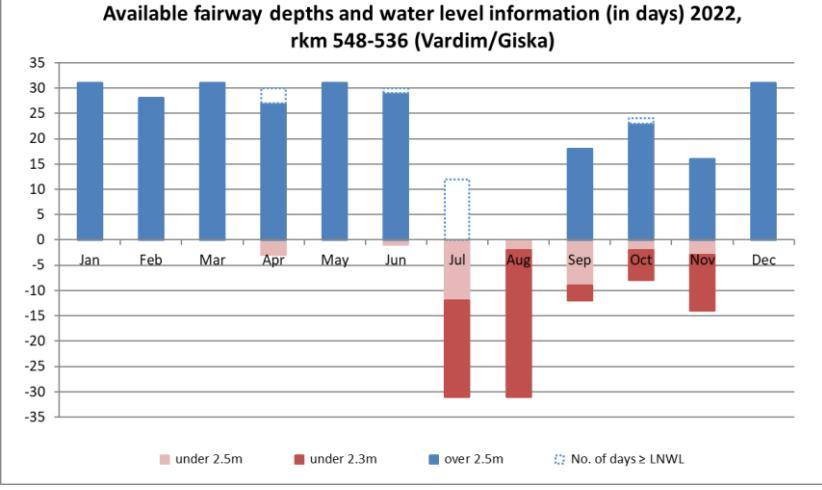
In 2022, the target fairway depth of 2.50m was achieved only on 207 days for 80m fairway width and on 224 days for 60m fairway width. The most critical bottleneck for navigation was again the section in the Belene Island area (rkm 565.000 – rkm 563.000) with a depth of 19 to 14 dm and a fairway width of 60 m on 141 days.
